New Jersey Transit: Rear Back-Up Camera
Replacement

Issue: Back-Up Camera Failing – Connector Terminals Corroding

Engineering Documentation: ECN#: N13-32863

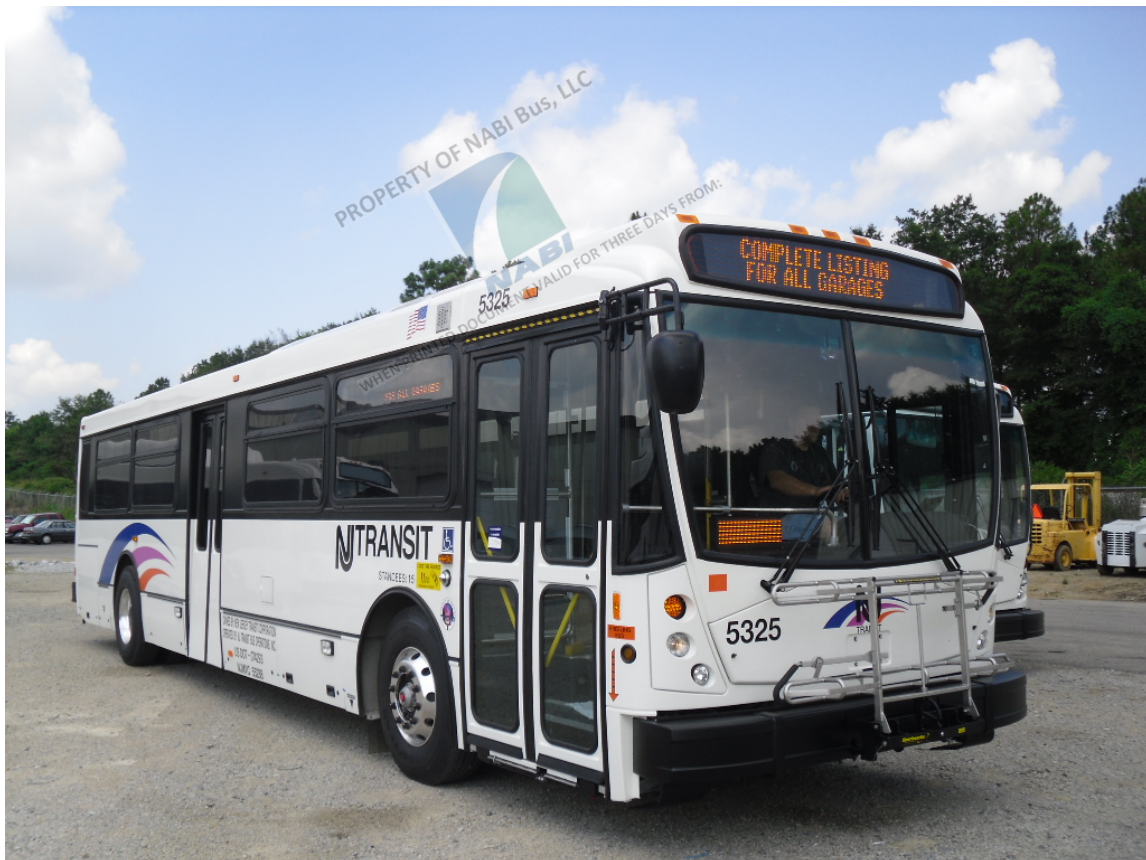
Reason/ cause: Existing Back-Up Camera Does Not Hold Up to Vibration – Wire Connectors Not Weatherproof

Solution: Replace Existing Back-Up Camera with More Robust Camera – Replace Connectors with Weatherproof Connectors .

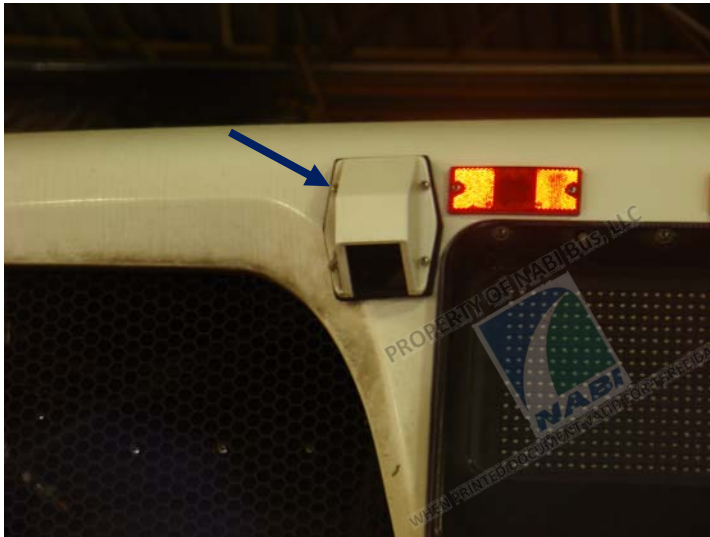
1. Park the bus and apply the parking brake.
2. Shut off the batteries using the battery disconnect switch.
3. Locate the rear cover for the back up camera (see below) and remove the camera cover.

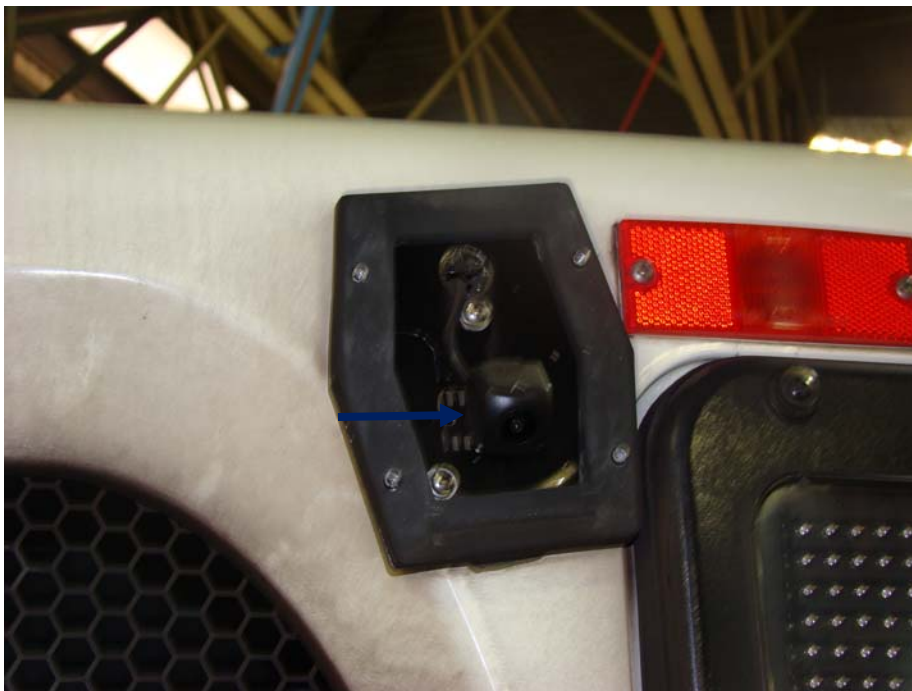
4. Remove the small screw that fastens the camera to the mounting bracket (see below).

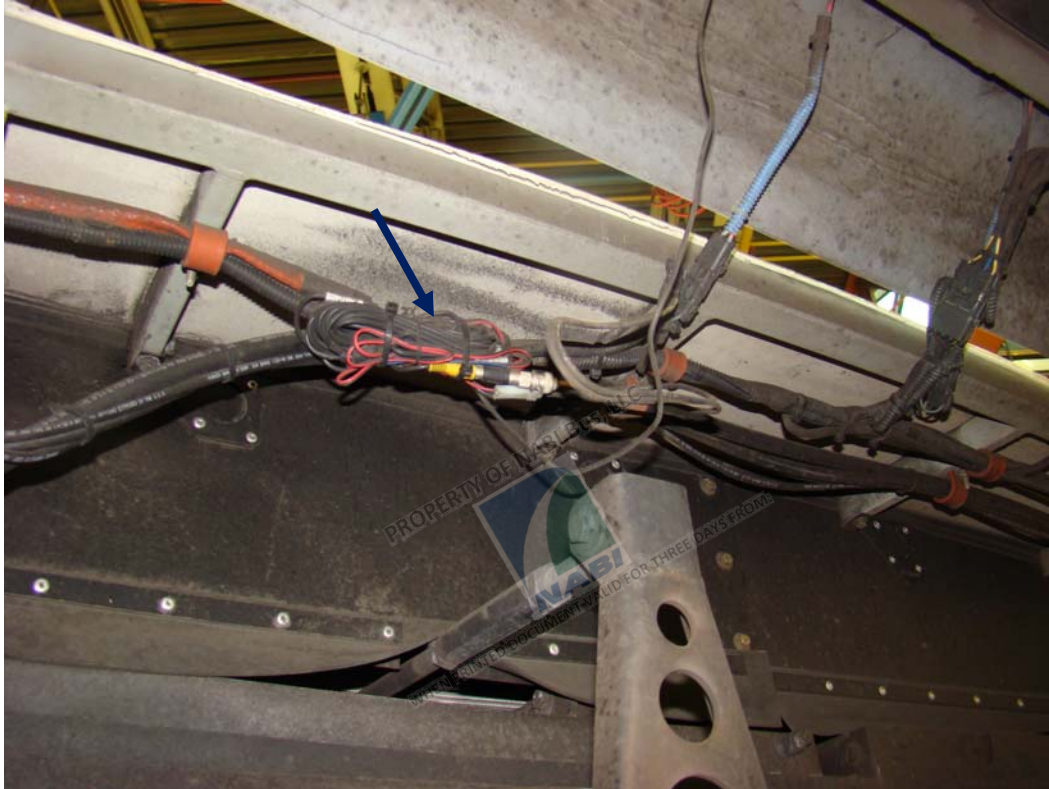
5. Open the upper rear engine door and locate the camera harness (see below).

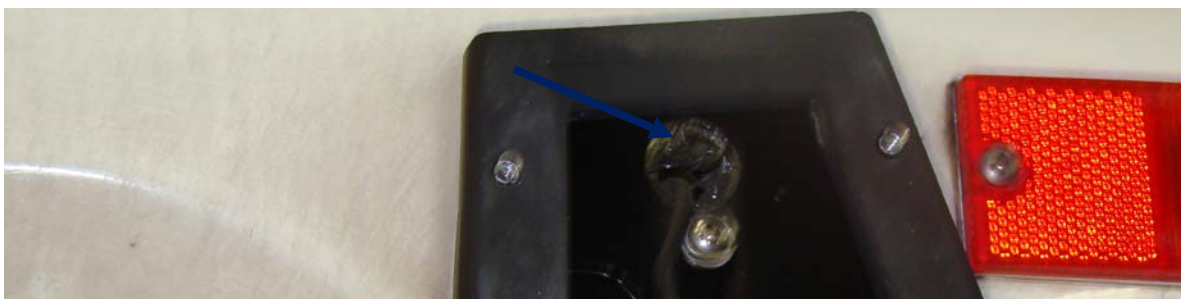
6. Disconnect the camera harness from the bus side connector and discard the removed camera & harness.
7. Remove the existing bus side connector (Molex, not Coax) & install terminals (500-1682-137), connector (500-1682-137) & lock (500-1682-138).
8. Close the upper rear engine door.
9. Remove the backing plate for the camera and enlarge hole in rear upper engine door where the removed camera harness ran through to 13/16" (see below).

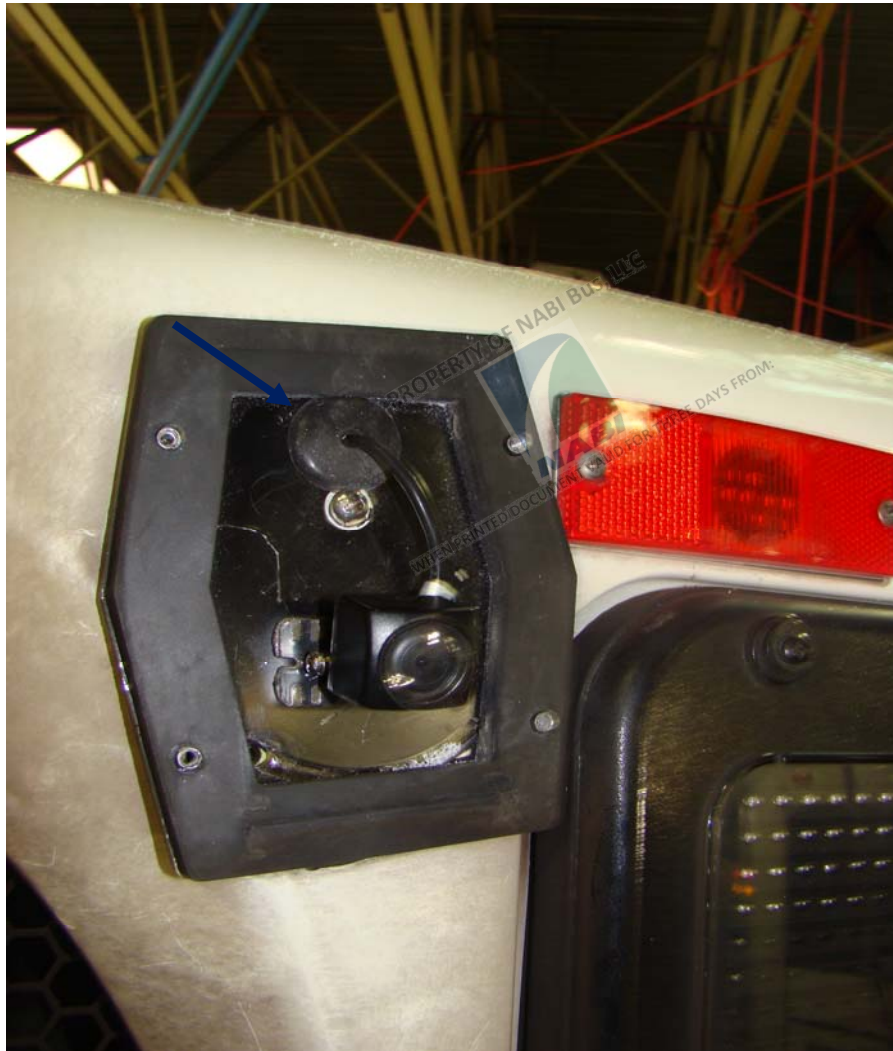
10. Reinstall backing plate (replace any failed rivet nuts as needed).
11. Install new camera (192-1635-001) to existing mounting bracket (leave loose) & route new camera cable through the previously enlarged hole.
12. Install rubber grommet (provided with camera) into the hole on the backing plate (see below).

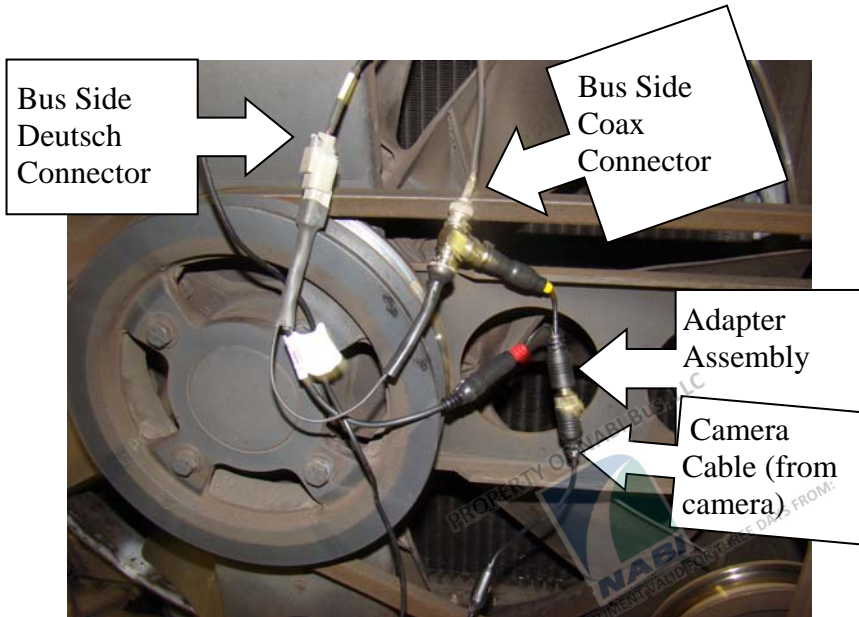
14. Install adapter assembly (531-1635-010) to the previously installed camera cable in step 11, the existing coax bus side cable & to the connector installed in step 7 (see below).

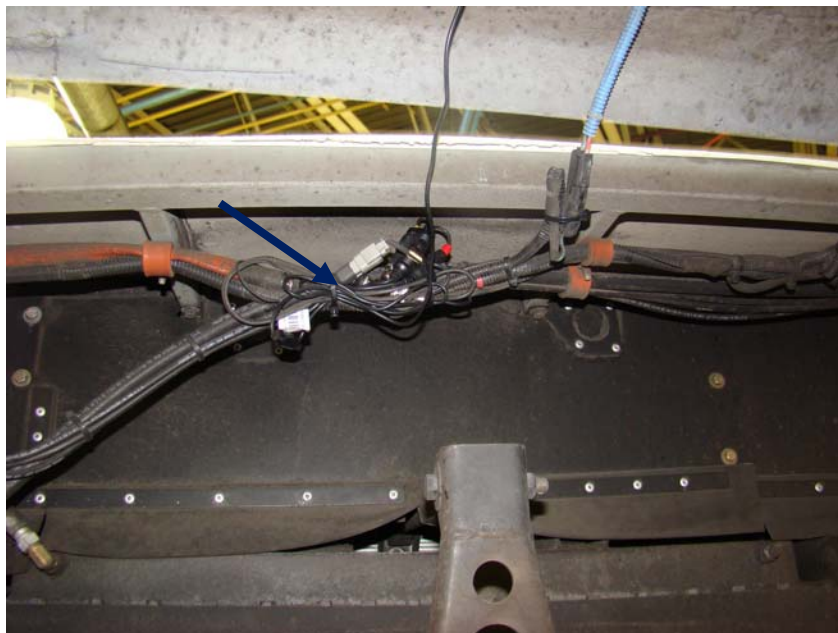
15. Secure the new adapter assembly and camera cable with wire ties as shown (see below).

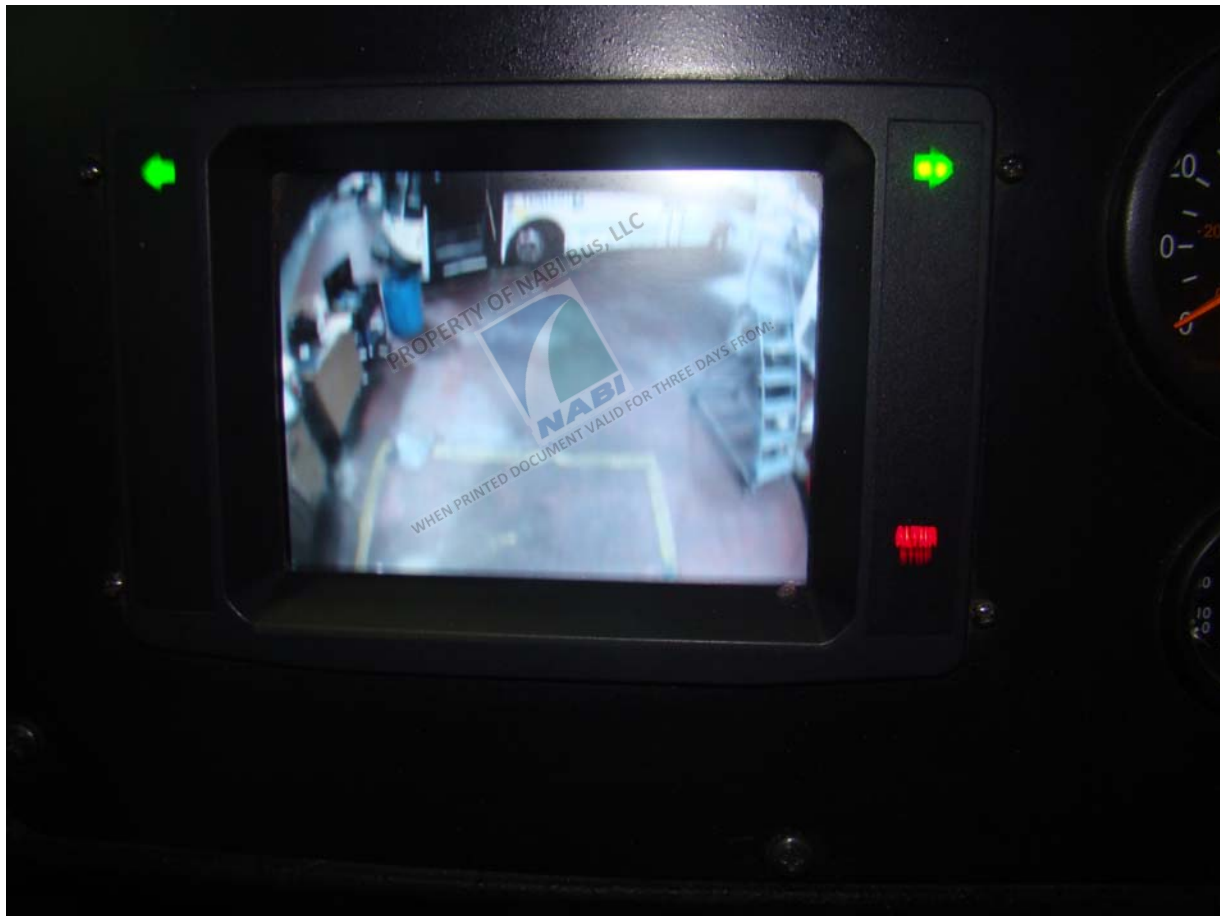
16. Close the upper rear engine door.
17. Turn on the batteries using the battery disconnect switch.
18. Place the vehicle in reverse while applying the brakes and check the camera angle.
Adjust the new camera so that its at the correct angle (see below).

19. Once the angle is correct, tighten the mounting screw for the camera that was left loose in step 11.
20. After tightening, verify the angle of the camera did not change using instructions from step 18.
21. Reinstall the existing camera cover removed in step 3.
22. Remove any debris caused by performing this retrofit.
