DART A/C Air Intake Grill Change

Property name and Top bus number: DART - 304500

Issue: A/C Grill Rusting

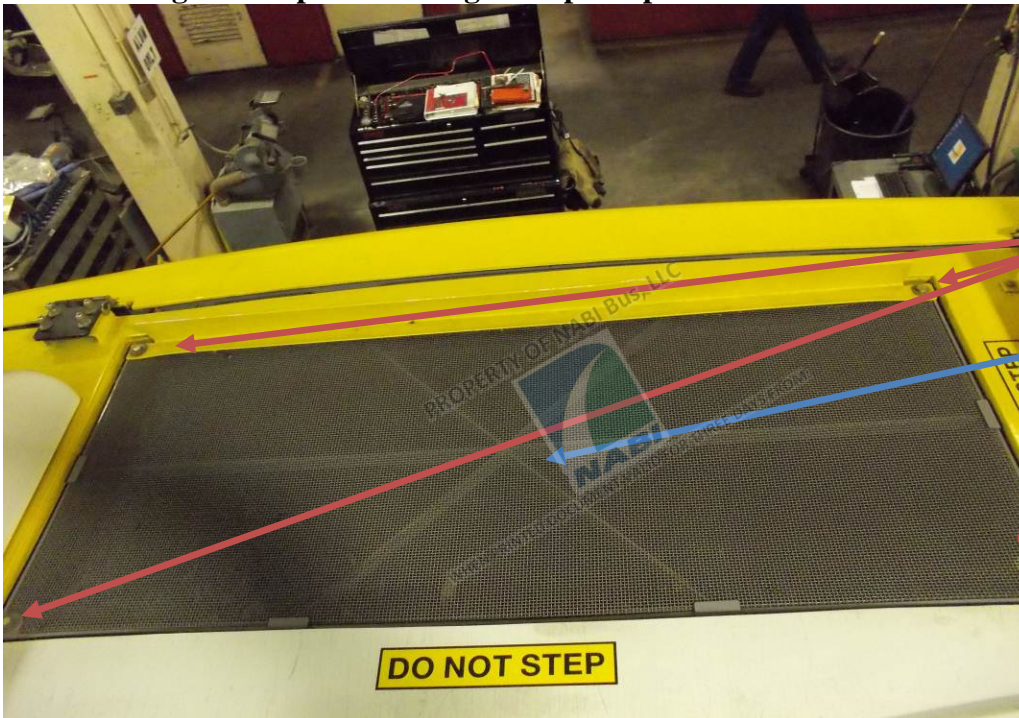
4 bolts that need to be removed. Old grill to be removed

1. Park the bus and apply the parking brake.
2. Turn off main battery disconnect switch(es)
3. At the rear of the bus on the roof at the A/C grill remove the 4 bolts that hold the grill in place.
4. Remove the grill and put the new grill in place put the 4 bolts back.

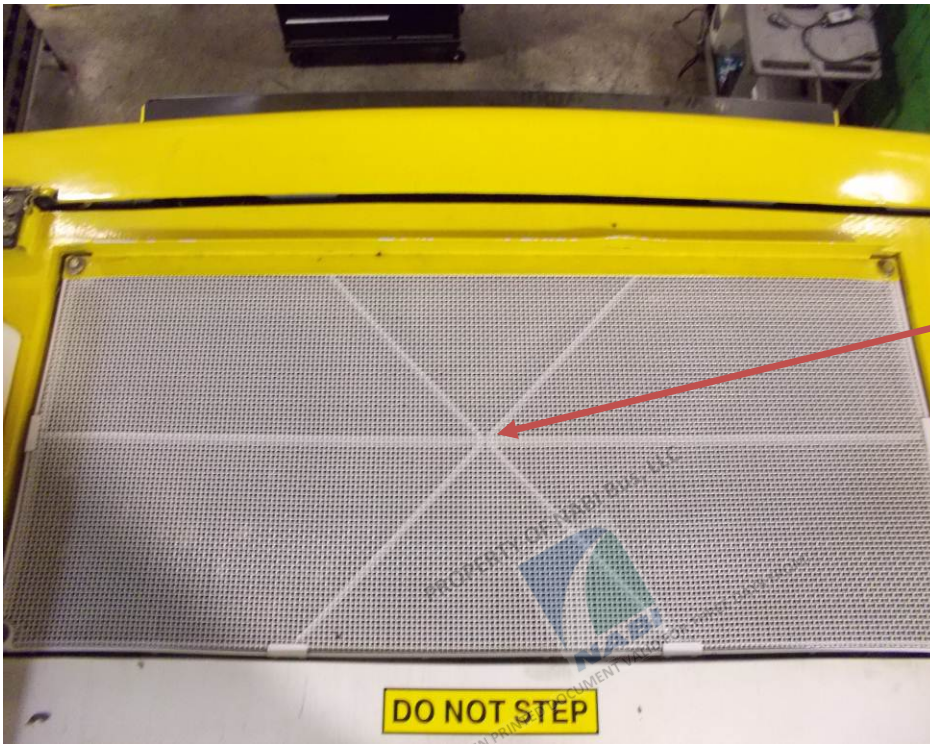
New grill installed.

5. Check for completeness of work.
6. Remove all tools from working area.
7. Turn the main battery disconnect switch(es) on.
