## DART :S/S Mirror Tapping Plate

**Property and Top Bus Number:** DART: 304500

**Issue:** Paint Cracks

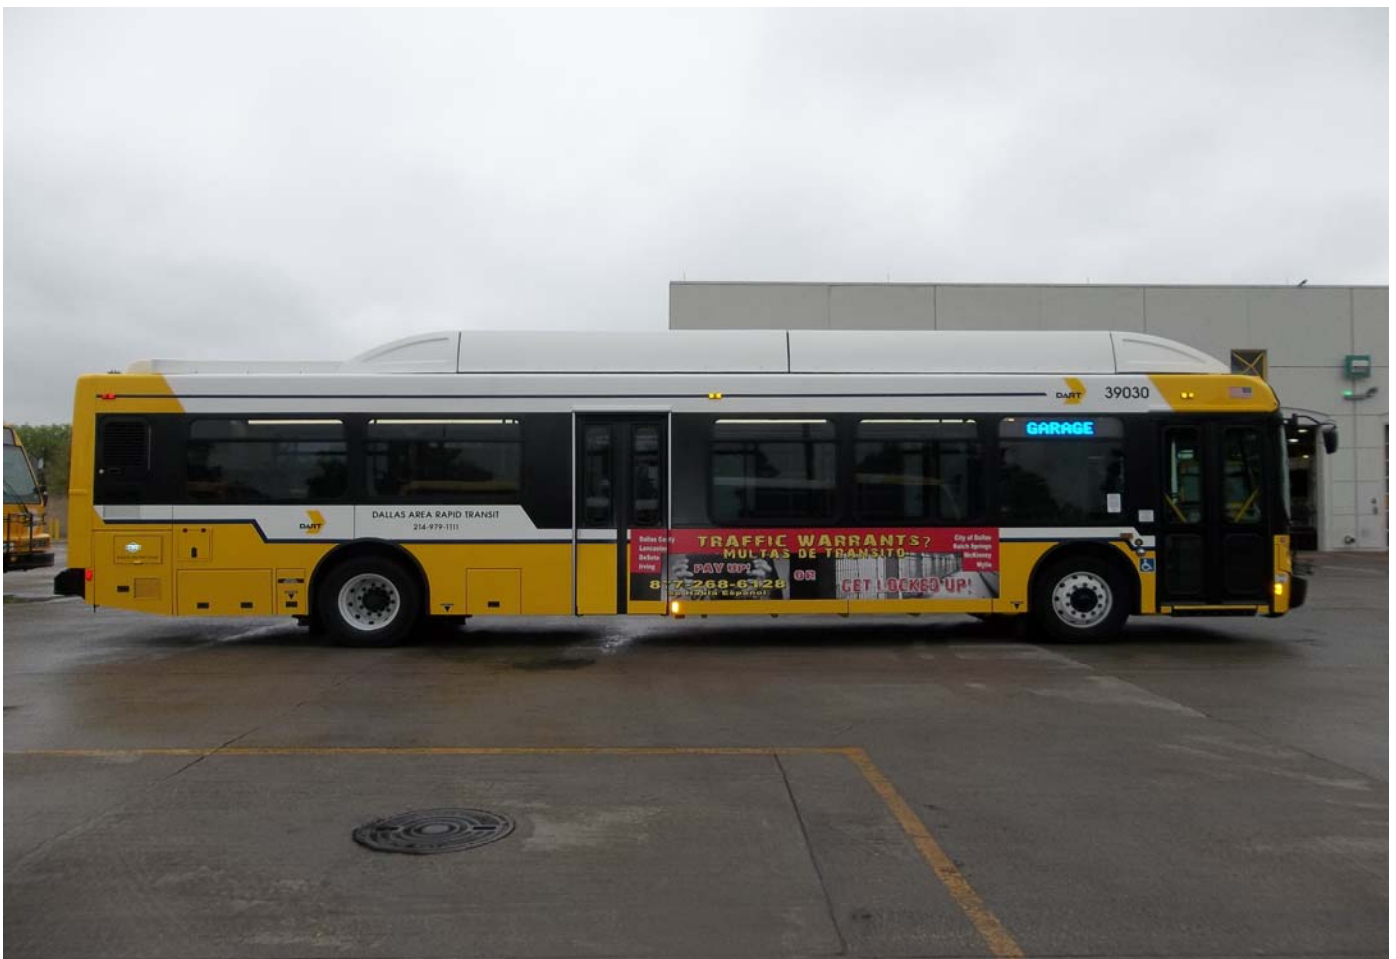
**Reason/ cause:** The paint is cracking where the tapping plate meets the fiberglass.

**Solution:** Grind out the paint at the seams and fill with sikaflex.

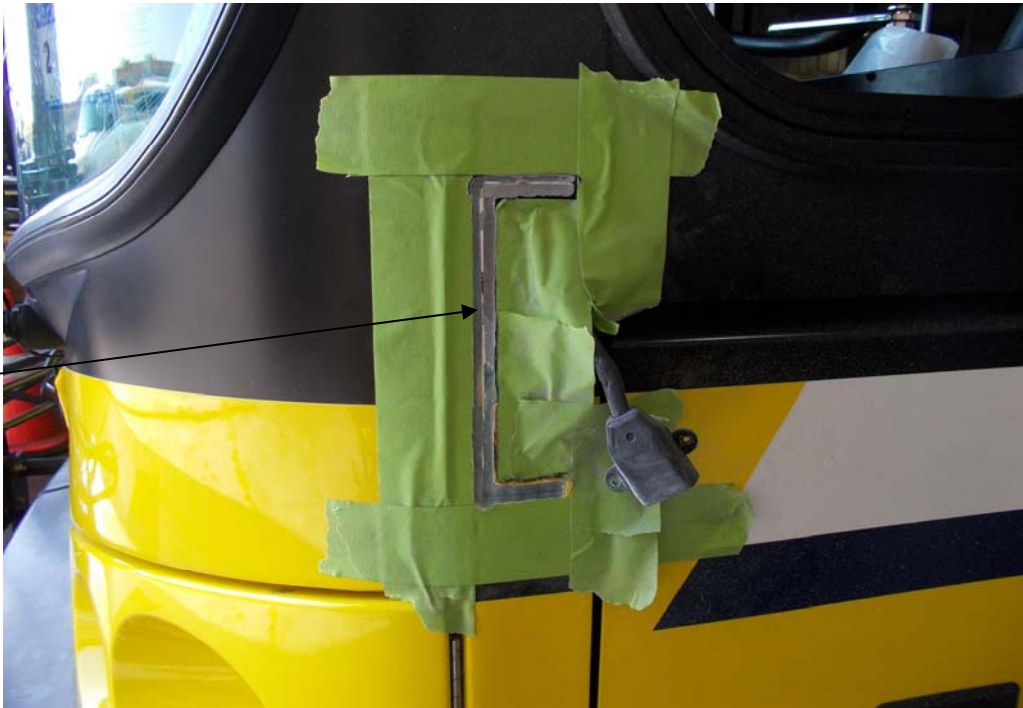
Tape off  
and sand as  
shown

1. Park the bus and apply the parking brake.
2. Turn off main battery disconnect switch(es).
3. On the S/S side remove the mirror by loosening the two 7/16 bolts and lifting up on the mirror and remove it. Unplug the mirror and put to the side to be put back later.

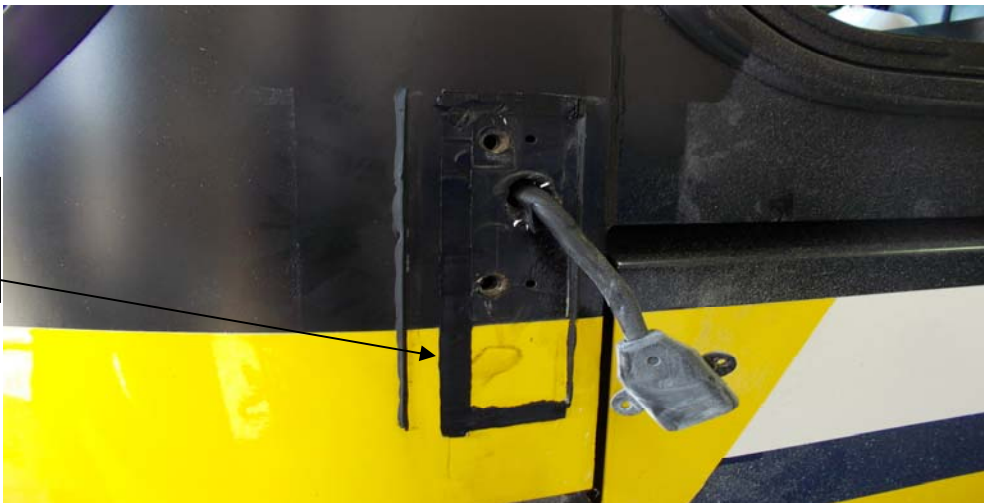
Sika  
installed

4. Clean with Denatured Alcohol. Let stand for one minute. Fill with sika smooth off and let set for one hour.
