## **NABI : C-Frame Welding**

**Issue:** Hairline crack on C-frame

**Solution:** Inspect, repair and re-align C-frames per this work instruction.

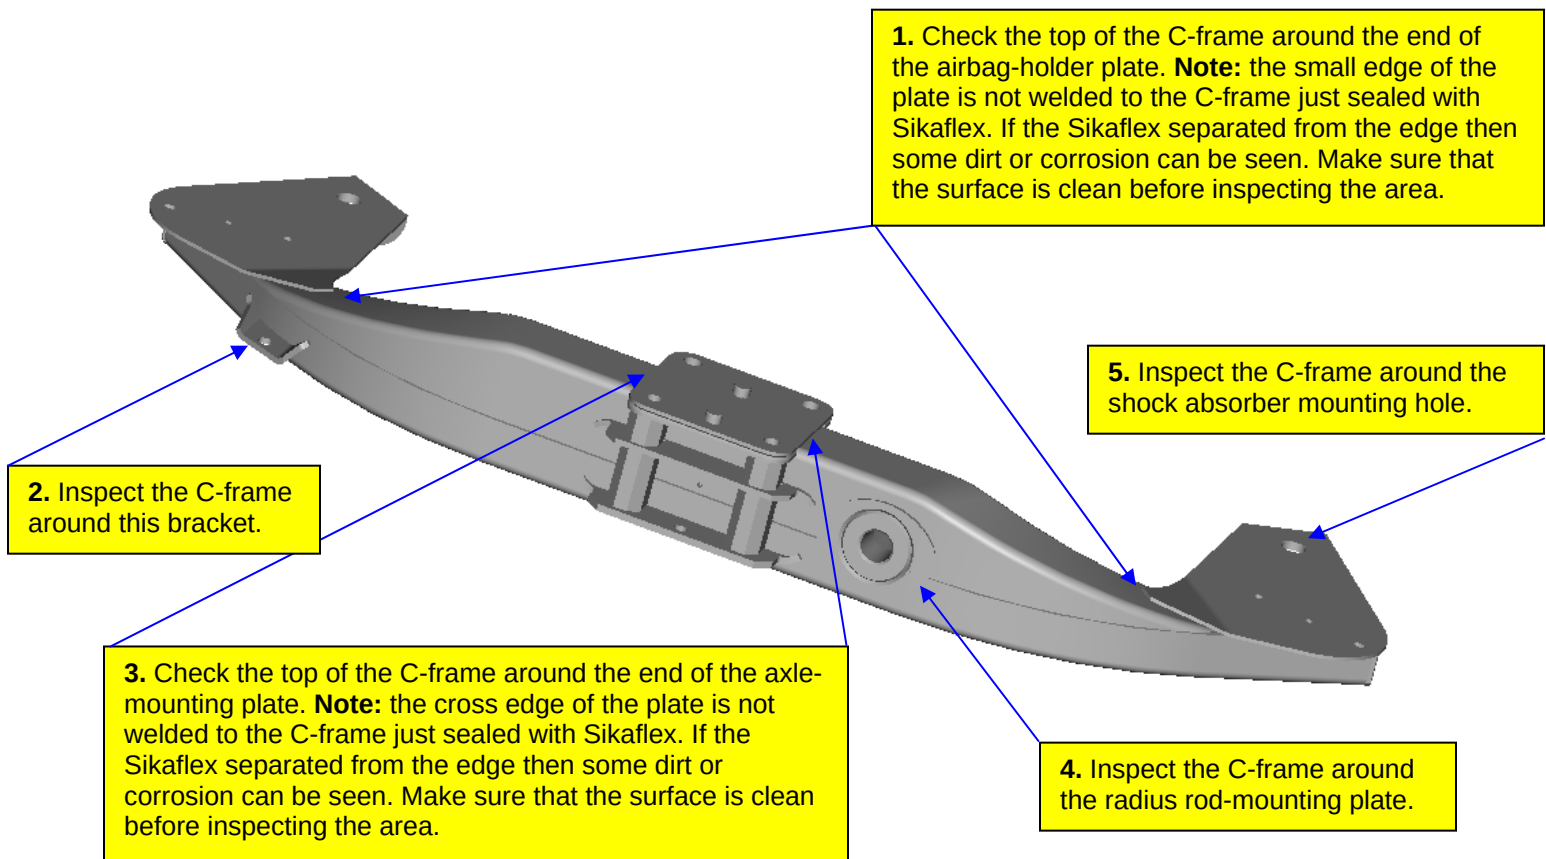
1. Lift the bus in the air or park bus over a service pit. Apply parking brake and block wheels if using pit.
2. Support the body by jack stands and release the air pressure from the air bags by disconnecting the leveling valve rods from the C-frame bracket and pulling the rods downward both sides.
3. Locate C-frames and inspect them according to the drawing below:

4. If crack longer than 3" was found then park the bus and contact NABI. The C-frame must be replaced before returning bus to service.

5. If hairline crack less than 3" was found (see picture below as an example) then proceed with the repair written below.
