# PREVOST

## WARRANTY BULLETIN

**WB13-56**

DATE :	SEPTEMBER 2013	SECTION :	12 - Brakes
EXPIRATION:	SEPTEMBER 2015		
SUBJECT :	AIR LEAK ON AIR DRYER PROBE

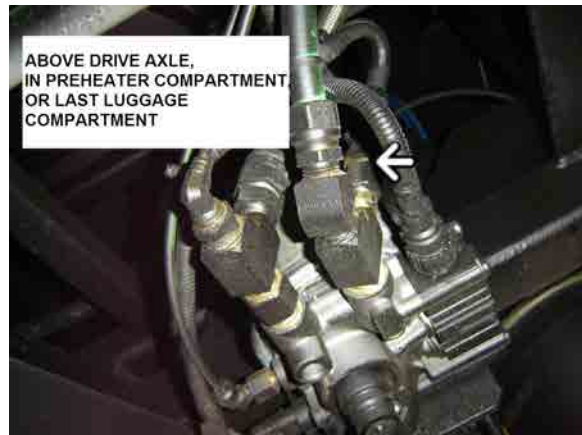
1. Lift vehicle
2. Release air pressure by front service compartment drain valve.
3. Air dryer may be located in one of these three locations :
  - A. Above drive axle, left side
  - B. In Spheros preheater compartment.
  - C. In last luggage compartment on the aft wall.

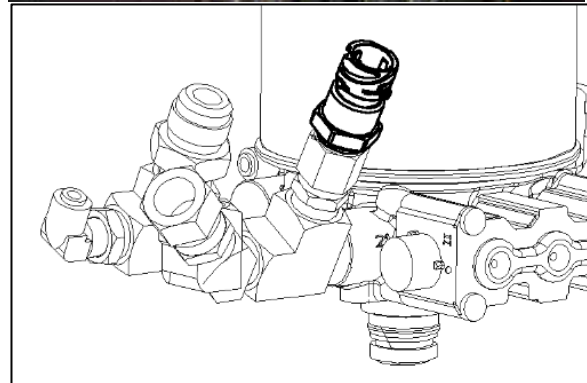
4. Disconnect and unscrew the probe, leaving the fitting on the air dryer (unscrew only the probe).

On the vehicles affected by this bulletin, the air dryer assembly may present a leak at the pressure probe connection. The O-ring in this location may be deformed due to the fitting arrangement. Adding a metal ring will prevent this issue.

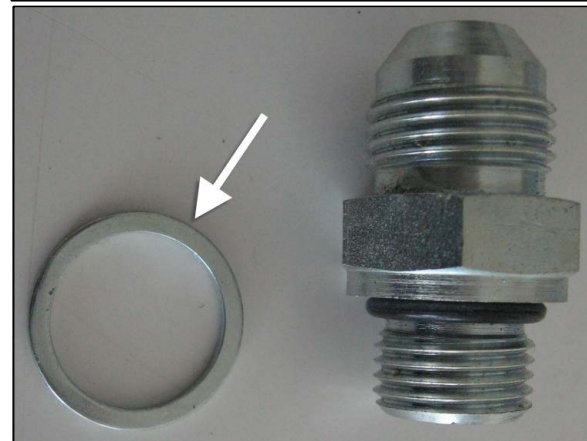
5. If you have fitting 641294, take this ring to install on the probe.

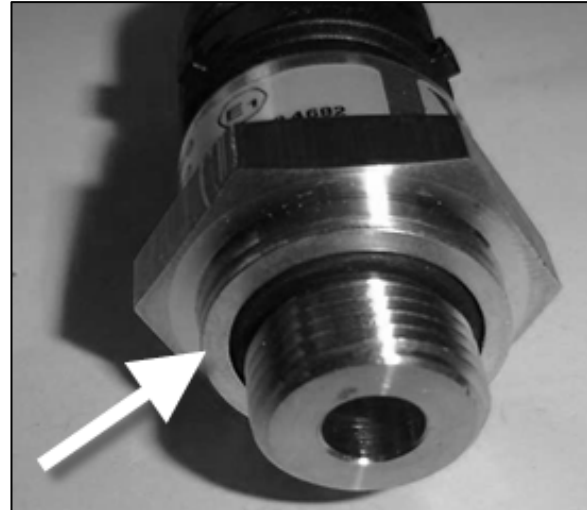
6. Add ring 504789 at arrow location and re-install probe on air dryer assembly.

7. Reconnect probe and verify for air leaks. Ensure system operates correctly.
