PREVOST

**WARRANTY
BULLETIN**

WB13-63A

DATE :	OCTOBER 2013	SECTION :	06 - Electrical
EXPIRATION:	OCTOBER 2015		
SUBJECT :	70 AMP CIRCUIT BREAKER INSPECTION AND REPLACEMENT

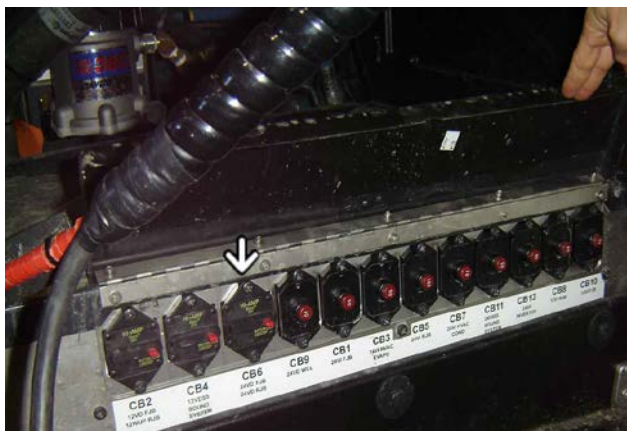
5. X3-45 coach:

Locate CB6

6. LeMirage XLII Entertainer:

Locate CB2
