PREVOST

**WARRANTY
BULLETIN**

WB13-58

DATE :	OCTOBER 2013	SECTION :	01 - Engine
EXPIRATION:	OCTOBER 2015		
SUBJECT :	AIR INTAKE HOSE REPLACEMENT

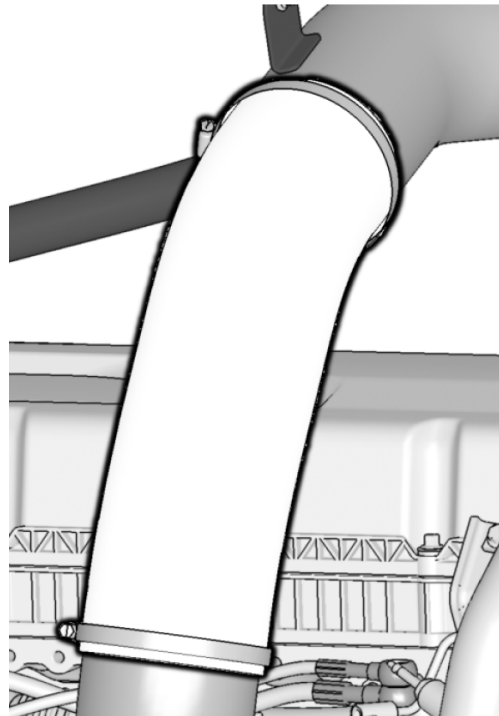
1. On the engine, locate this air intake flexible hose on the left side of the engine.

2. Remove the clamps and hose
3. Install a clean cap on engine air intake to protect from dust and debris.
4. Replace by new hose #033195 and #504786 clamps.

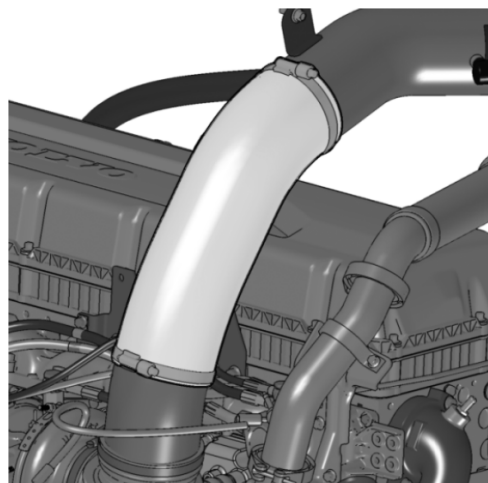
Attach lower clamp to support provided in this area.

5. Pay particular attention to the tail of the clamp to make sure it does not touch any hoses in the surrounding area.

Re-orient or shorten the tail if required.
