Service Bulletin

Subject: Center Seat Accessory Power Outlet Inoperative (Inspect Fuse F1DR 15 amp)

Models: 2014 Chevrolet Silverado 1500

2014 GMC Sierra 1500

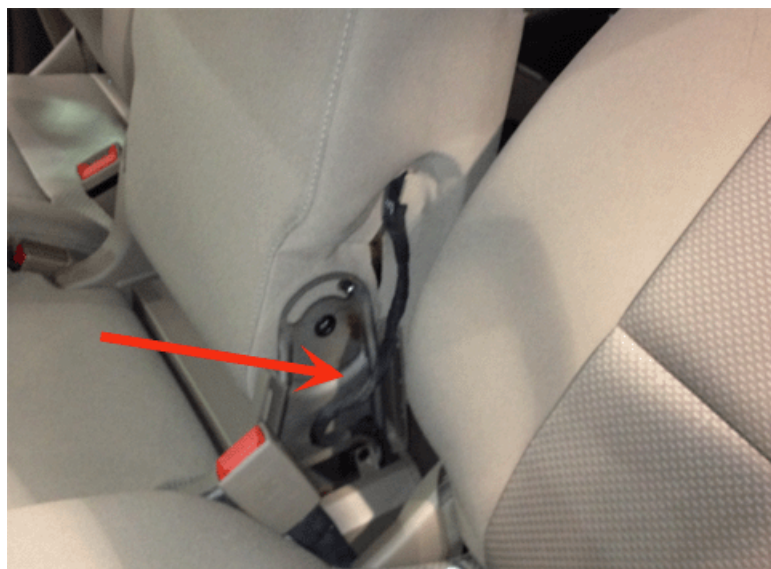
If the fuse is blown inspect for a short to ground on circuit 850 near the left pivot for the center seat armrest, as shown below. If the circuit is shorted repair as necessary and protect the harness so it does not reoccur.
