Bulletin No.: PI1034

# Service Bulletin

**Subject:** Check Engine Light On with DTC P0442 Set

**Models:** 2014 Chevrolet Impala  
Equipped with 3.6L Engine (RPO LFX)

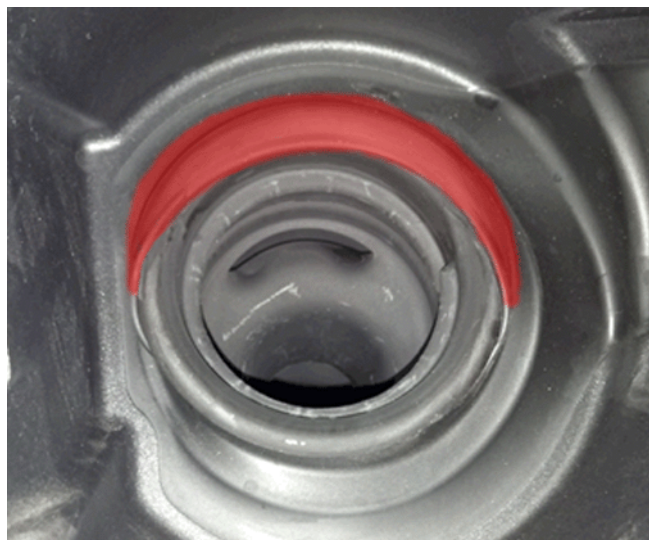
Some customers may comment on a check engine light being on. The technician may find DTC P0442 set.

This condition is due to the seal on the fuel tank filler pipe housing not seated properly during vehicle assembly, causing a small EVAP leak and the seal to overlap the fuel tank filler neck as shown in the illustration above.

Using a trim stick, push the seal over the filler neck and clear the DTC.
