Service Bulletin

PRELIMINARY INFORMATION

Subject: Water Leak at Driver/Front Passenger Floor Area and/or Front Carpet Wet

Models: 2010-2013 Cadillac SRX

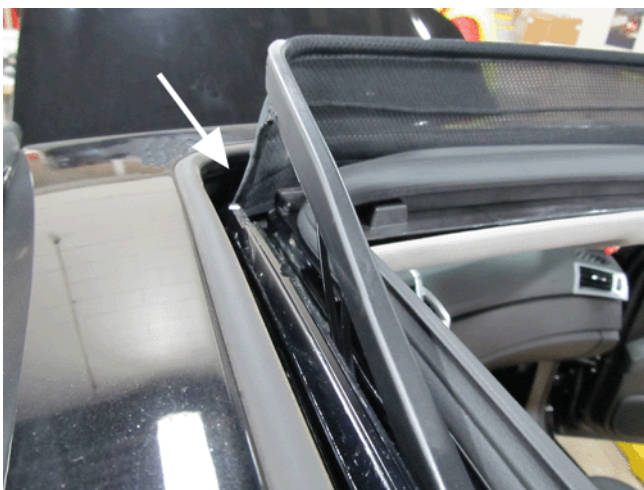
4. Pour water into the outboard front corner of the sunroof frame on one side of the vehicle, and immediately inspect the area rearward of the front tire for water flowing out onto the floor surface.
5. Repeat steps 3 and 4 on the opposite side.

- If water is properly flowing out the front drain hoses, jump ahead to the “Seal Cowl Seam Repair Procedure” section below and complete the repair steps listed.
- If water is NOT properly flowing out the front drain hoses, first replace BOTH sunroof front drain hoses following the repair steps below, then continue ahead and complete the “Seal Cowl Seam Repair Procedure” repair steps.

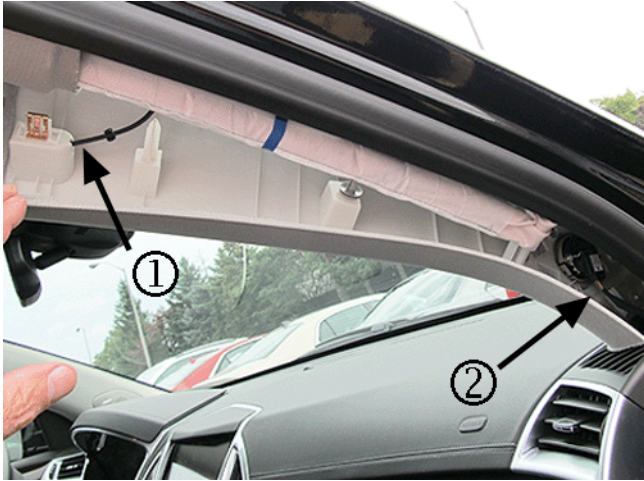
1. Starting on the left or right side, remove the windshield garnish molding from the A-pillar by pulling gently from the top to disengage the attachment clip. Detach the rubber stop (1) on the tether clip from the molding and disconnect the speaker wiring harness (2).

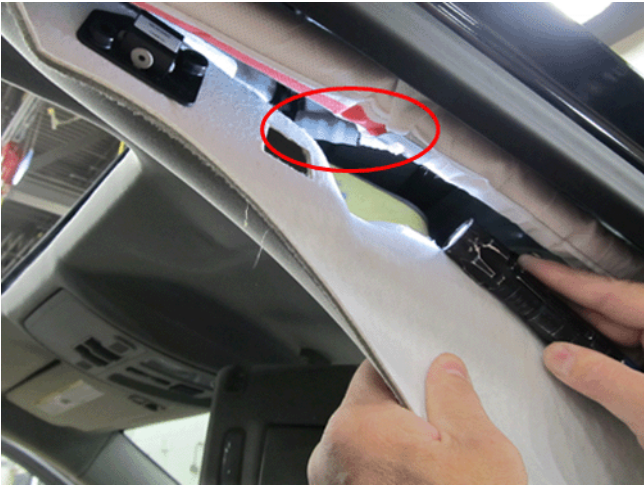
4. Pull the front corner of the headliner downward to access the drain hose and sunroof drain spigot connection, circled above.
