Emissions Recall

Subject: Exhaust Gas Recirculation (EGR) Pipe Cover Kit Installation

Bulletin: RCB-007-11

Affected Models: Certain 2011MY NE8J, NJ8J, and NV8J equipped with a J08 engine

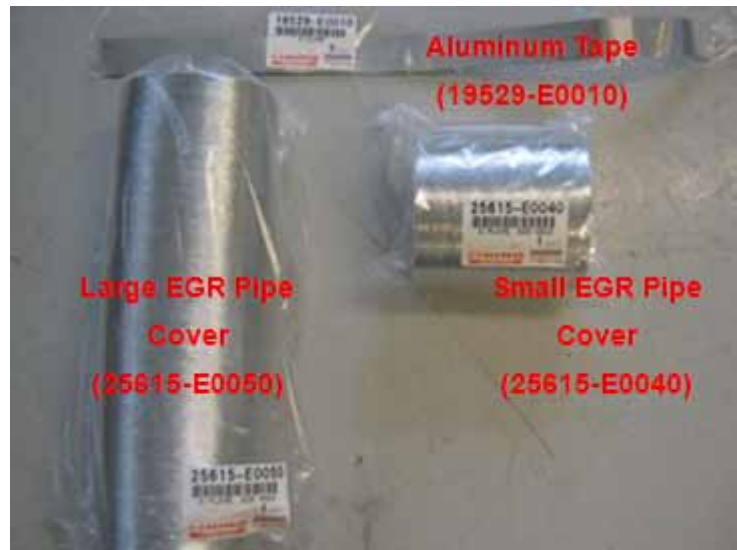
PART NUMBER	DESCRIPTION	QUANTITY
04001072E0	A7610 EGR Kit	1

Kit Contents	
25615E0050	Large EGR Pipe Cover
25615E0040	Small EGR Pipe Cover
19529E0010	Aluminum Tape

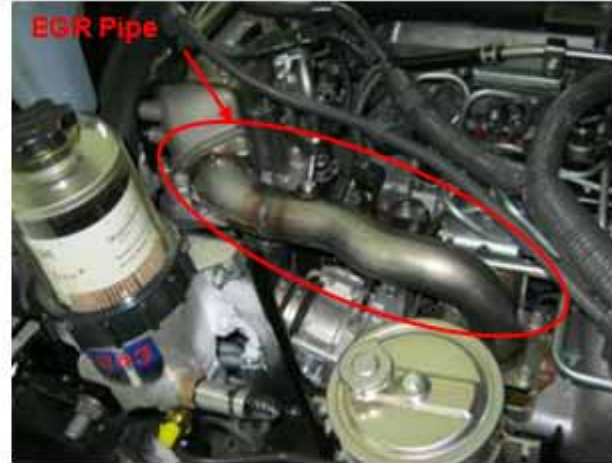
6. Raise the hood and find the Exhaust Gas Recirculation (EGR) pipe. A two piece insulating cover will be installed onto this EGR pipe.

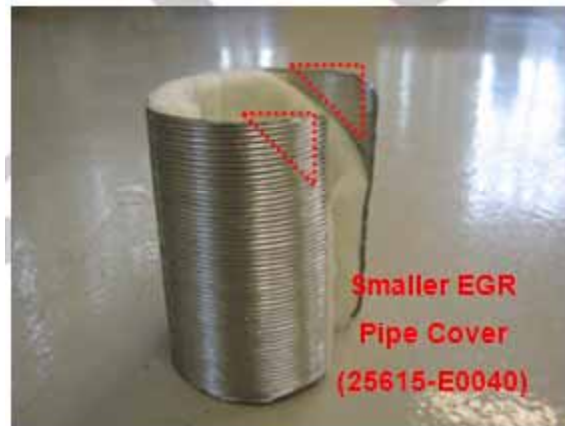
7. Locate the smaller of the two EGR pipe covers (25615E0040). This smaller cover will need to be trimmed before it can be installed onto the EGR pipe.

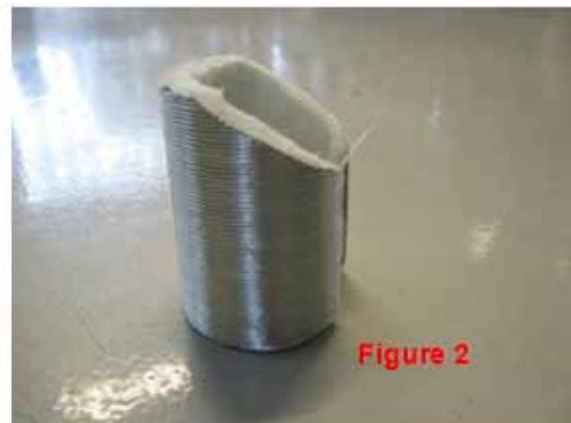
8. Trim the flexible aluminum exterior cover on the smaller EGR pipe cover to match the border of the inner white insulating wrap. Cut along the red dotted line as illustrated in figure 1. Confirm that the smaller EGR pipe cover is correctly cut as illustrated in figure 2.

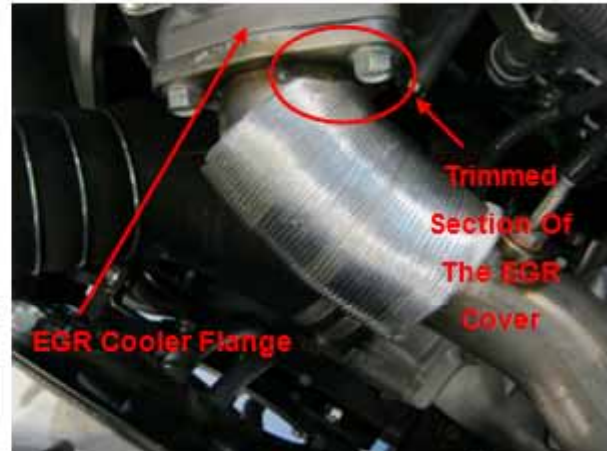
9. Install the smaller of the two EGR pipe covers (25615E0040) onto the forward section of the EGR pipe. The edge of the EGR pipe cover that was trimmed in step 8 will need to be positioned against the EGR cooler flange as shown in the photographs below.

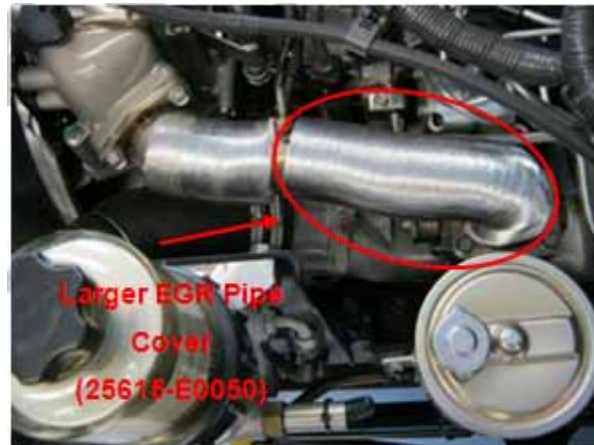
10. Install the remaining larger EGR pipe cover (25615E0050) onto the EGR pipe and after positioning the EGR pipe cover with the open slit facing downward then squeeze both the small and large covers around the EGR pipe. By squeezing them around the EGR pipe, you will be able to better form and insulate the wrap around the pipe.

NOTICE: The open slit on the EGR pipe covers should always be positioned so the opening is facing downward as described above. Most, if not all of this slit will be closed when the cover is squeezed together and then taped closed.

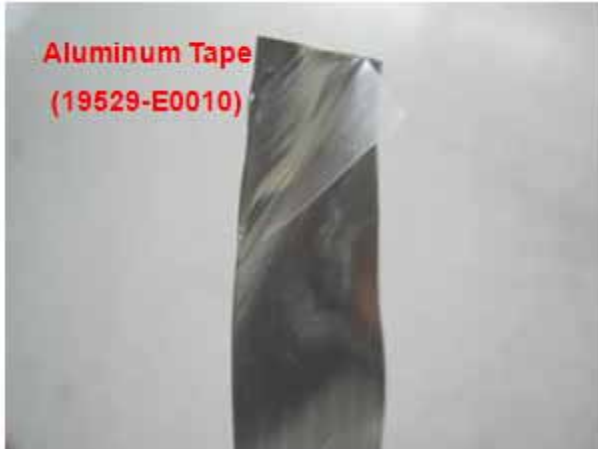
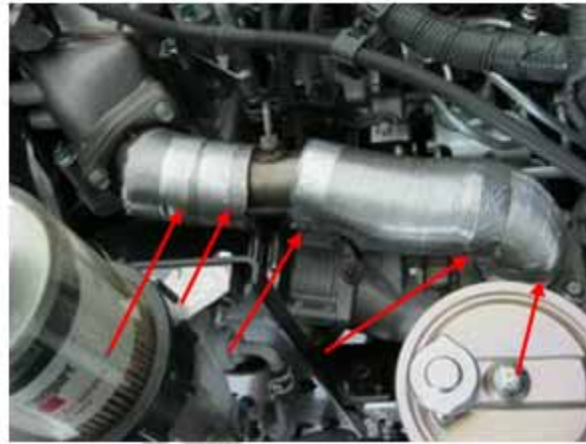
11. Peel back the clear backing from the aluminum tape (19529E0010) and wrap the two EGR pipe covers one location at a time. Care must be taken in order to wrap the EGR pipe covers in the 5 separately listed locations, 3 on the larger EGR pipe cover and 2 on the smaller EGR cover. It is recommended that the clear backing material for the aluminum tape should only be peeled back as it is being wrapped around the EGR pipe.
