REFERENCE:	Nova Bus Manuals
SECTION:	09: Engine and cooling
RS N°:	MQR 7621-346
EFFECTIVE IN PROD.:	L647 (2012MR)

SUBJECT:	Radiator Assembly anchorage and surge tank cap
JUSTIFICATION:	New procedure for the radiator assembly anchorage levelling to optimize the filling of the coolant and surge tank cap N36242 replace by N65114

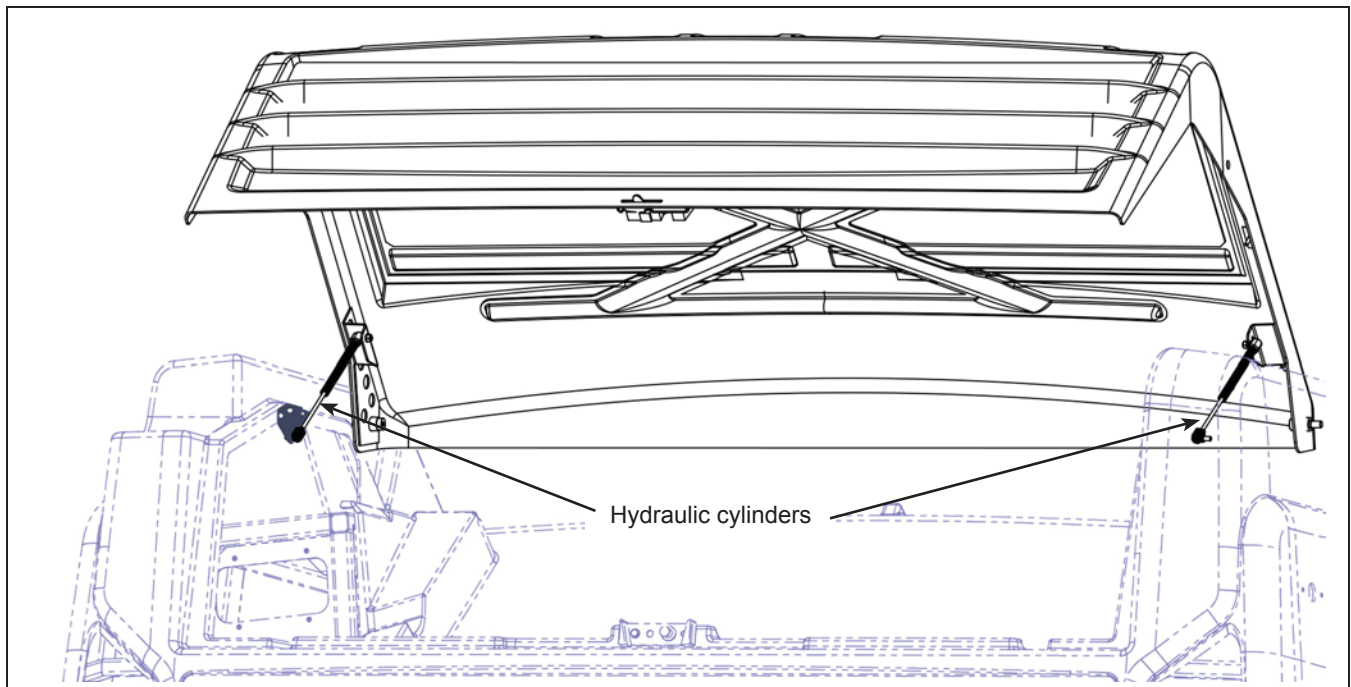
Figure 1 - Typical Anchorage for the Radiator Access Door

- 1.1. Remove the radiator access door. Retain the hardware. See Figure 1.

- 1.46. Close the engine door.
- 1.47. Install the radiator access door using the retained hardware. See Figure 1. ❖

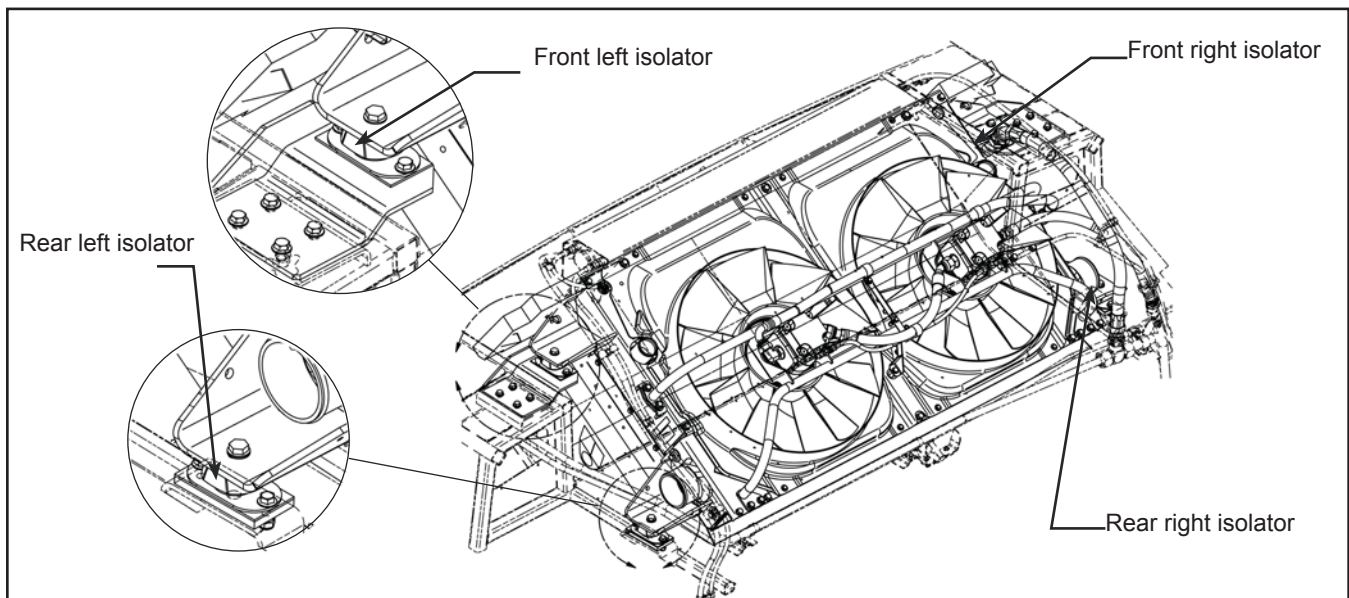
Figure 2 - Isolators Identification

- 1.11. Place the radiator assembly in a secure and accessible area.
- 1.12. Remove the isolators from the support. Retain the hardware. See Figure 2

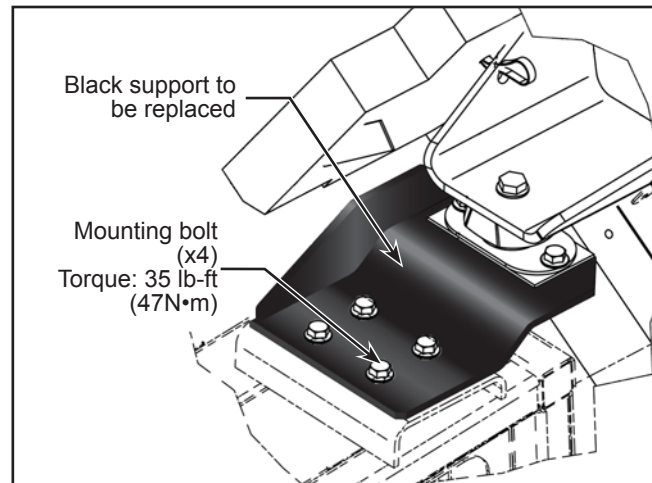
Figure 3 - Upper Black Support (Left Side Shown/ Right Side Similar)

- 1.14. Replace the front supports with new upper supports N66783 (left support) and N66782 (right support) using the retained mounting bolts. Apply Loctite 242 thread locker or the equivalent to the bolts. See Figure 3.

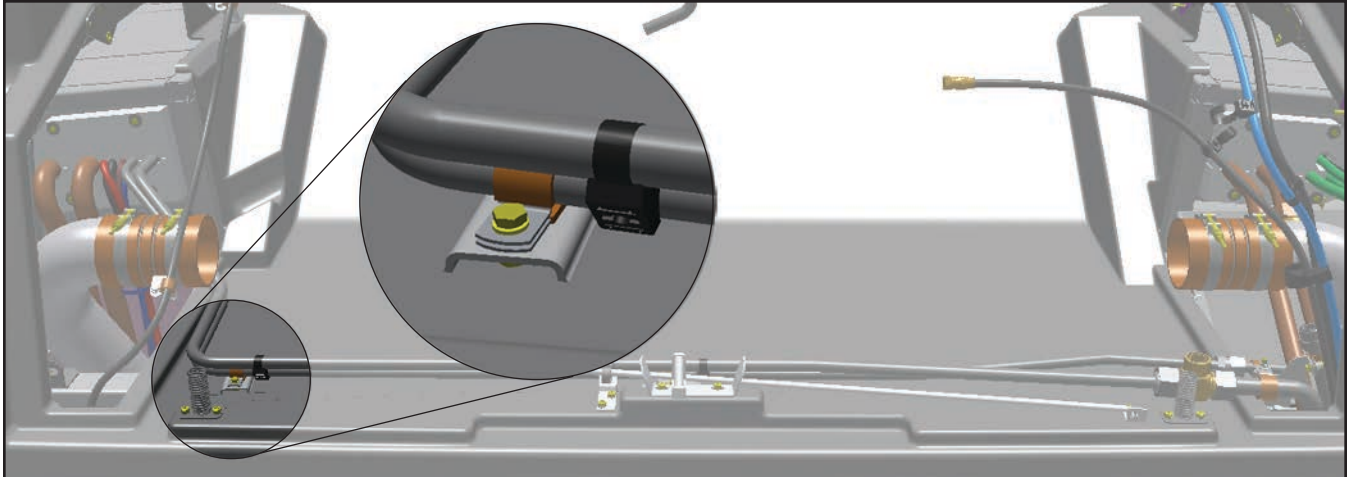
Figure 4 - Hydraulic Pipe Brackets

- 1.15. Make sure that the hydraulic pipe brackets, located in rear portion of the radiator compartment, are still bonded to the rear shell. See Figure 4.

- 1.17. Using Sikaflex 252, bond the hydraulic pipe brackets to the fiberglass surface. If needed, apply a thicker coat of Sikaflex 252 to fill the gap between the bracket and repaired surface. Refer to section 01-000: **BODY** of the Nova Bus maintenance manual for fiberglass surface repair instructions.
- 1.18. Secure the hydraulic pipes to the brackets. If there is contact between the two pipes, separate them with double-ring tiewraps N37749.

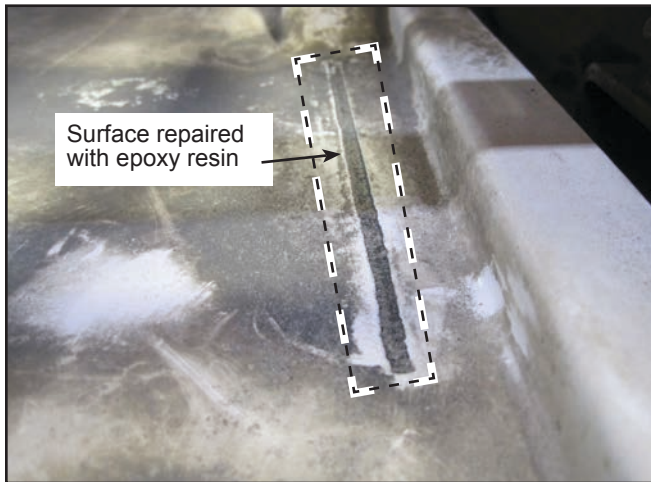
Figure 5 - Surface Damage Repaired with Epoxy Resin

- 1.16. Wipe clean the fiberglass surface located beneath the radiator and if needed under the hydraulic pipe bracket, then inspect the surface for any wear or damage caused by the radiator rubber guard and the hydraulic piping support . The fiberglass or gelcoat surface might be damage, grooved or perforated.
 - 1.16.1. If the surface is lightly damaged apply epoxy resin to repair in such a way to obtain a smooth and uniform surface. Refer to section 01 : **BODY** of the Nova Bus LFS maintenance manual for fiberglass and gelcoat repair instructions. See Figure 5.
 - 1.16.2. If the surface is grooved or perforated, install a thin plate of stainless steel to cover the damaged fiberglass or gelcoat. Refer to section 01 : **BODY** of the Nova Bus LFS maintenance manual for the fiberglass and gelcoat repair instructions. See Figure 6.

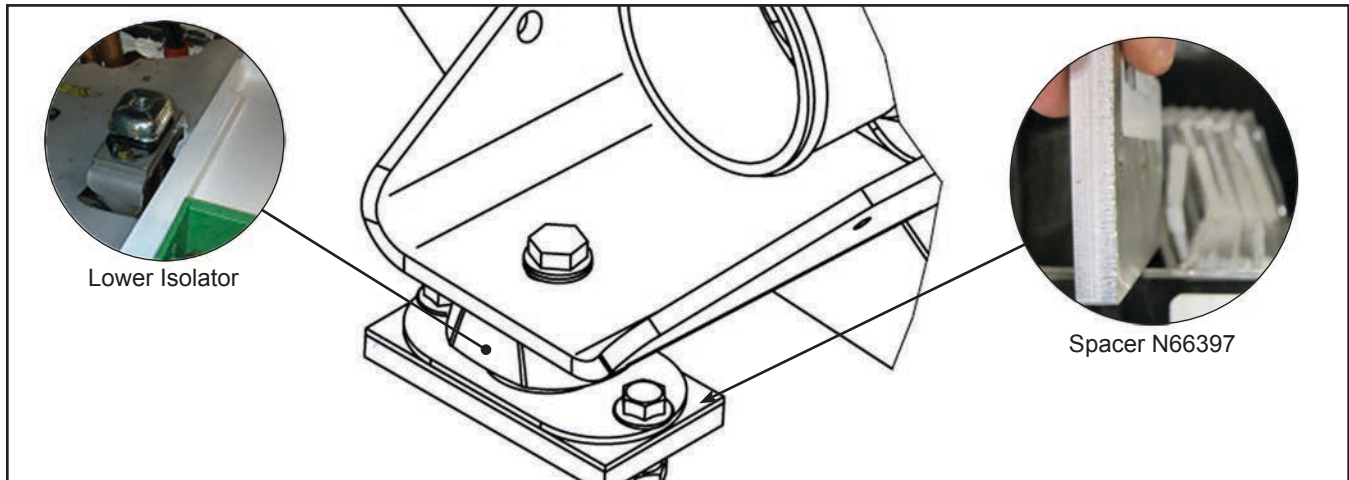
Figure 7 - Installation of Spacers N66397 on the Lower Supports

- 1.19. Install a 3/8" spacer N66397 and new isolator N43343 using N16891 bolts and retained hardware on both rear supports of the structure. Apply Loctite 242 thread locker or the equivalent on the bolts. Do not tighten the bolts. See Figure 7.

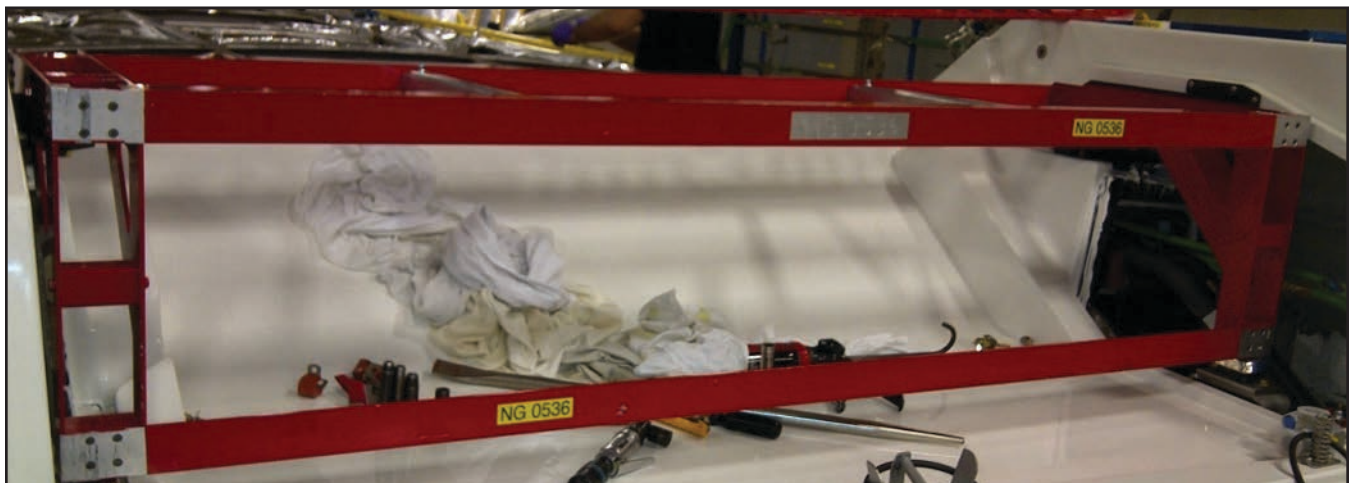
Figure 8 - Leveling Jig

- 1.20. Install new isolator N43343 on the front support. Apply Loctite 242 thread locker or the equivalent on the bolts. Do not tighten the bolts.
- 1.21. Install the leveling jig onto the isolators. Secure the jig to the isolators with the centering pins. See Figure 8.

- 1.22. Ensure the jig is level and sits properly on both lower isolators. If there is a gap between the jig and the upper isolators, insert one or a few thin spacers (N66725) or a combination of thin and thick spacers (N66397) in order to fill the gap.

- 1.23. Remove the leveling jig and place in a secure area.
- 1.24. Remove the bolts and isolators which require leveling.
- 1.25. Place the spacers measured with the leveling jig between the support and the isolator. The retained bolts might be too short due to the new spacer. If needed use N16891 bolts in a way to obtain two threads beyond the nuts.

- 1.26. Ensure proper installation by mounting the leveling jig onto the isolators. The jig should sit properly on all four isolators. If needed add or remove spacers to readjust.

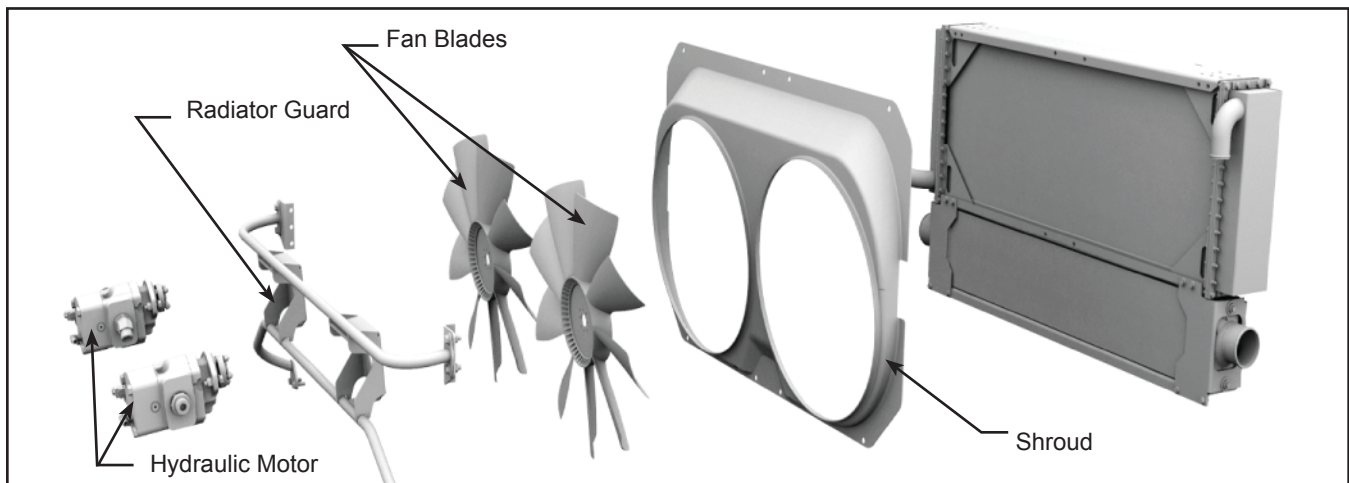
Figure 9 - Radiator Assembly

- 1.30. Remove the radiator spider assembly and the shroud from the radiator. See Figure 9.

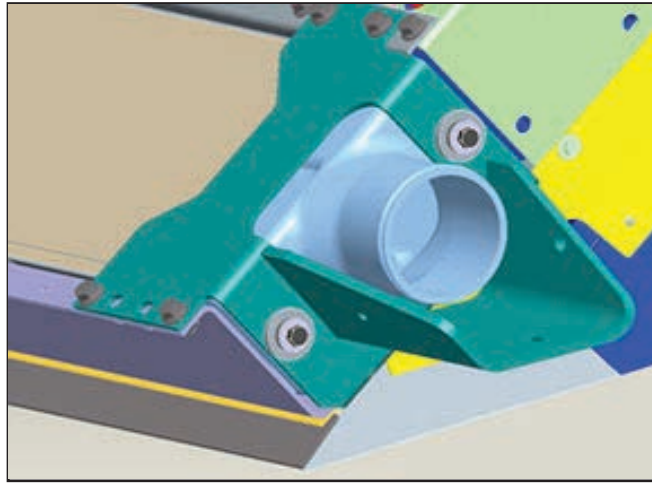
Figure 10 - Lower Supports to Replace

- 1.31. Replace the lower support of the radiator assembly with the new right support N8899180 and left N8899181. See Figure 10.

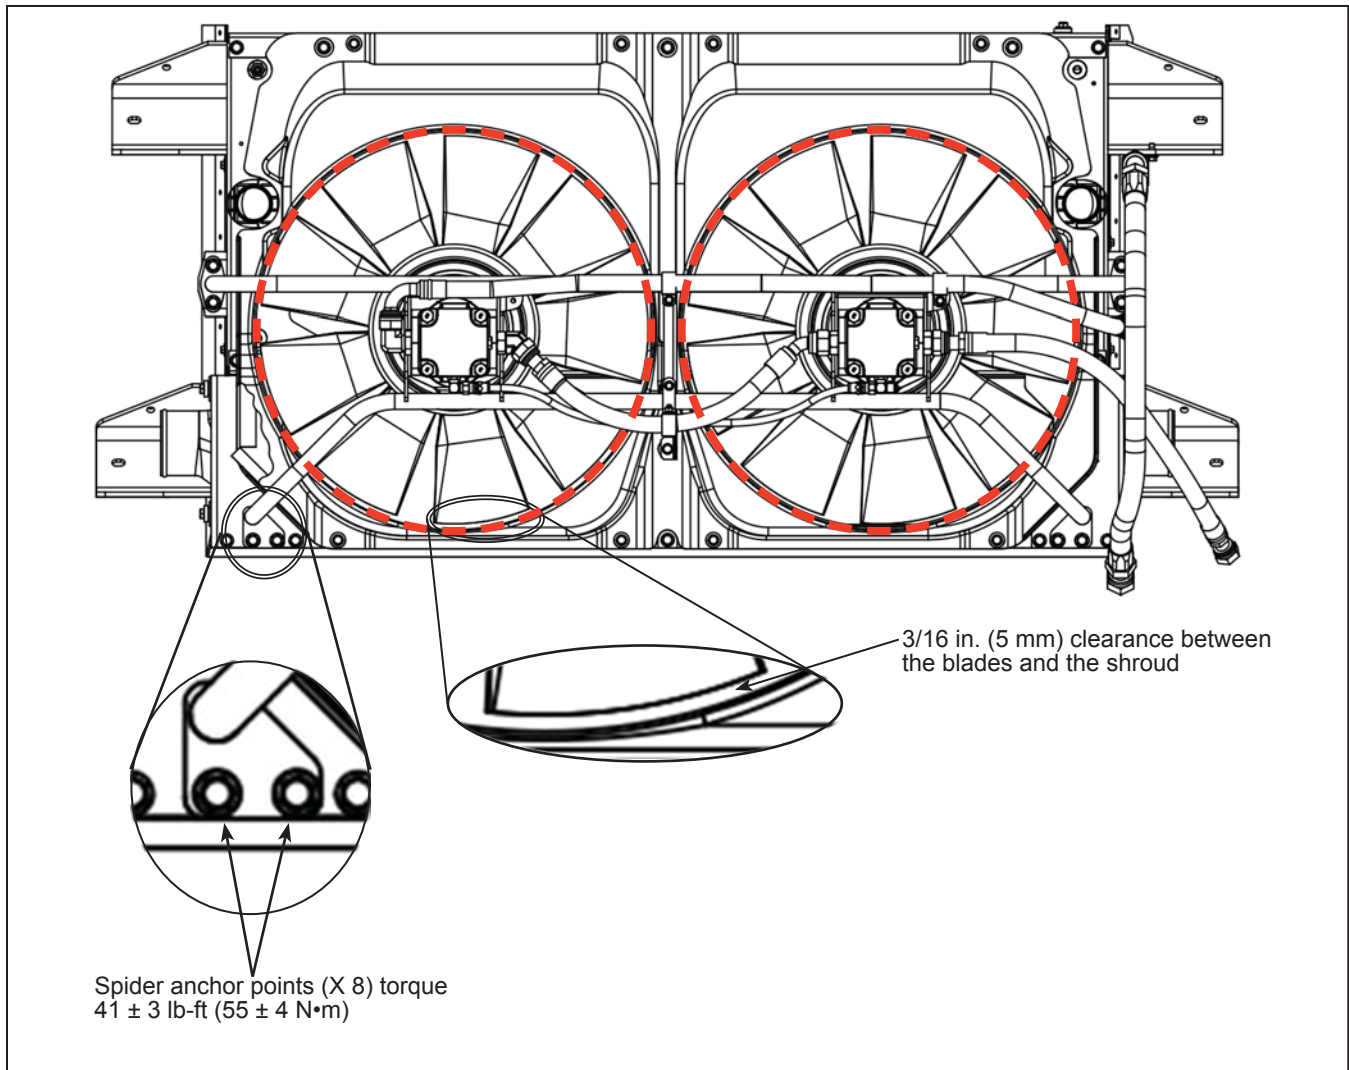
Figure 11 - Torque of the Spider and Spacing Between the Shroud and the Blades

- 1.36. Install the spider and the shroud on the radiator. Adjust the spacing between the internal contour of the shroud and the fan blades in such a way to obtain 3/16 in. (5 mm) clearance. Tighten the shroud bolts once the spacing is adjusted and torque the spider anchor bolts. See Figure 11.

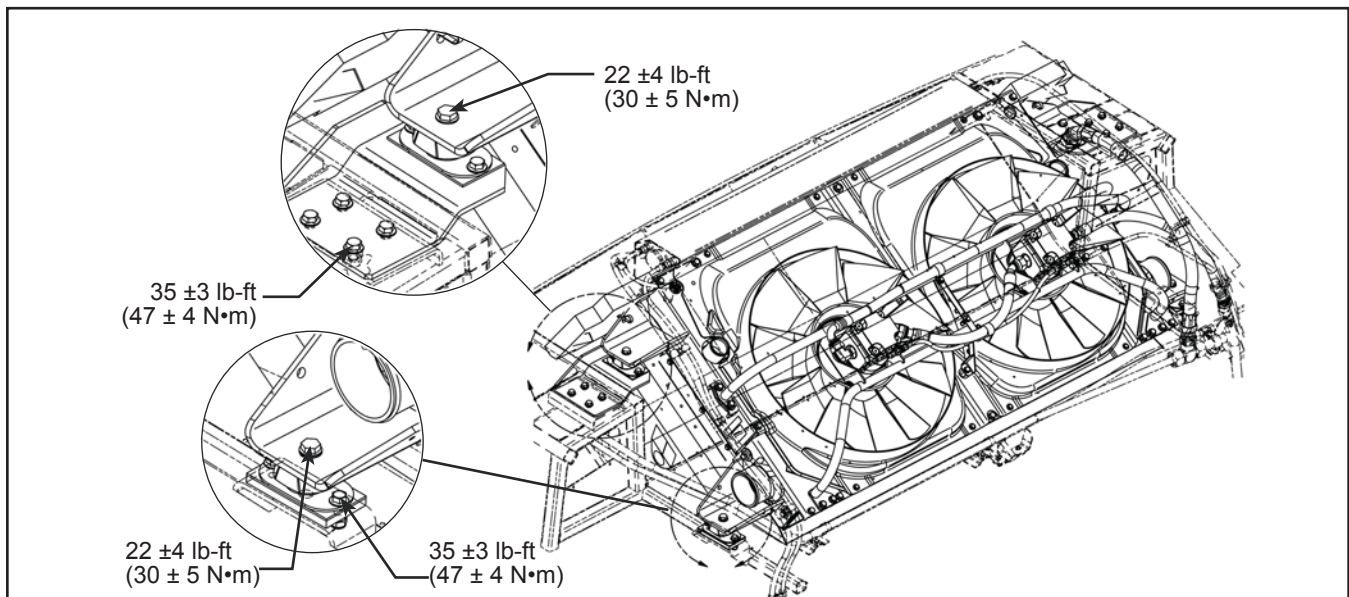
Figure 12 - Radiator Installation and Torque Value

Radiator mounting support holes and isolators might not align correctly. To obtain proper alignment, loosen the isolator anchor bolts and move the isolator in such a way to line up with the mounting support holes. Torque the isolator anchor bolts to 35 ± 3 lb-ft (47 ± 4 N•m). See Figure 12.

- 1.39. Apply Loctite 242 thread locker type or the equivalent on the radiator anchor bolts.
- 1.40. Place the anchor bolts and pre-tighten.
- 1.41. Apply the torque specified in Figure 12.

- 1.28. Remove the levelling jig and set aside in a secure area.
- 1.29. Repeat the tightening sequence of step 1.26 by applying a tightening torque of 35 ft-lb (47N•m) on the isolator bolts. See Figure 12.

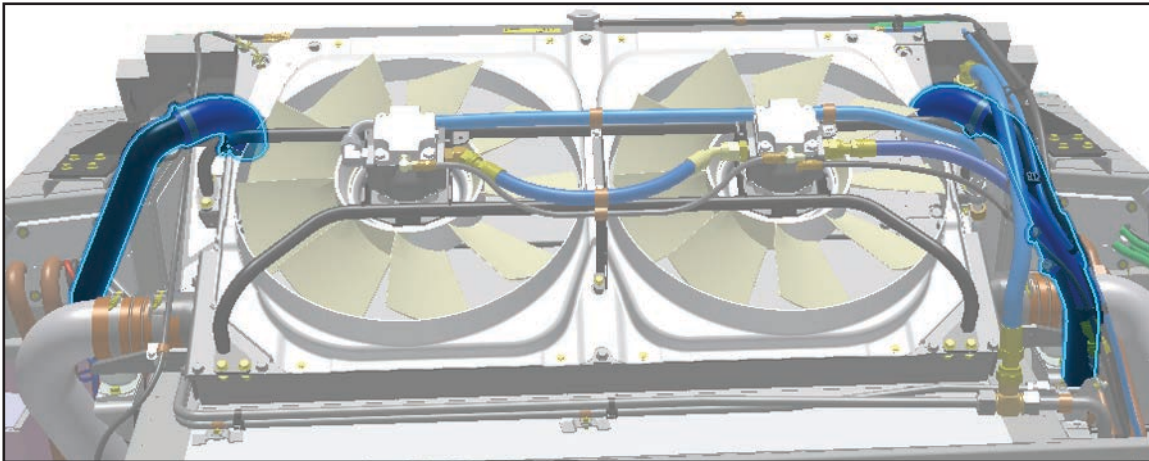
Figure 14 - Cooling System Piping

Install and tighten the piping according to the procedure indicated in section 99 : GENERAL PRACTICES of the Nova Bus LFS maintenance manual and as indicated in Figures 13 to 15.
