REFERENCE:	Nova Bus Manuals
SECTION:	12: Interior furnishing
RS N°:	–
EFFECTIVE IN PROD.:	–

SUBJECT:	Five-passenger rear seat rod support.
JUSTIFICATION:	Jam nut missing on the rod support.

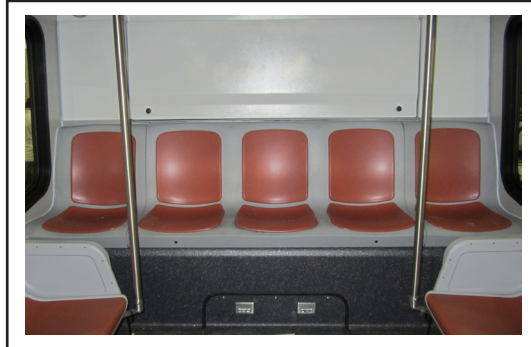
Figure 1 - View of the Five-Passenger Rear Seat

- 1.1. Locate the five-passenger rear seat. See Figure 1.

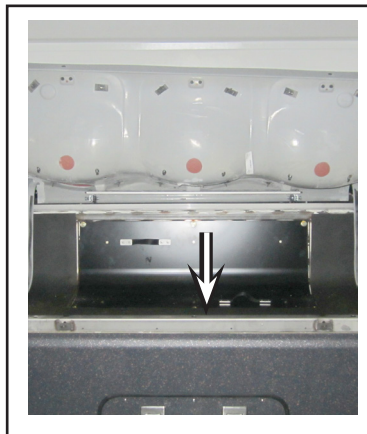
Figure 2 - Rod Support Location Under Rear Seat

- 1.2. Lift the middle seats and locate the rod support. See Figure 2.
