# Technical Service Bulletin

#### 72 Noise from center armrest

72 13 06 2016946/3 September 9, 2013. Supersedes Technical Service Bulletin Group 72 number 08-09 dated December 4, 2008 for reasons listed below.

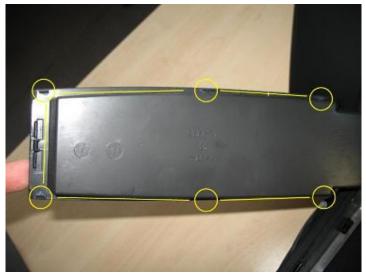
**Figure 1.** The inner liner of the center armrest, removed. Yellow circles highlight the areas to be lubricated.

1. Use a thin brush to lubricate the attachment points between the inner liner and lower trim (Figure 1). Use special lubricant **G 060172A3.**

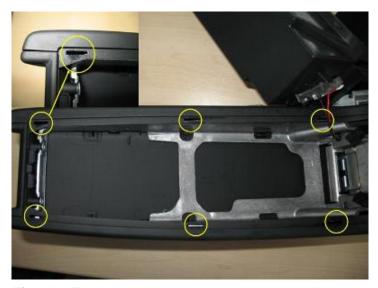
**Figure 2.** The mounting points into which the inner liner is slotted.

- 3. Remove any lubricant residue on the visible surfaces with all-purpose cleaner D 00940104.
- 4. Remove the lower trim to lubricate the contact surfaces (Figure 2 and Figure 3).

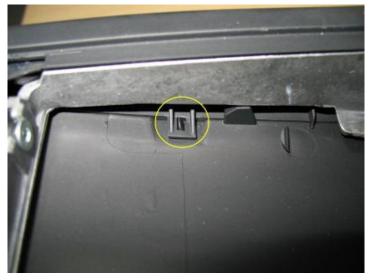
Figure 3. A mounting point of the lower trim.

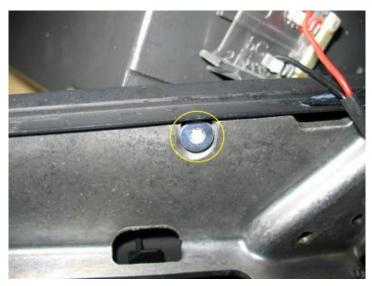
Figure 4. A Torx bolt, which attaches the side trim.

5. Carefully check the Torx bolts (Figure 4) for tight fit.
