# Technical Service Bulletin

## 35 0B5 7 Speed S-tronic, leaks from transmission

35 13 12 2028085/4 June 18, 2013. Supersedes Technical Service Bulletin Group 35 number 13-09 dated April 1, 2013 for reasons listed below.

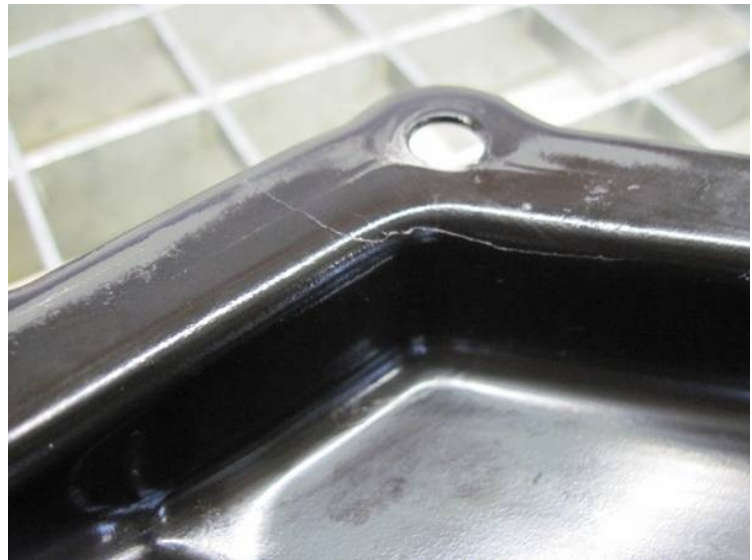
- Crack in the oil pan (Figure 2).

*Figure 2. Crack in the oil pan.*

5. If pan is cracked as in Figure 2, and no loose bolts on the mechatronics unit are found, replace oil pan and seal.
6. If there is a leak between gearbox housing and intermediate housing as in Figure 3, reseal the case by following instructions in Elsa >> *Repair manual* >> *Transmission* >> *S Tronic Transmission Internal Components* >> *35 Gears, Shafts* >> *Removal and Installation* >> *Sensor Module with Transmission Input Speed Sensor -G612-, -G632-, -G676- and Circuit Board 3.*

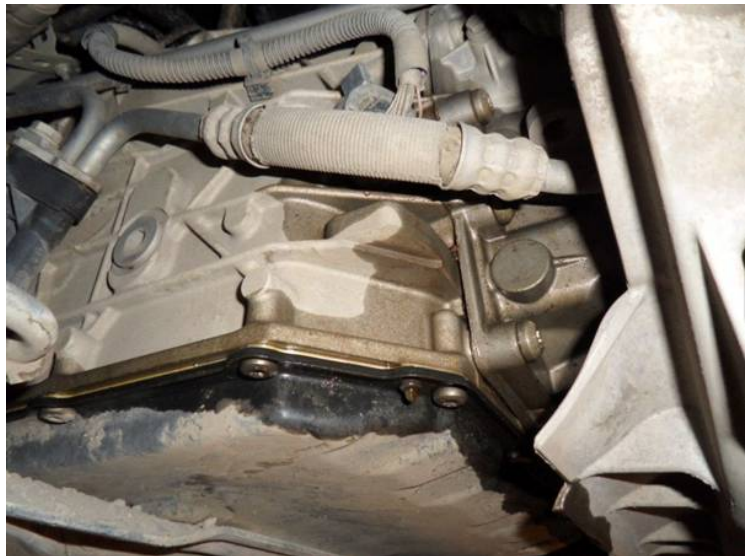
- Leak between gearbox housing and intermediate housing (Figure 3).

**Tip:** The source of the leak may be confused with o-ring of drain plug.

**Figure 3.** Leak between gearbox housing and intermediate housing.

**Note:** These instructions require transmission case disassembly. Audi Academy course # 950224 is required viewing before attempting repair service. Complete the course and the assessment # 950224B before attempting repair or warranty claim may be denied. The course and assessment can be found on the Audi Academy CRC site.

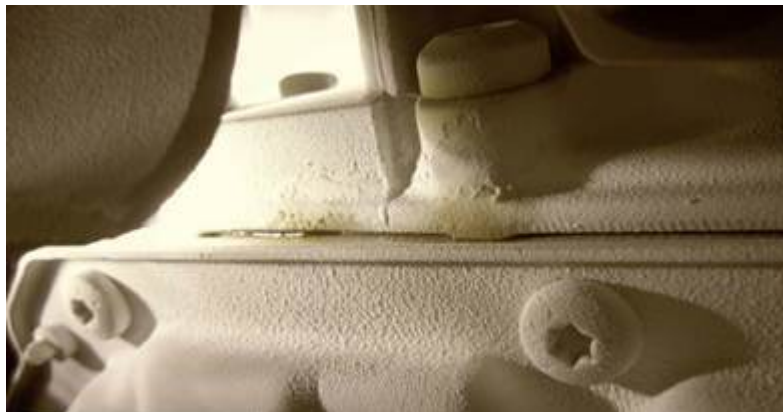
1. Locate the leak by first thoroughly cleaning and drying the stained area. Then, apply talcum spray (or similar) to the area that was stained with oil (Figure 4).

**Figure 4.** Leak located with Talcum spray.

2. Warm up the vehicle (test drive) and re-check for leaks.
3. If the leak is around the oil pan, remove the oil pan and check the gasket for imperfections or damage. If the oil pan is undamaged, only replace the oil pan seal.

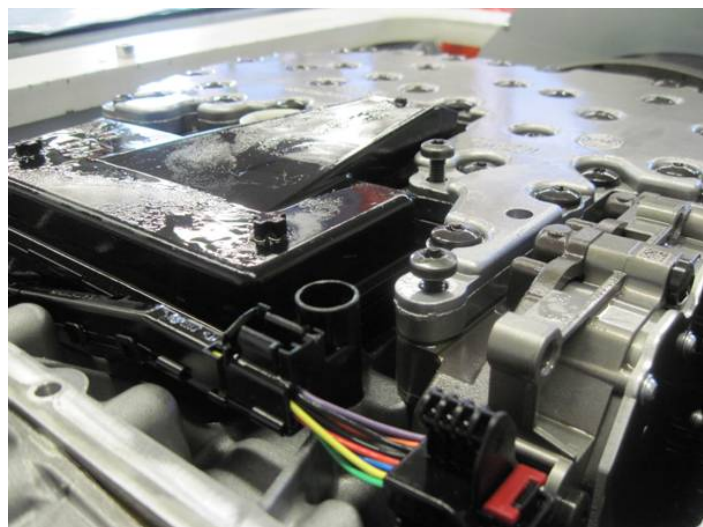
**Figure 6.** Loose bolts in the mechatronics.

4. If the oil pan is damaged (Figure 5), check the mechatronics for loose bolts (Figure 6). Replace any loose bolts and torque according to the repair manual instructions. Also, replace the pan and seal.

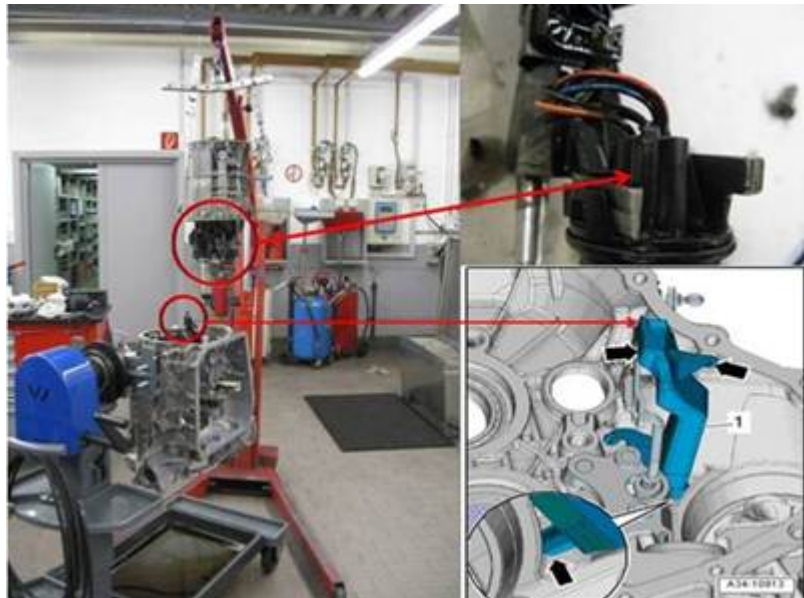
**Tip:** Use caution when lifting or lowering intermediate housing to avoid damage to components (Figure 7).

**Figure 7.** Caution points: drip tray Sensor module connector.

7. Assemble according to the repair manual and check/correct the oil level.
