# Technical Service Bulletin

#### 85 Defroster outlet trim deformed

85 13 15 2033426/1 March 29, 2013.

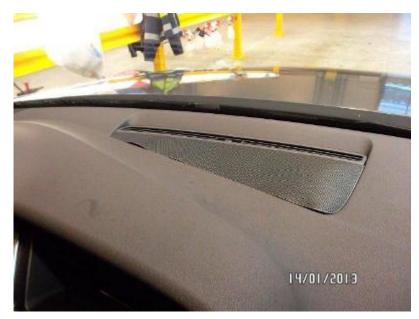
The trim panel at the defroster vent on the instrument panel is deformed (Figure 1).

Figure 1. Deformed defroster vent trim panel.

The trim panel is composed of a material which expands in a moist condition. The instrument panel restricts this expansion which leads to deformation of the trim.

Replace the defroster vent trim panel.
