# Technical Service Bulletin

## 85 Instrument panel vents cannot be adjusted

85 13 14 2033428/1 March 28, 2013.

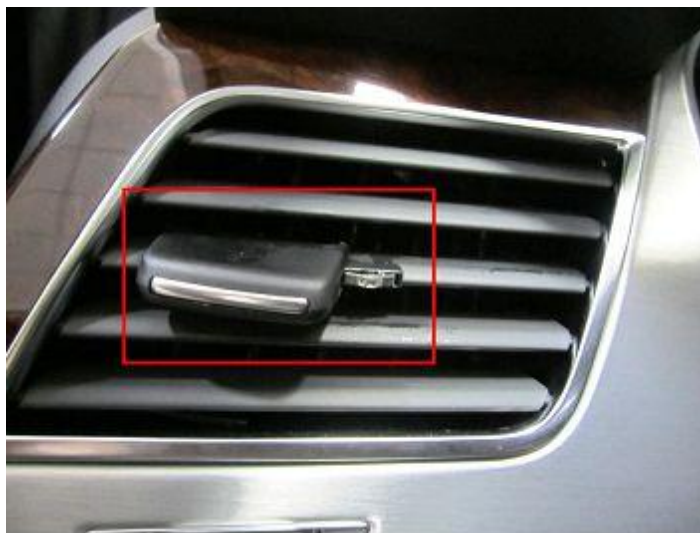
The force required to adjust the vent is greater than the attachment strength of the knob. As a result, the knob may break (Figure 1).

**Figure 1.** Broken instrument panel vent knob.

A more robust vent assembly is implemented.

Replace the instrument panel vent.
