# Technical Service Bulletin

## 60 Sunroof drain hose leaks

60 13 21 2030593/2 March 13, 2013. Supersedes Technical Service Bulletin Group 60 number 12-20 dated August 27, 2012 for reasons listed below.

Model(s)	Year	VIN Range	Vehicle-Specific Equipment
Audi Q7	2007 - 2010	All	Not Applicable

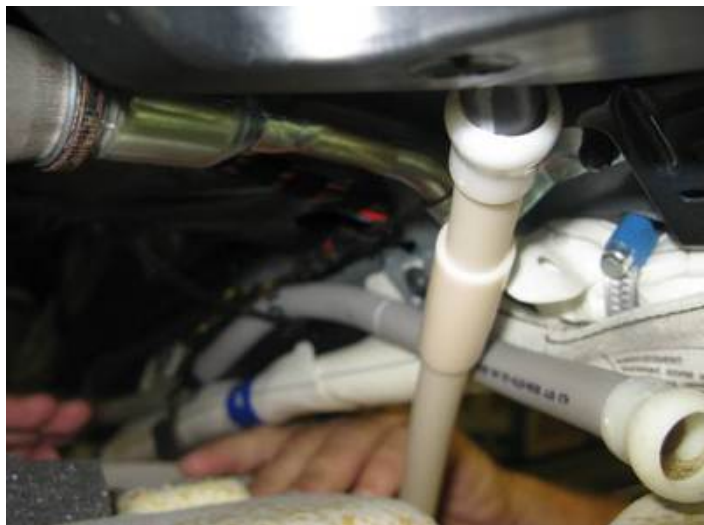
*Figure 1. Disconnect original drain.*

1. Disconnect the original drain hose from the sunroof frame.

Attach the repair section in its place (Figure 1).

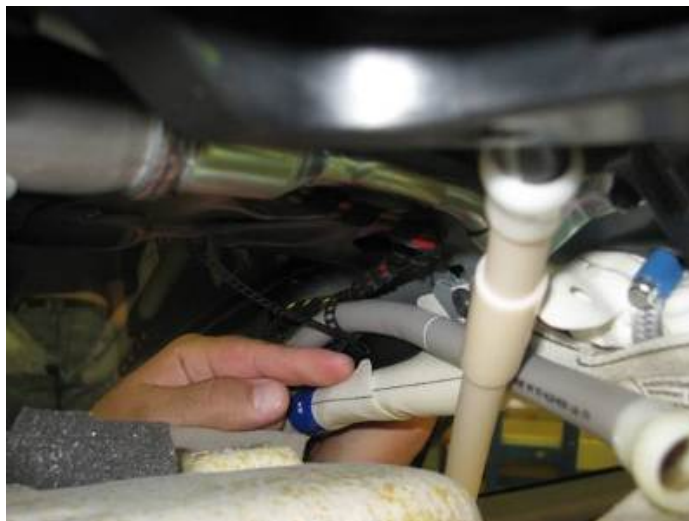
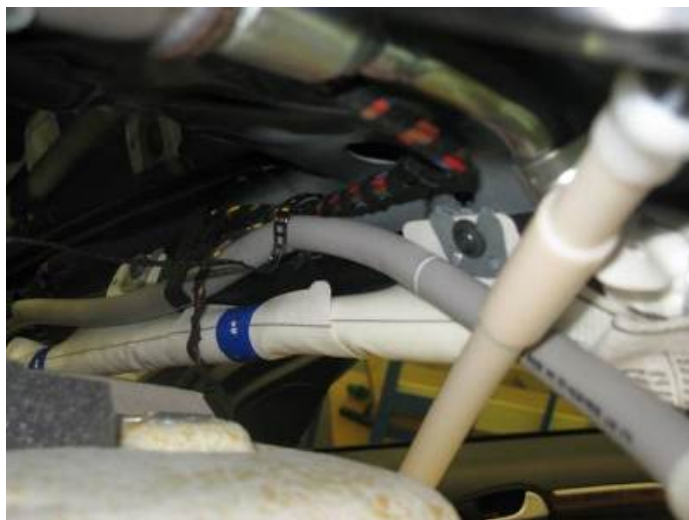
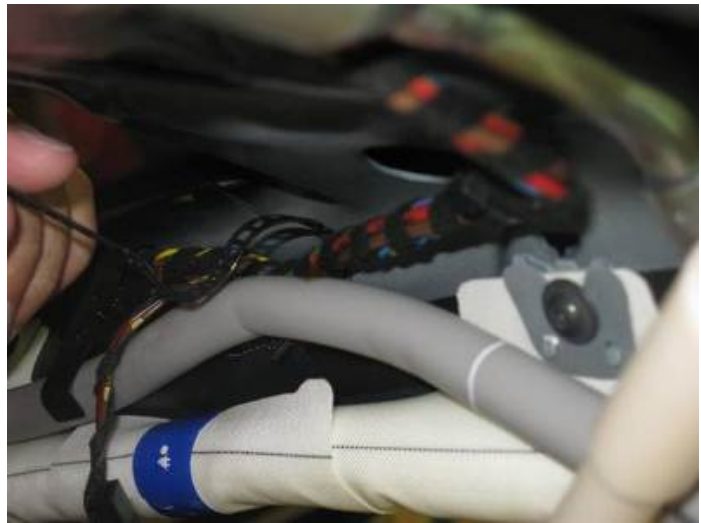
*Figure 2. Open existing ties along A-pillar.*

*Figure 3. Open existing ties along A-pillar.*

**Figure 4.** Open existing ties along A-pillar.

2. Open the existing cable ties along the A-pillar (Figures 2, 3, and 4).

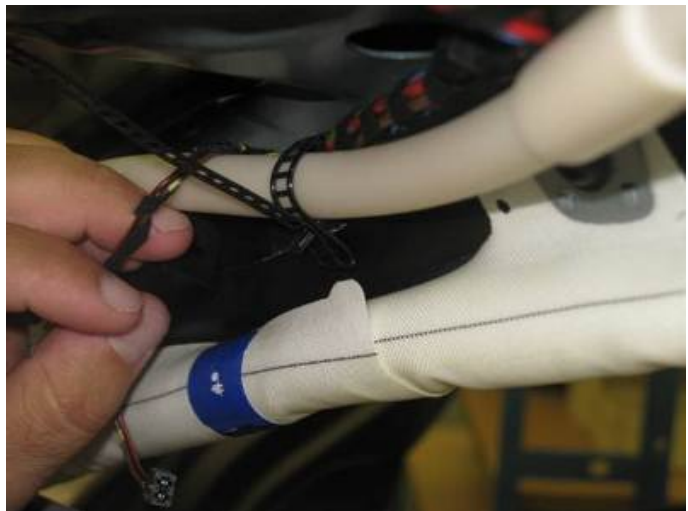
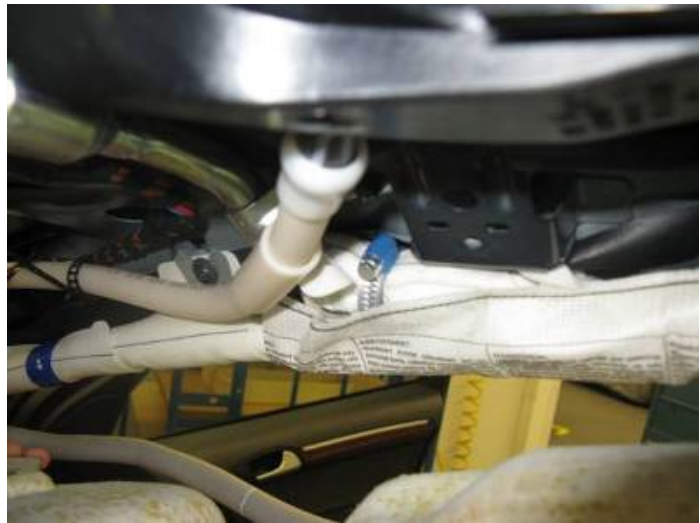
**Figure 5.** Routing the repair section through the cable ties.

**Figure 6.** Routing repair section and attaching.

3. Route the repair section through the cable ties and reattach (Figures 5 and 6).

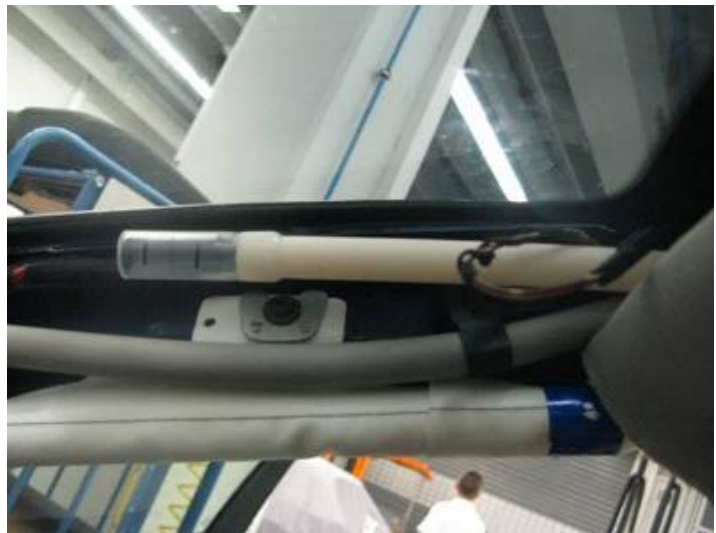
**Figure 7.** Align both hoses.

4. Align both hoses next to one another (Figure 7).

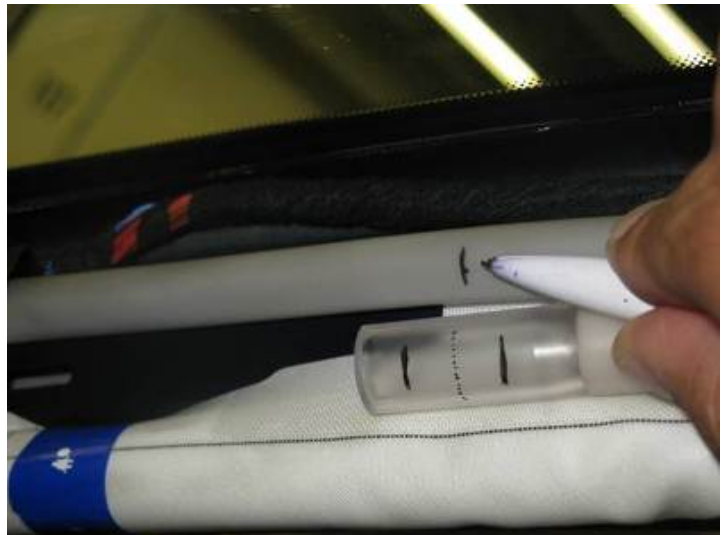
**Figure 8.** Marked at half the length of the union.

5. Mark the original hose at half the length of the union on the repair section as shown (Figure 8).

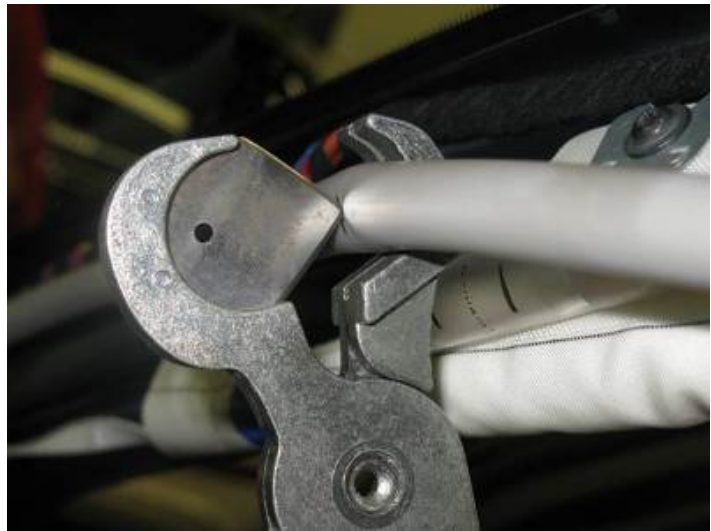
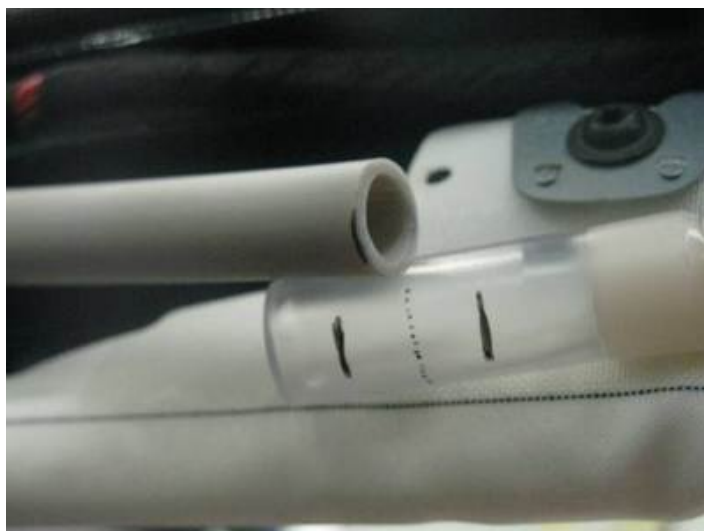
**Figure 9.** Cut the hose.

**Figure 10.** Cut hose.

6. Cut the original hose at the mark you made in step 5 (Figures 9 and 10).

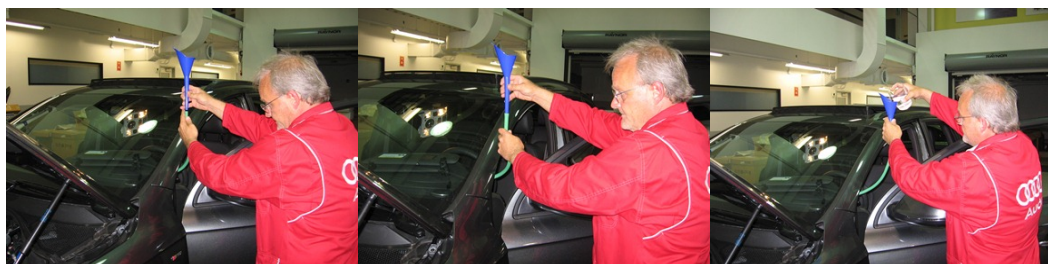
**Figure 11.** Fitting of the funnel and water testing the lower section of the hose.

7. Test that there is no leak or obstruction in any part of the lower section of the original hose by inserting a funnel with a small nozzle (~12mm – 13mm in diameter) into the open section of the lower hose enough so as to create a watertight seal, but not to excessively distort the hose. Slowly pour 200ml – 300ml of water into the funnel (Figure 11).

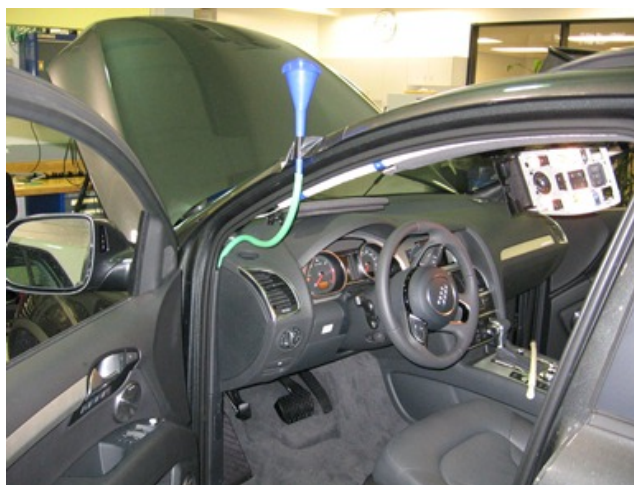
**Figure 12.** Inspect for any additional leaks or obstructions.

8. Carefully inspect the water flow and check that there are absolutely no additional leaks into the cabin or obstructions preventing proper flow in the lower section of the hose (Figure 12).

Should any additional leaks or obstructions be found, it will be necessary to replace the entire hose. The repair kit cannot be used in this case. If the lower section of the hose tests OK, continue with step 9.

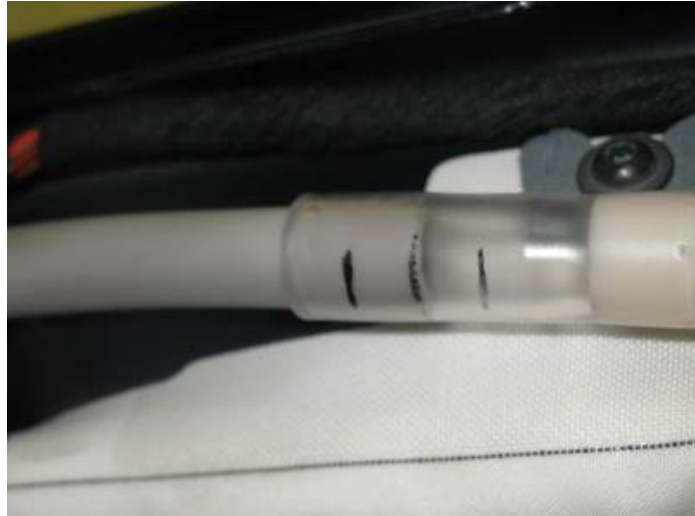
*Figure 13. Lower section of hose inserted into the union.*

9. Push the end of the lower section into the union to the half-way mark (Figure 13).

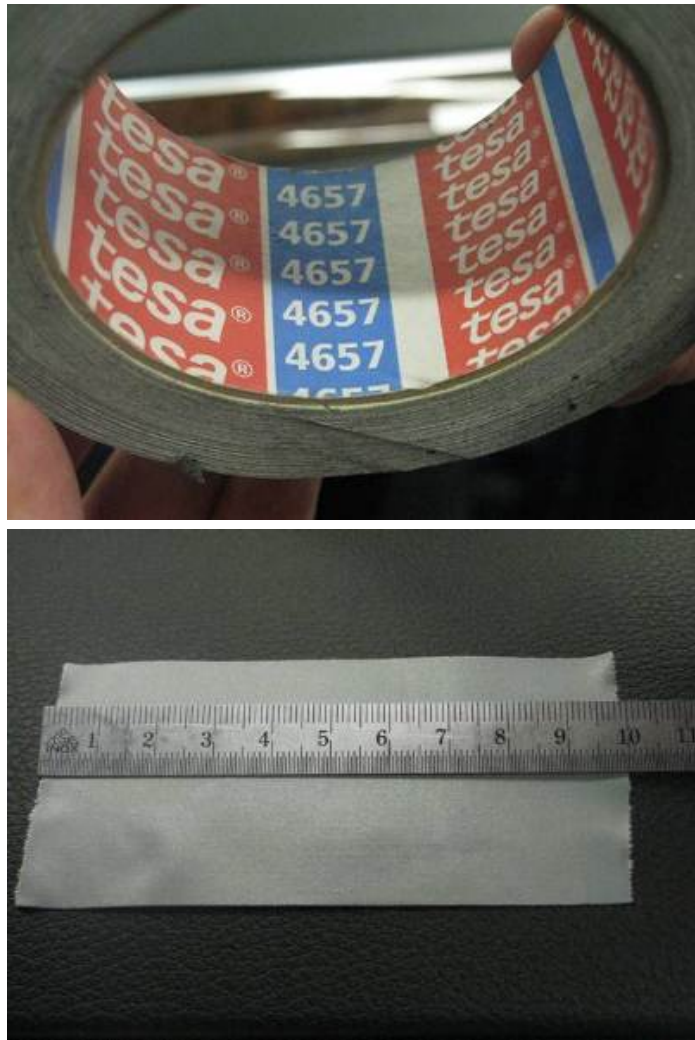
*Figure 14. Duct tape and measurement.*

10. Cut a strip of duct tape (or equivalent) approximately 10 cm long and 5 cm wide (Figure 14).

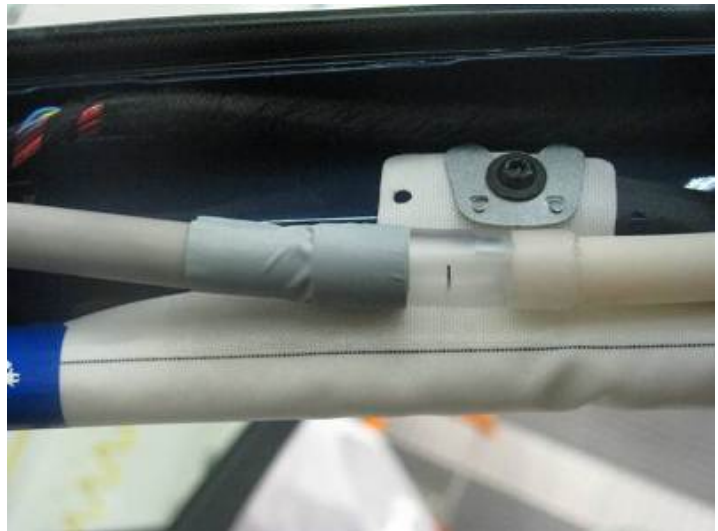
**Figure 15.** Wrap tape around connection.

11. Wrap the tape around the connection as shown (Figure 15).

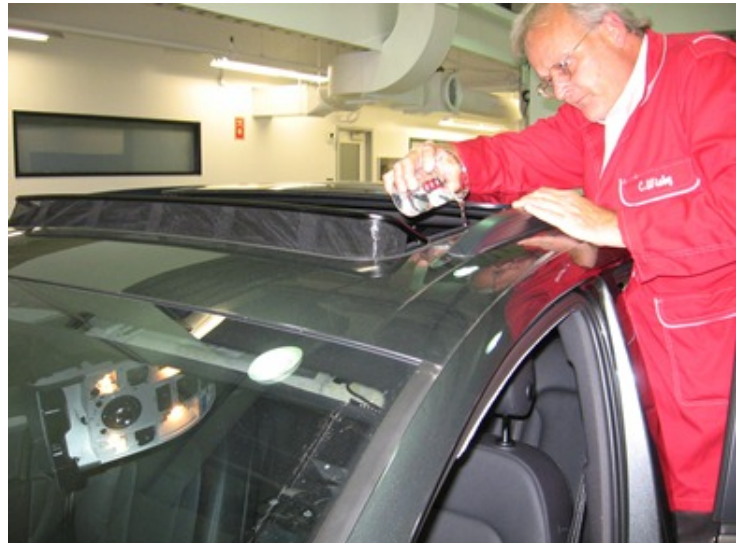
**Figure 16.** Test by pouring 200ml of water into the drain channels.

12. Carefully and accurately route the drain hose in the original path and through the retaining clips along the 'A' pillar.
13. Test the repair by pouring approximately 200ml of water into the drain channels of the sunroof frame (Figure 16).

14. Monitor the flow and check for water tightness of the repair.
15. Reassemble the interior trim.
