Technical Service Bulletin

85 Instrument panel vents cannot be adjusted

85 13 13 2032579/2 February 25, 2013. Supersedes Technical Service Bulletin Group 85 number 13-12 dated January 22, 2013 for reasons listed below.

Model(s)	Year	VIN Range	Vehicle-Specific Equipment
Audi Q7	2012	000001 - 999999	Not Applicable
Audi Q7	2013	000001 - 009159

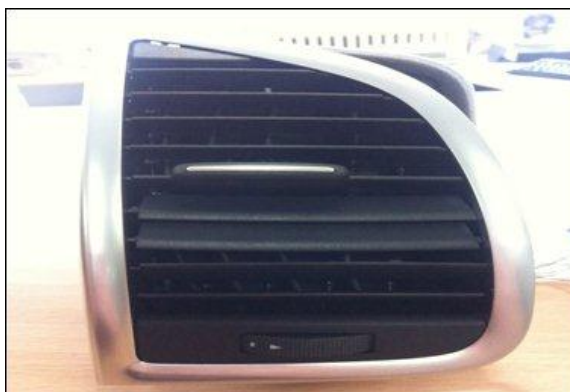
The air distribution fins in either of the outer instrument panel vents do not adjust. The fins may be broken or loose and cause a rattling sound (Figure 1).

Figure 1. Damaged fins on an outer instrument panel vent.

Replace the instrument panel vent.

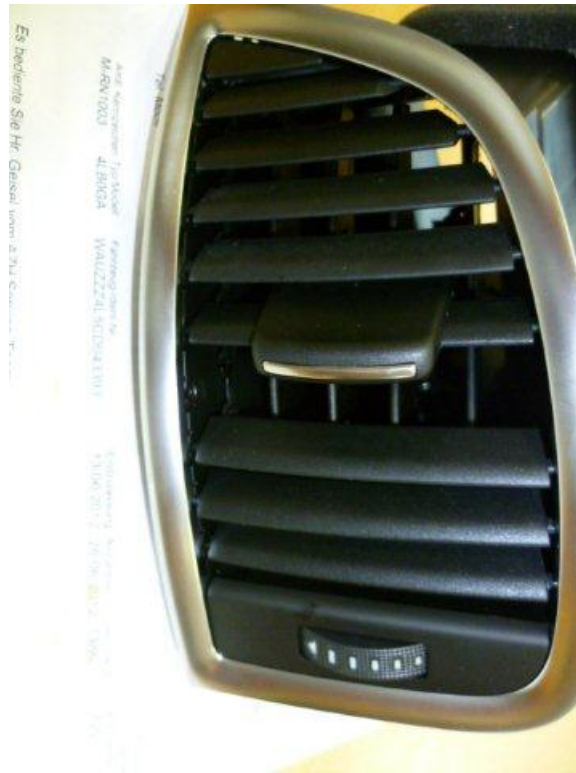
The fins may also be missing (Figure 2).

Figure 2. Missing fins on an outer instrument panel vent.
