# Service Action Campaign

Code: 19i4

**Subject: 2009 – 2011 Model Year Audi A6 Vehicles Equipped with  
3.0L TFSI Engine  
Radiator Mountings**

February 19, 2013

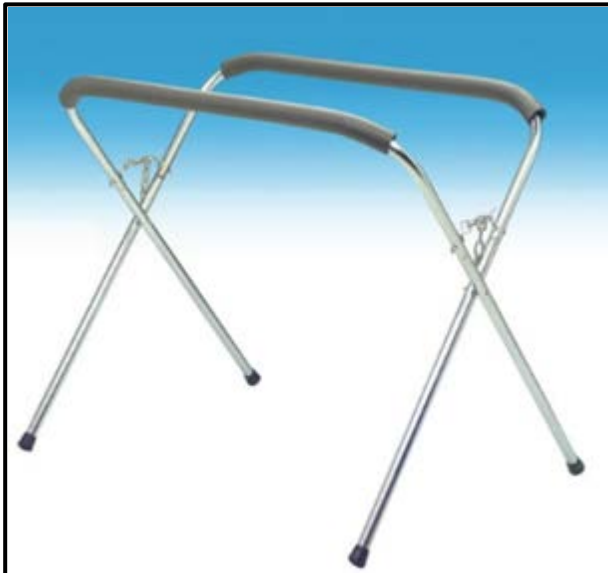
- Bumper stand (as shown or equivalent)

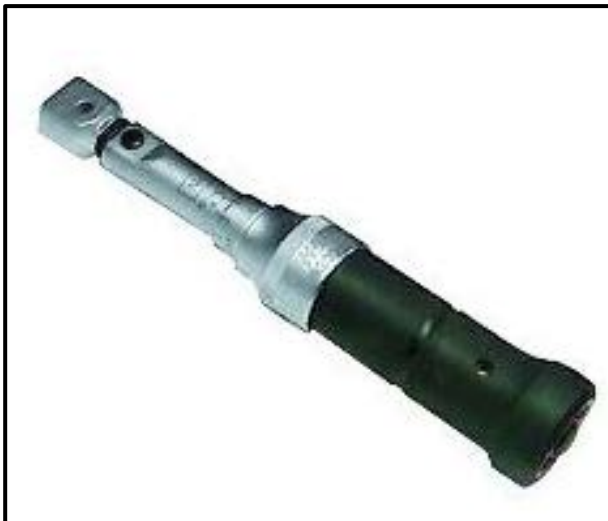
- VAG1783 Torque Wrench (or equivalent).

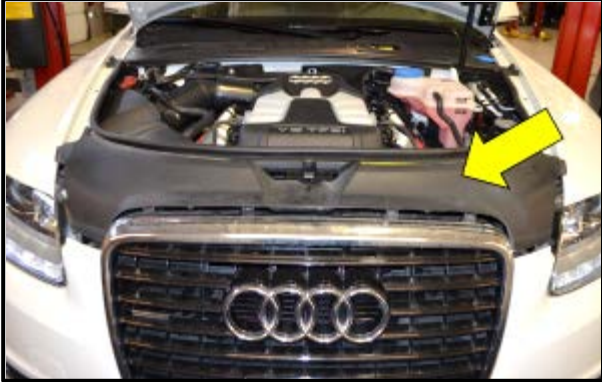
- Open the hood.
- ⇐ Remove the upper radiator shroud <arrow>.

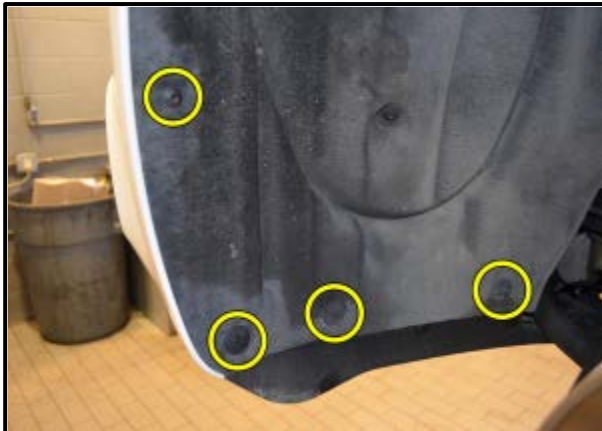
- Remove both front wheels.
- ⇐ Remove these four fasteners from the wheel housing liner <circles>.

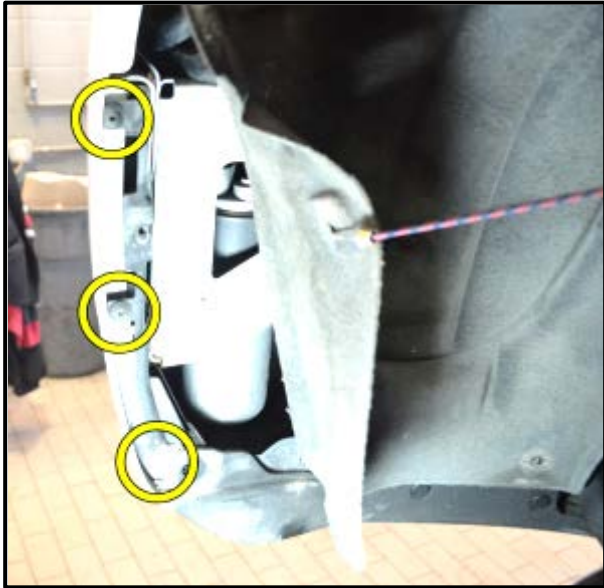
⇐ Remove the three fasteners from the fascia mounting bracket <circles>.

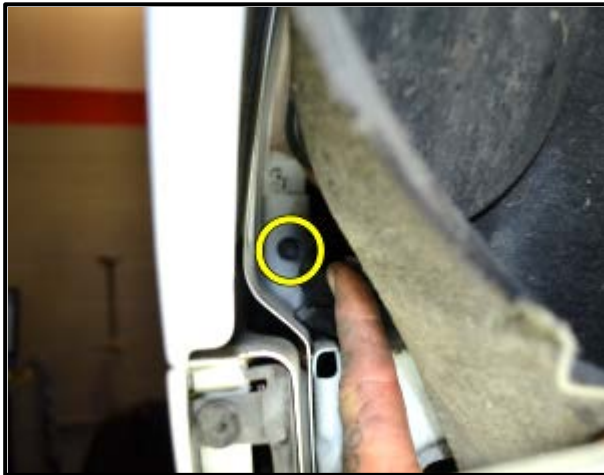
⇐ Remove the front bumper mounting nut <circle>.

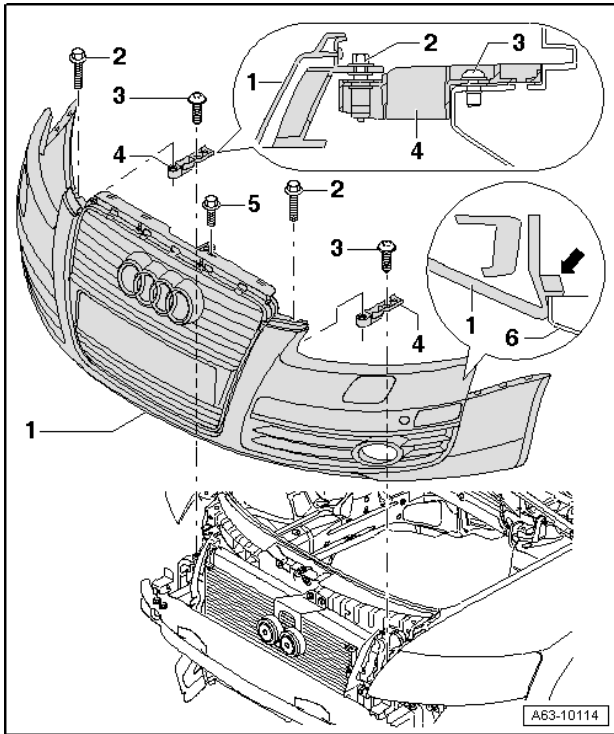
⇐ Remove the three mounting bolts from the top of the fascia (positions 2 and 5).

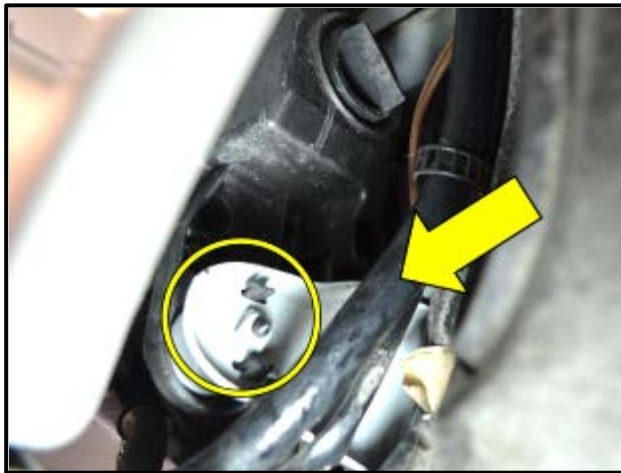
**Tip:** Inside the left front fender, reposition the headlight washer hose <arrow> so it rests in front of the headlamp mounting bracket <circle>. This will provide adequate slack in the hose when removing the fascia from the vehicle and prevent damage to the washer fluid line and/or fittings.

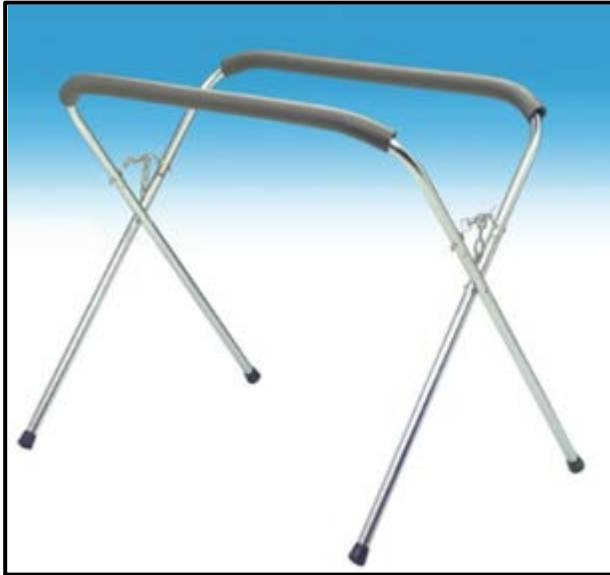
- Position an appropriate stand in front of the vehicle.

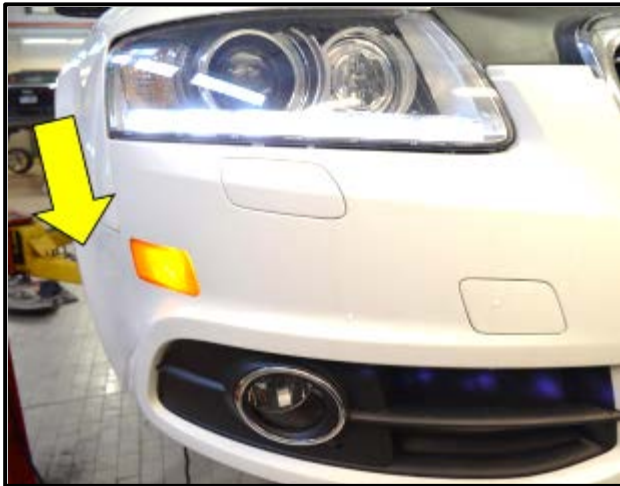
- ◀ Remove the front fascia from the vehicle by pulling straight forward on each side of the fascia where indicated <arrow>.
- Rest the fascia on the stand with a 5-6" gap between the fascia and the vehicle.
- Disconnect the washer solvent hose (located on the driver side only) and all the electrical connections between the vehicle and the fascia.
- The fascia should now be completely free from the vehicle – place it carefully out of the way.

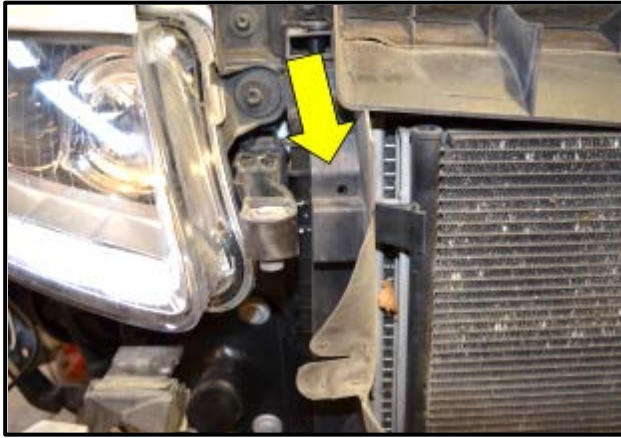
- ⇐ Remove the passenger side radiator shroud <arrow>.

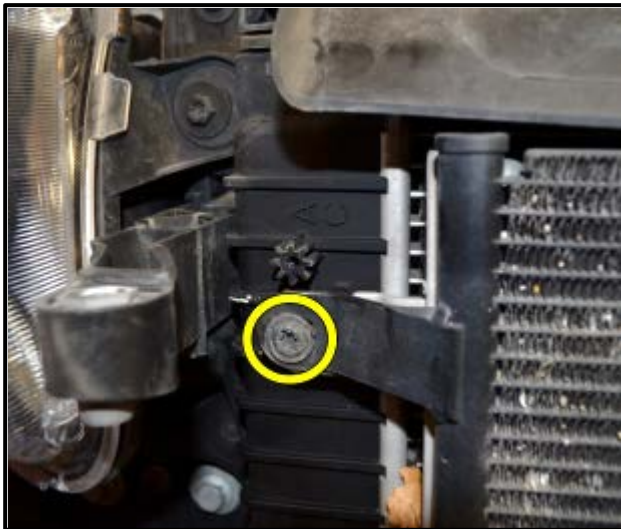
- ⇐ Remove the upper and lower mounting screws from the passenger side of the charge air cooler <circle> and discard them (upper screw shown).

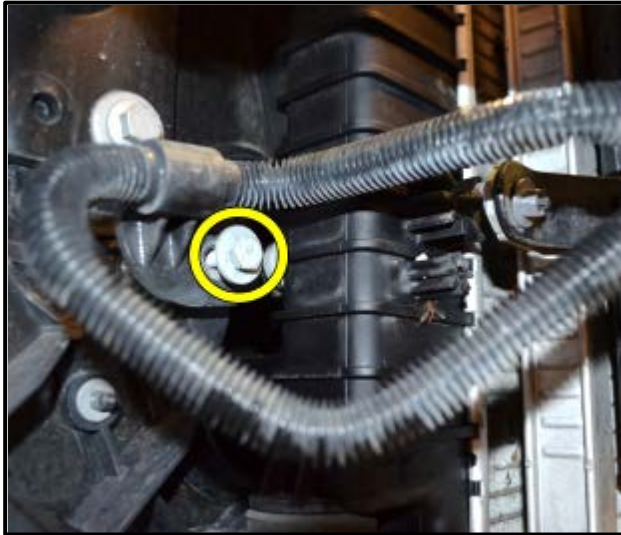
← Loosen the mounting bolt for the power steering fluid cooler <circle>.

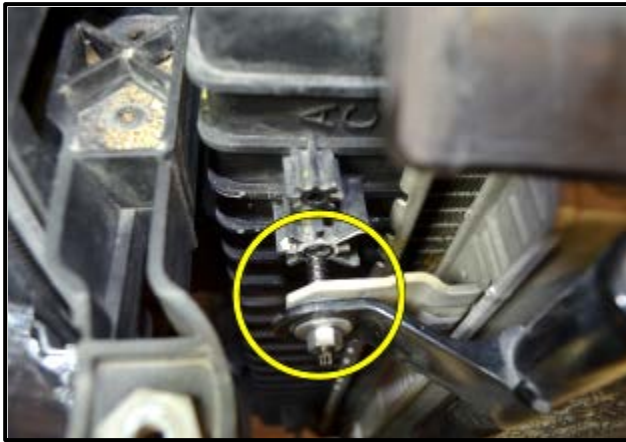
- Gently pull the charge air cooler and A/C condenser forward, away from the radiator.

← Install a stud from repair kit p/n 4F0 198 763 through the mounting tabs of the charge air cooler and a/c condenser <circle>.
