Technical Service Bulletin

53B6 UPDATE – Drain Valve (NVLW)

August 13, 2013

Model(s)	Year	VIN Range	Vehicle-Specific Equipment
A7	2012 – 2013	See Campaign/Action screen in ElsaWeb	None

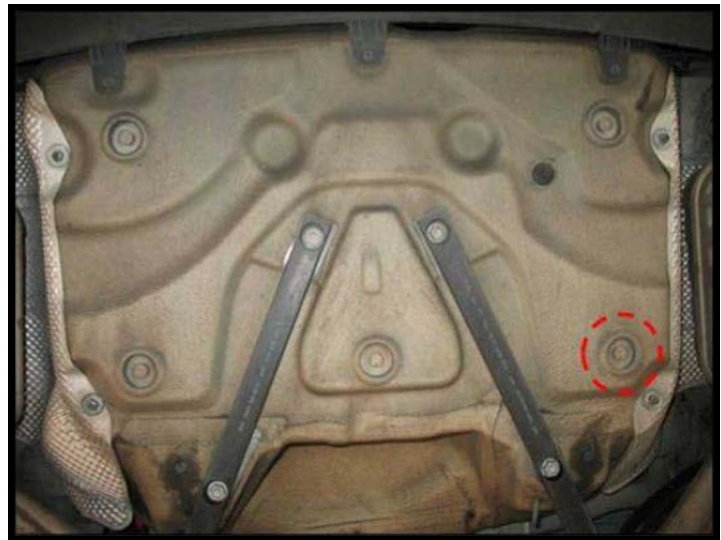
Figure 1. Red circle indicates the sealing cap that is stuck to the right side of the battery recess.

1. Use a lifting platform to lift the vehicle.
2. Working from underneath the vehicle, use a hot air blower to warm and remove the sealing cap that is stuck to the right side of the battery recess (Figure 1).

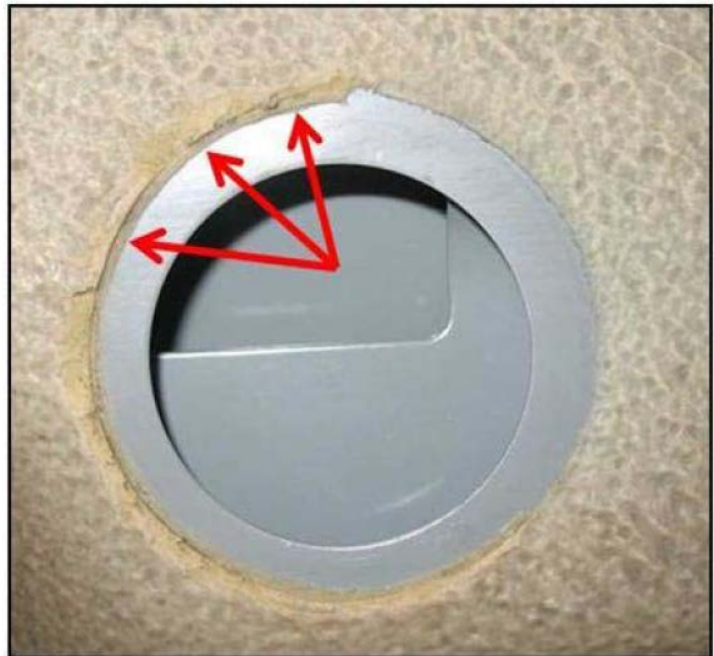
Figure 2. Red arrows indicate excess underseal.

3. Remove any excess underseal (Figure 2).

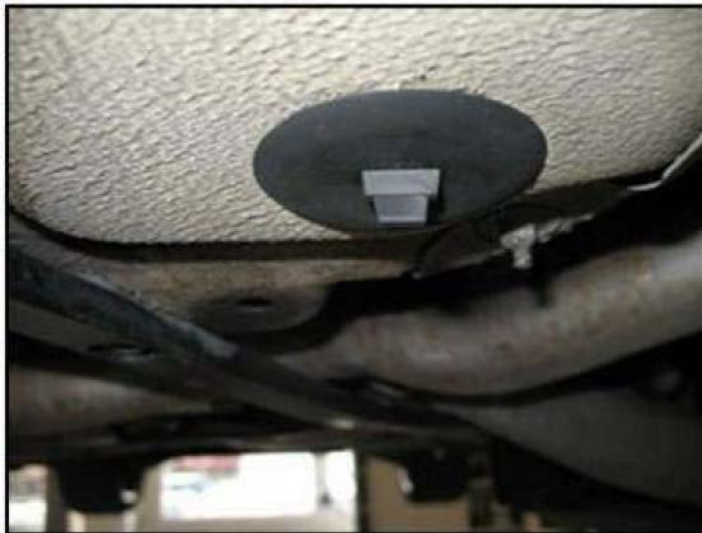
Figure 3. Installation of drain valve.

4. Fit drain valve. The direction of installation is not critical (Figure 3).
