46 Brake noise analysis and handling

46 13 53 2034181/1 August 7, 2013.

Model(s)	Year	VIN Range	Vehicle-Specific Equipment
TT (without TT RS)	2008 – 2013	All	Not applicable
A3	2005 – 2013		
A4 (B6/B7)	2005 – 2008		
A4 Cabrio (B6/B7)	2005 -2009		
A6 (C6)	2005 – 2011		
A8 (D3)	2004 – 2010		
Audi Q7	2007 – 2013

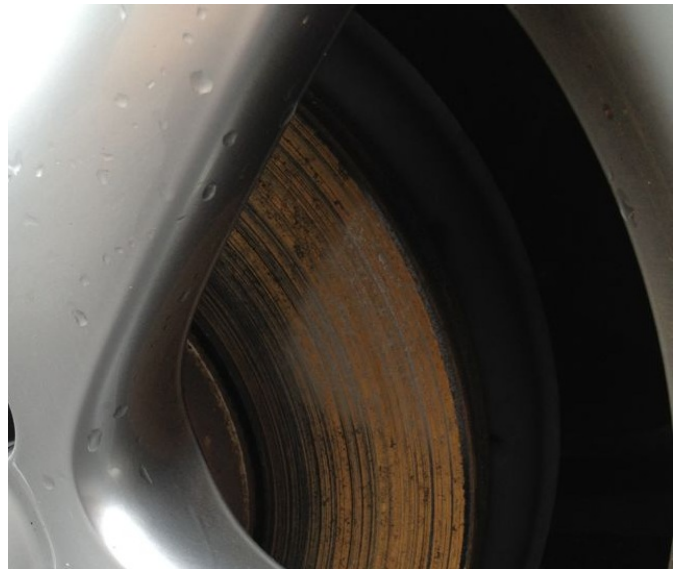
- Discs are covered with rust. Rust can form when the vehicle has not been driven for a long period of time (Figure 1).

Figure 1. Disc covered with rust.

4. Clean the brake pads and discs:
 1. With careful consideration of the traffic situation, perform between 2 and 5 ABS stops from speeds above 50 mph. Between each ABS stop, allow the brake components to cool by driving the vehicle for more than one minute at speeds greater than 50 mph.

2. Let vehicle sit for a couple of hours to cool down.
 3. Test drive again. If the noise was not eliminated after completion of steps 1 and 2 please contact the Audi Technical Assistance Center (TAC) before replacing any parts. This will assist us in diagnosing any potential issues with the condition noted above.

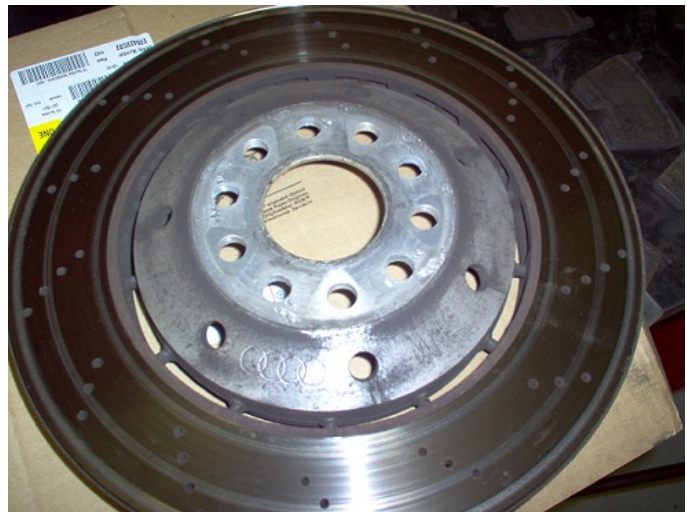
- Discs are grooved (Figure 2).

Figure 2. Grooved disc.

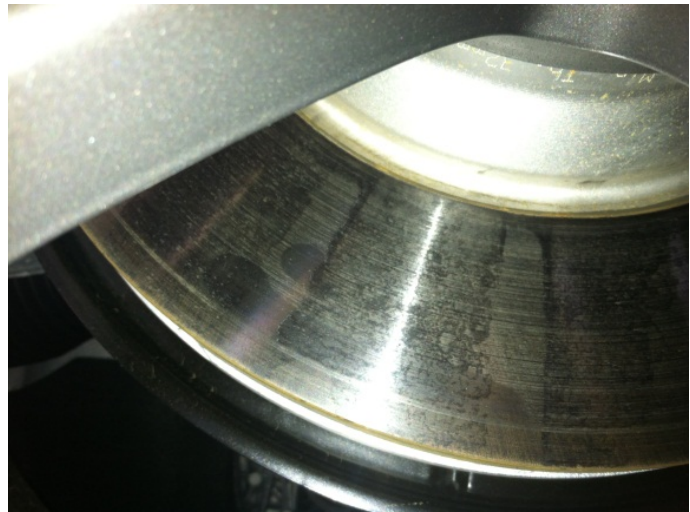
6. There is chemical contamination on the braking surface of the brake disc due to wheel or tire cleaner being sprayed directly onto the brake disc (Figure 3 and Figure 4).

Figure 3. Discoloration on the brake disc due to chemical contamination from cleaner that was sprayed directly onto the disc.

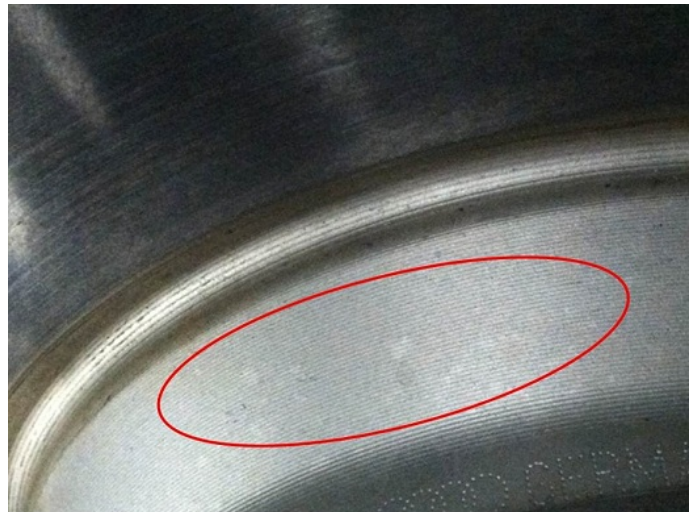
Figure 4. Small spots and discoloration due to chemical contamination from cleaner that was sprayed directly onto the disc.

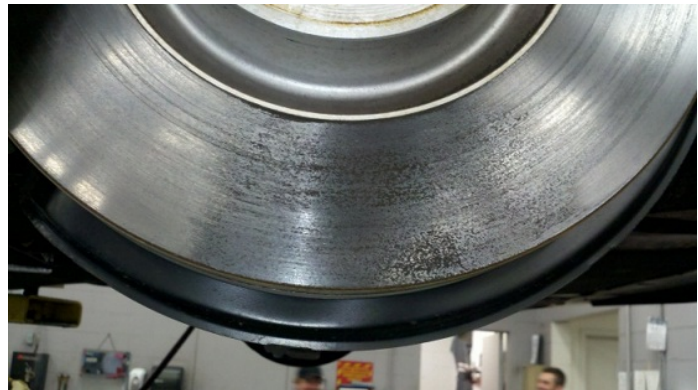
7. There are “pad marks” on the brake disc as a result of brake pad material transferring to the discs (Figure 5). Pad marks can occur when a vehicle has been parked for long periods of time in a wet or snowy environment.

Figure 5. Brake pad material has transferred to the discs.
