Service Bulletin

Subject: Pulsating/Rotational Noise from Right Rear of Vehicle on Brake Apply

Models: 2012-2013 Chevrolet Cruze
Equipped with Drum Brake (RPO J93)
Vehicles Built Prior to VIN Breakpoint D7161078

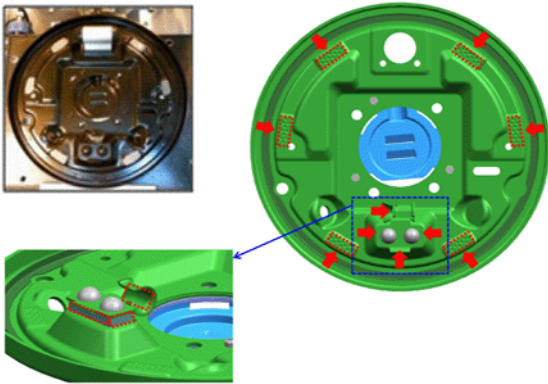
Some customers may comment about a pulsating/rotational noise coming from the right rear of the vehicle during brake apply.

This noise may be caused by an interaction between the brake drum and brake shoe.

The right rear brake drum and rear brake shoes need to be replaced including applying a high temperature grease, GMP/N 12345996 (in Canada, 10953501), or equivalent, on all the locations of the backing plate as shown in the illustration above.

Note: DO NOT replace the left rear drum as this noise condition only pertains to the right side.
