Service Bulletin

Subject: High Release Efforts on Driver or Passenger Seat Back Latch or Release Handle Difficult to Operate

Models: 2010-2012 Chevrolet Camaro

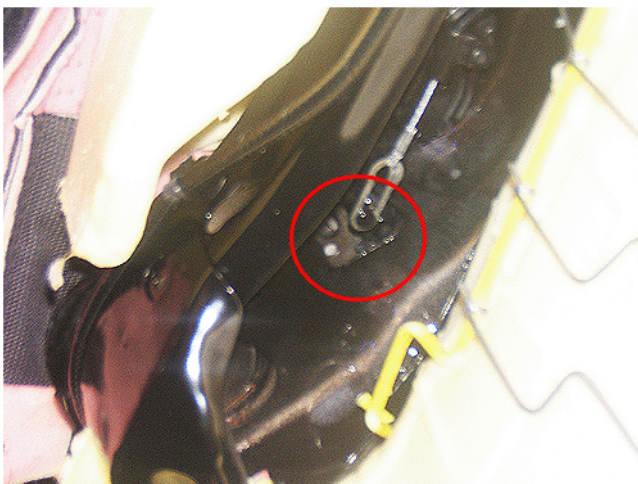
Technicians are to apply GM Super Lube®, P/N♦12346241 (in Canada, P/N 10953474), or equivalent, to the left and right seat back latches on both the driver and passenger seats, following the steps below. The location of the driver's left side seat back latch is shown circled in the graphic above.

Do This	Don't Do This
Lubricate the driver and passenger seat back latch.	<ul style="list-style-type: none"> • DO NOT replace the driver or passenger seat back cushion frame. • DO NOT replace the seat back cushion latch release handle.

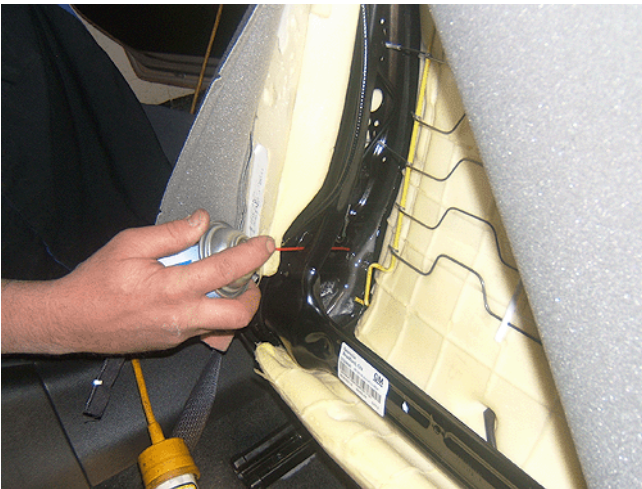
Note: One side latch has open access while the opposite side may have more limited access due to its location behind the seat recliner motor. Openings in the seat back frame should allow application of the spray to both the front and back side of the latches.

2. Gain access to the release latches by disengaging the seat back cover rear J-channel from the seat frame, then unzipping the cover on each side.
