# Service Bulletin

**Subject:** Squeaking/Creaking Type Noise Heard When Using Clutch Pedal

**Models:** 2012-2013 Chevrolet Sonic  
Equipped with Manual Transmission (RPOs MZ4, M26)

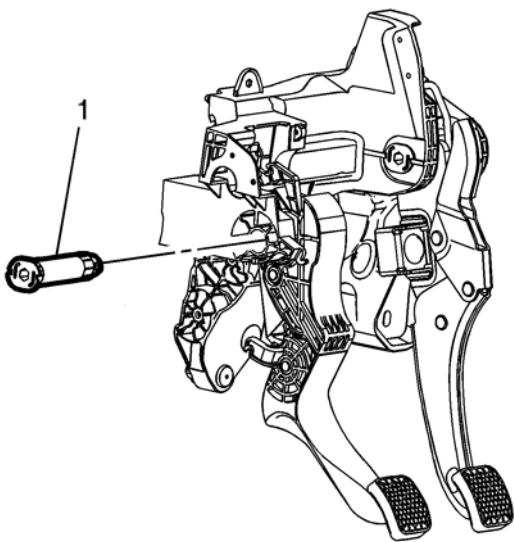
Some customers may comment on a squeaking/creaking type noise heard when using the clutch pedal.

This may be caused from lack of or no lubrication on the clutch pedal pin (1) shown in the illustration above.
