**Document ID:** IK0900088  
**Revision:** 0  
**Created:** 10/4/2013  
**Last Modified:** 10/8/2013  
**Author:** Bob Ford

**Title: RE Model IC Bus Surge Tank De-Aeration Hose Installation**

**Applies To: RE Model School and Commercial Bus with 2010 EPA MaxxForce DT**

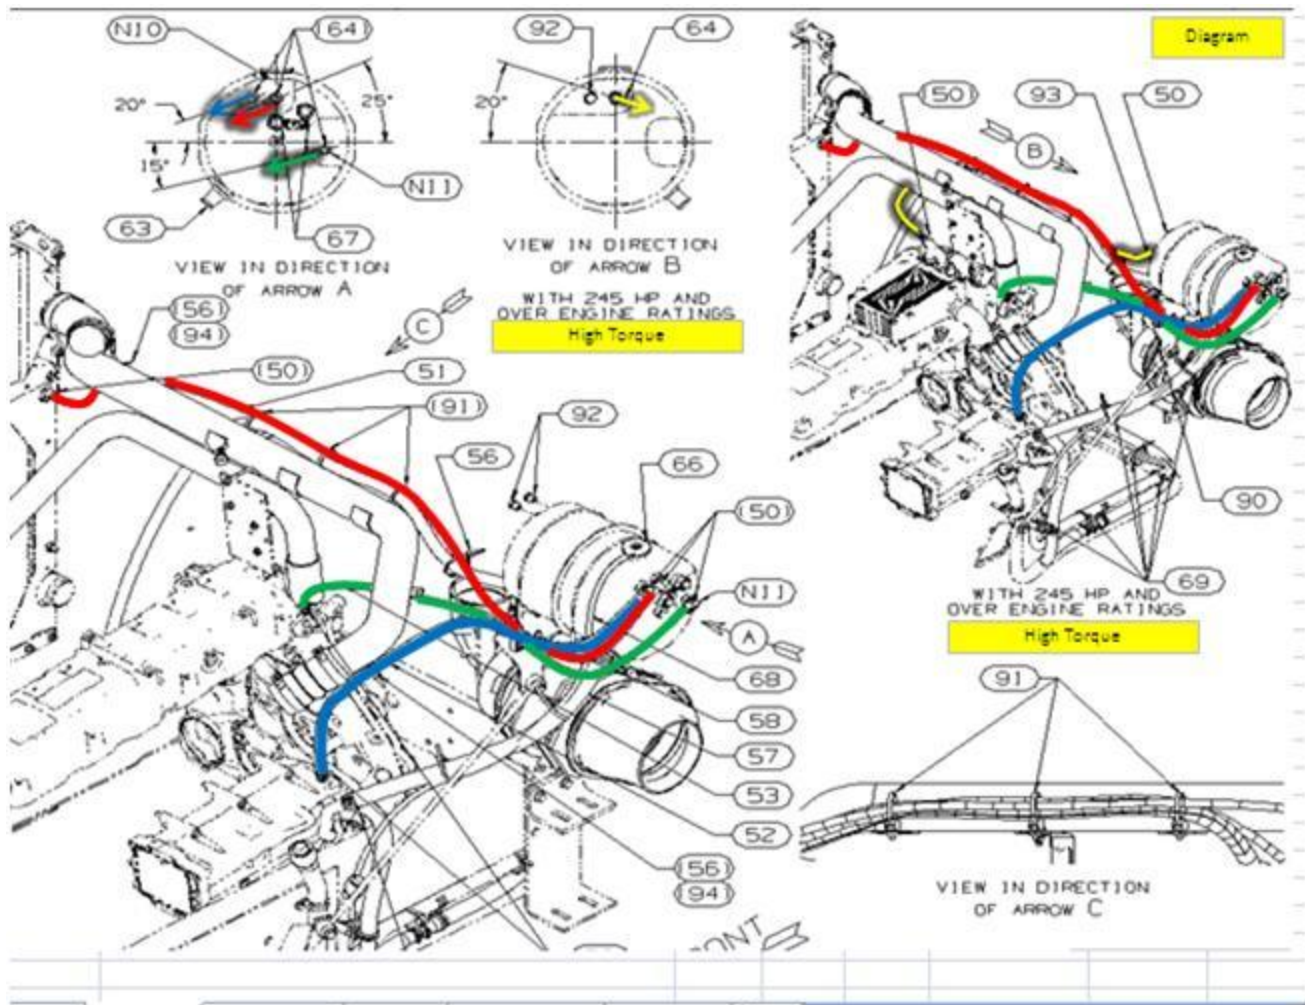
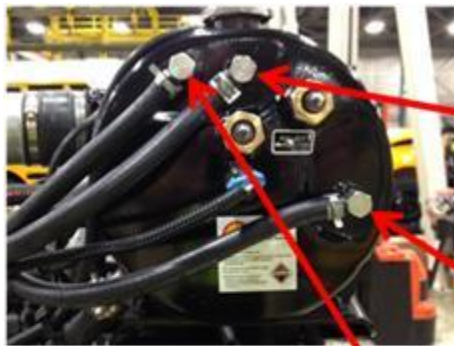
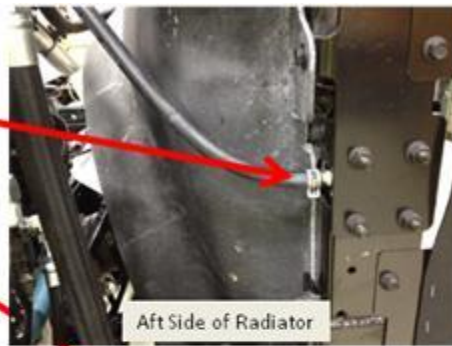
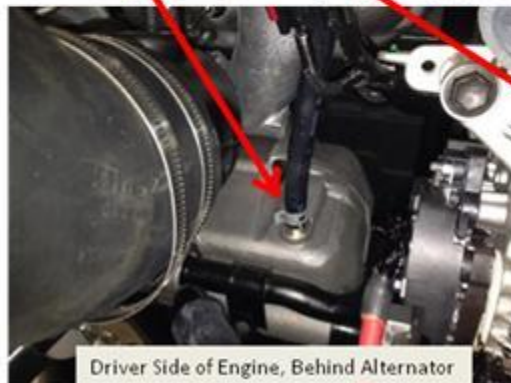
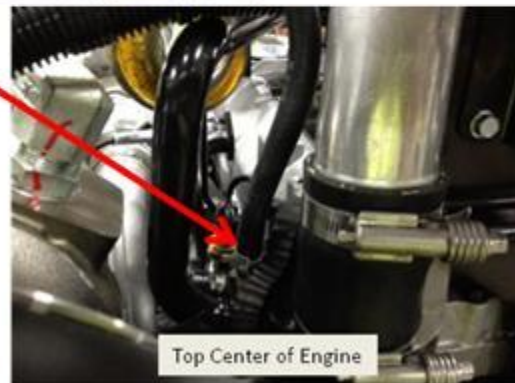
Below diagram outlines the correct installation of the de-aeration hoses on the RE Model Bus, School and Commercial, with 2010 MaxxForce DT.

Intermittent low coolant warning, SPN 111 FMI 1, with coolant level maintained above sensor location.

De-aeration hose installation should be confirmed when diagnosing low coolant warning concerns. Corrections to hose installation should be made at surge tank eliminating any hose replacement.
