**Document ID:** IK2200127  
**Revision:** 0  
**Created:** 10/11/2013  
**Last Modified:** 10/17/2013  
**Author:** Bob Ford

**Title: BE and CE Model Electrical Panel Decal**

**Applies To: BE and CE Bus Models Build Start Date: April 2, 2012 Build End Date: Sept 16, 2013**

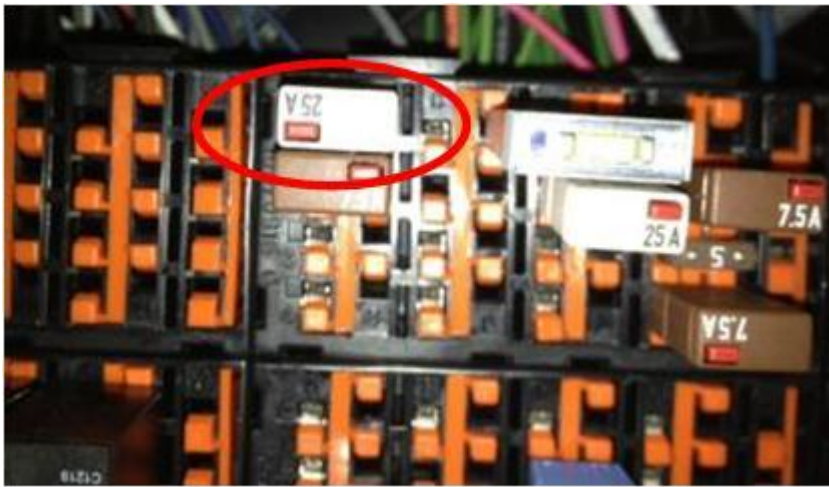
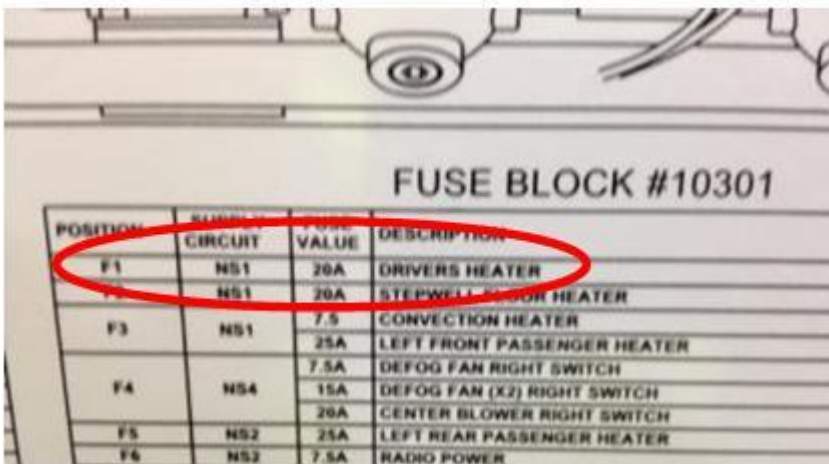
BE and CE electrical panel decal incorrectly states the driver heater fuse/breaker value. The decal lists the driver heater fuse, F1, value at 20A. Units are correctly produced with a 25A fuse/breaker.

Use of a 20A fuse/breaker can result in intermittent tripping of the fuse/breaker.

No action is required at this time to replace the decal.

If the driver heater circuit is suspect and the fuse / circuit breaker is rated at 25A follow normal circuit troubleshooting procedures.
