# ***SERVICE PROCEDURE***

**13512R1  
OCTOBER 2013**

**SUBJECT: NON-COMPLIANCE RECALL  
IC Bus™ Passenger Seat Back Foam on Certain  
AE, BE, CE, and RE School Bus Models Built 11  
February 2010 through 17 June 2013 with IC Bus  
Seats.**

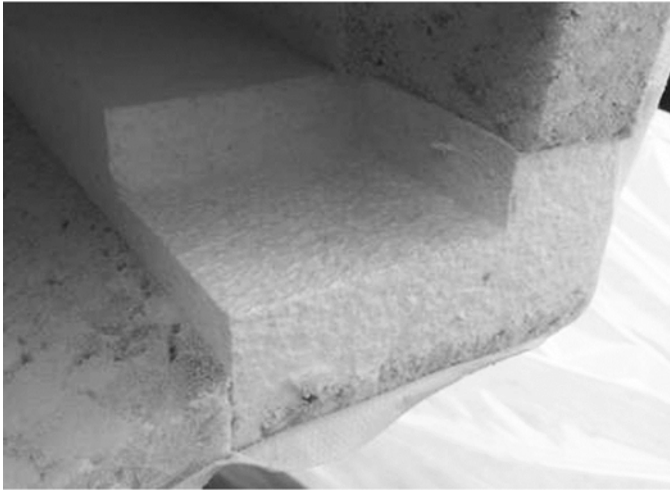
**Figure 3. Replaced Seat Back Foam.**

- a. Replaced seat back foam has a smooth square cut notch at affected area (Figure 3). No inserts are necessary. Proceed to Step 11.

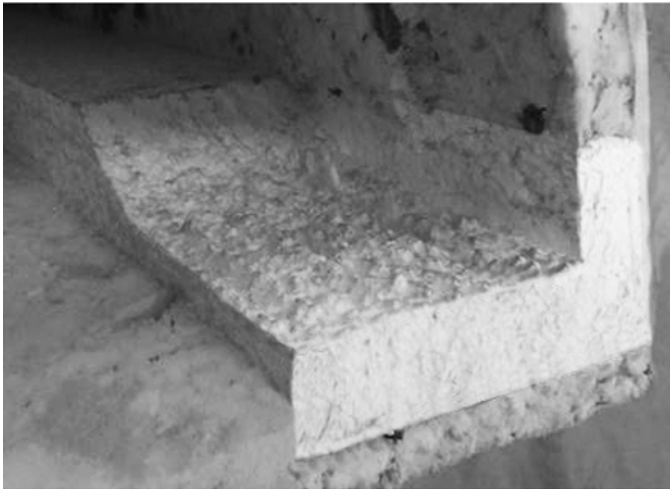
**Figure 4. Original Seat Back Foam.**

- b. Original seat back foam has a coarse bevel gut notch in affected area (Figure 4). Foam inserts must be installed. Proceed to Step 7.
