Countries: CANADA, UNITED STATES, PUERTO RICO
Document ID: IK0700041
Availability: ISIS, Bus ISIS, FleetSIS
Revision: 2
Major System: EXHAUST
Created: 10/20/2011
Current Language: English
Last Modified: 12/13/2013
Other Languages: [Français](#), [Español](#),
Author: Steve Kueller
Viewed: 1091

Title: Exhaust Bellows Damage

Applies To: DuraStar, WorkStar, PayStar, TranStar, ProStar models when equipped with bellows exhaust pipe.

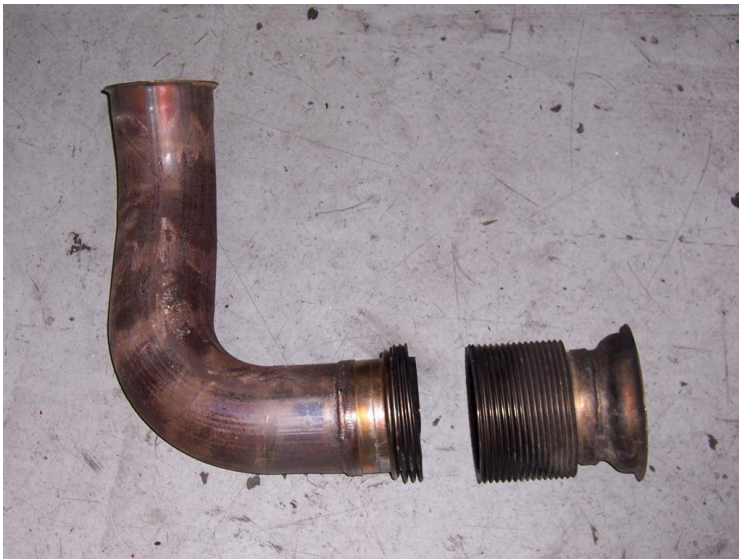
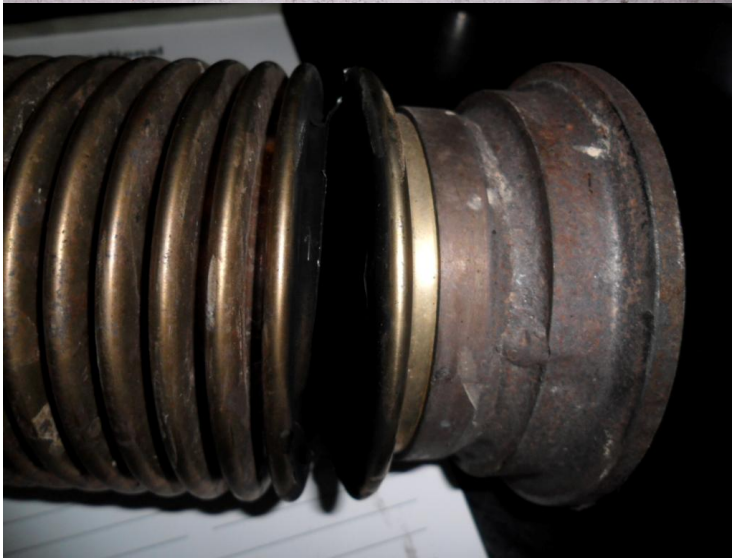
Exhaust bellows damage may occur anytime the bellows is bent out of form. Bending of bellows portion of the pipe can stress the bellows and cause premature cracking in the bellows core. Bending can be caused by improper installation or removing one end of the pipe and forcing the pipe out of position during diagnostic procedures.

- Broken or cracked bellows, Exhaust leak, Exhaust noise

1. Replace any damaged pipe taking care not to bend the bellows out of form during installation.
2. Do not bend the bellows out of form to run the engine while performing diagnostics . If necessary to run the engine with the exhaust pipe disconnected from the aftertreatment assembly remove the clamps from both ends and locate the pipe away from the area.
