Document ID: IK0700047
Revision: 1
Created: 6/28/2012
Last Modified: 12/10/2013
Author: Keith Kierzek

Title: Horizontal Aftertreatment Mounting Bolt Torque

Applies To: ProStar, TranStar, WorkStar equipped with MF 11/13 engines

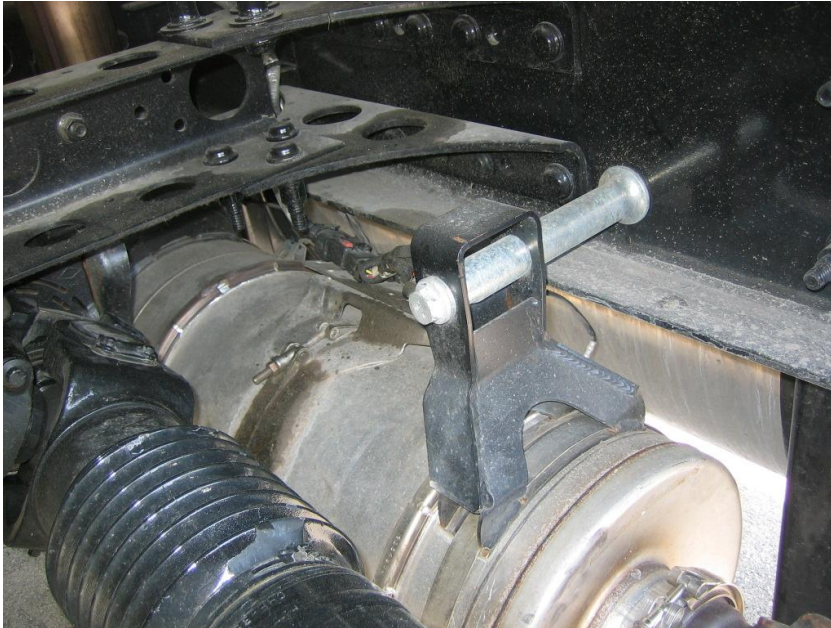
Horizontal Aftertreatment Support Rod Bolt loose or backed out of Aftertreatment Support Hanger Rod.

1. Inspect for Support Rod Bolt to be loose or backed out of Support Rod
2. If loose inspect bolt for wear and replace if necessary

Torque Support Rod Bolt to 88-108 NM / 65-80 Ft. Lbs.
