**Title: RE Model IC Bus Surge Tank De-Aeration Hose Installation**

**Applies To: RE Model School and Commercial Bus with 2010 EPA MaxxForce DT**

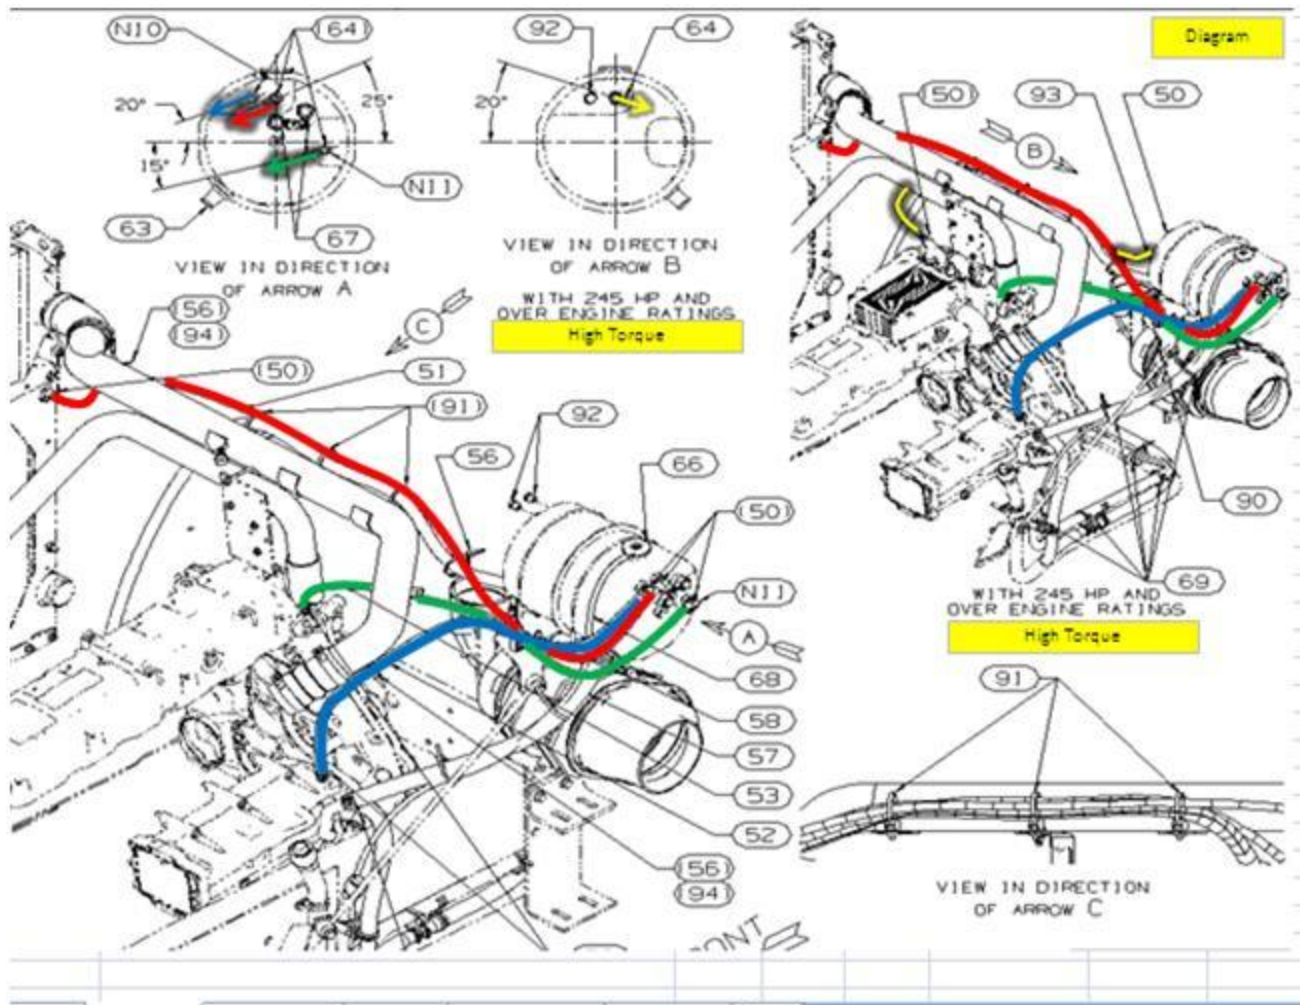
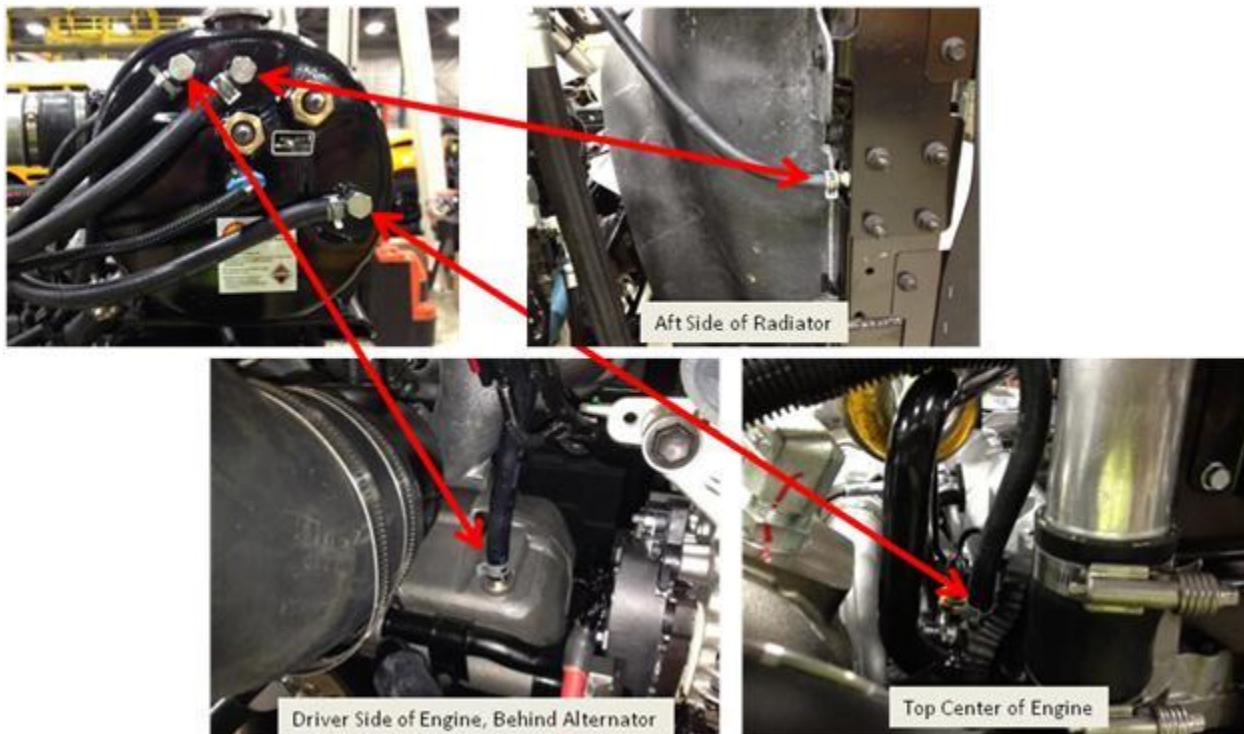
Below diagram outlines the correct installation of the de-aeration hoses on the RE Model Bus, School and Commercial, with 2010 MaxxForce DT.

Intermittent low coolant warning, SPN 111 FMI 1, with coolant level maintained above sensor location.

De-aeration hose installation should be confirmed when diagnosing low coolant warning concerns. Corrections to hose installation should be made at surge tank eliminating any hose replacement.
