**Document ID:** IK1500047  
**Revision:** 2  
**Created:** 5/5/2010  
**Last Modified:** 12/23/2013  
**Author:** Frank Amstadt

**Title:** Filterminder Air Restriction Gauge Improvement

**Applies To:** ProStar, LoneStar, 8600 Equipped with 0016HKC, FILTER MINDER UNDER HOOD W/SWITCH

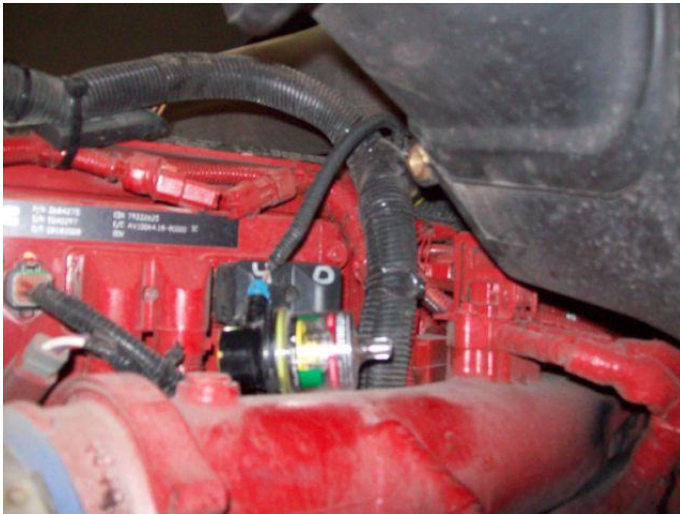
Filterminder Stem broken

- Filterminder will be hanging from wire harness

1. Visual inspection of the Filterminder Air Restriction Gauge

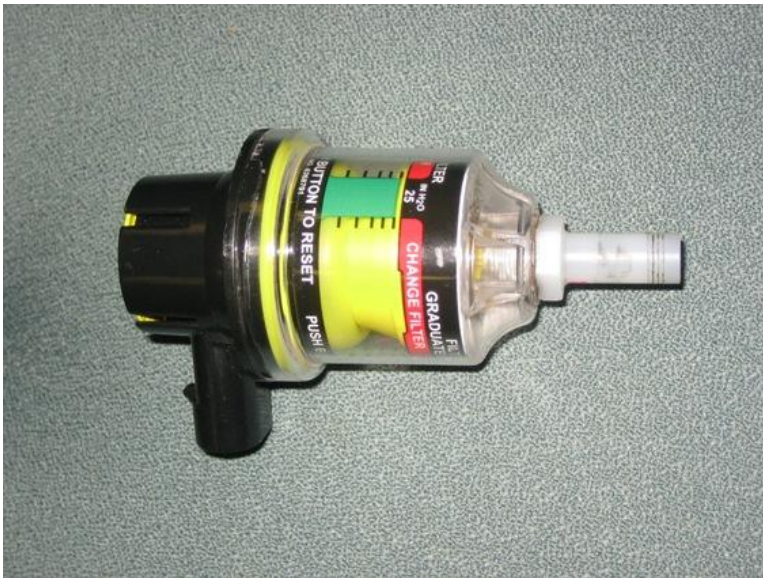
Replace Broken Filterminder with Improved Filterminder Assembly

| Part # | Description | Qty. |
|---|---|---|
| 3876780C1 | Air Restriction Gauge | 1 |
