# Local Campaign Request Form

<i>Title</i>	<input type="text" value="EGR mass flow tube replacement"/>		
<i>Customer (s) involved</i>	<input type="text" value="GLI 2011 fleet (47 vehicles), NYCT Flett (90)"/>		
<i>Comments</i>	<input type="text" value="Multiple codes related to EGR mass flow, resulting in clogged DPF and towings"/>		
<i>Ref to procedure</i>	<input type="text" value="See attached document"/>

## VENTURI PIPE CHANGE OVER. DIRECT REPLACEMENT

- Dave Langlois
- Greyhound
- Jan-16- 2013

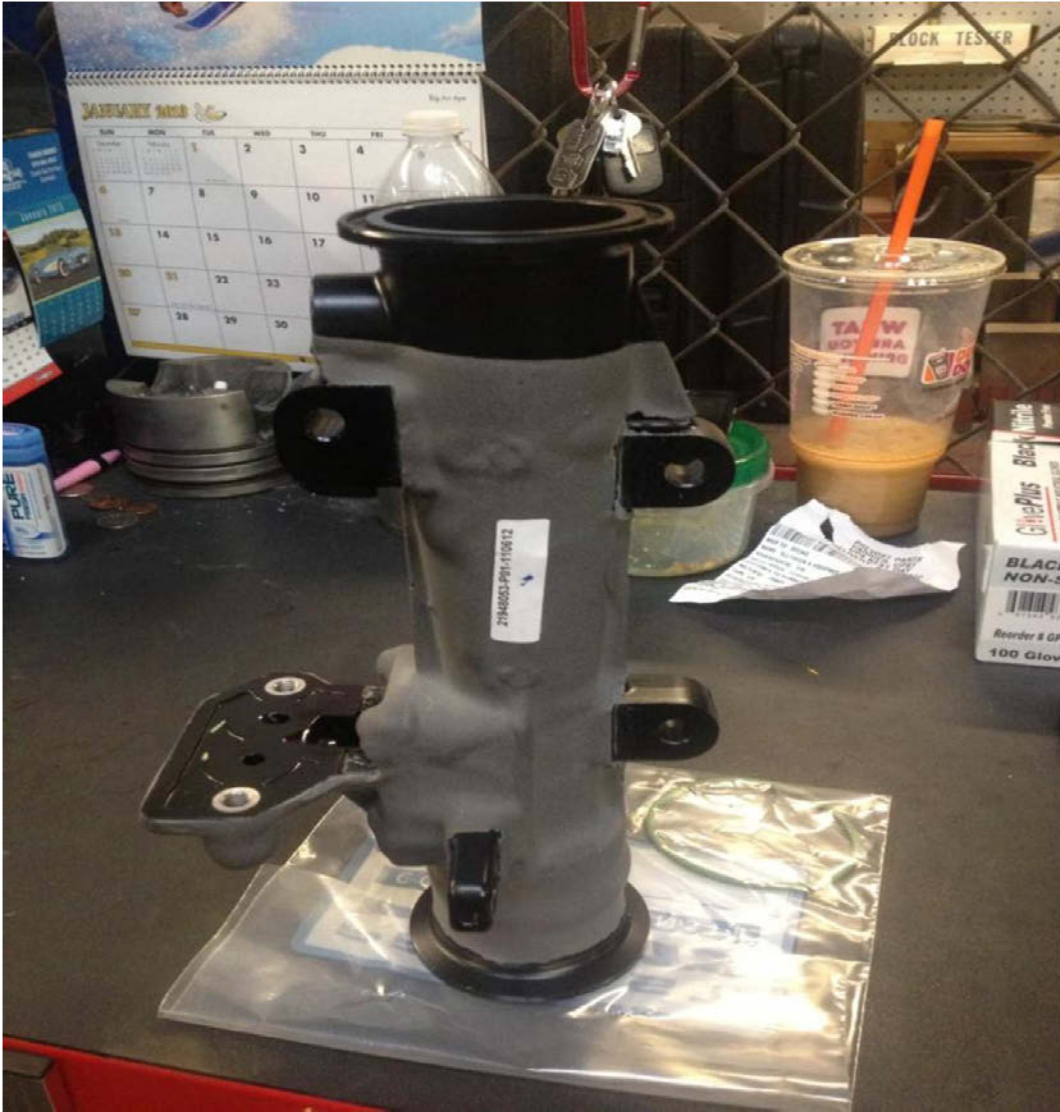
**WHAT THE NEW PIPE LOOKS LIKE. GREY INSULATION AROUND PIPE. BLOCK IS ATTACHED TO IT. HAS BIGGER PRESSURE TUBES INTO PIPE**

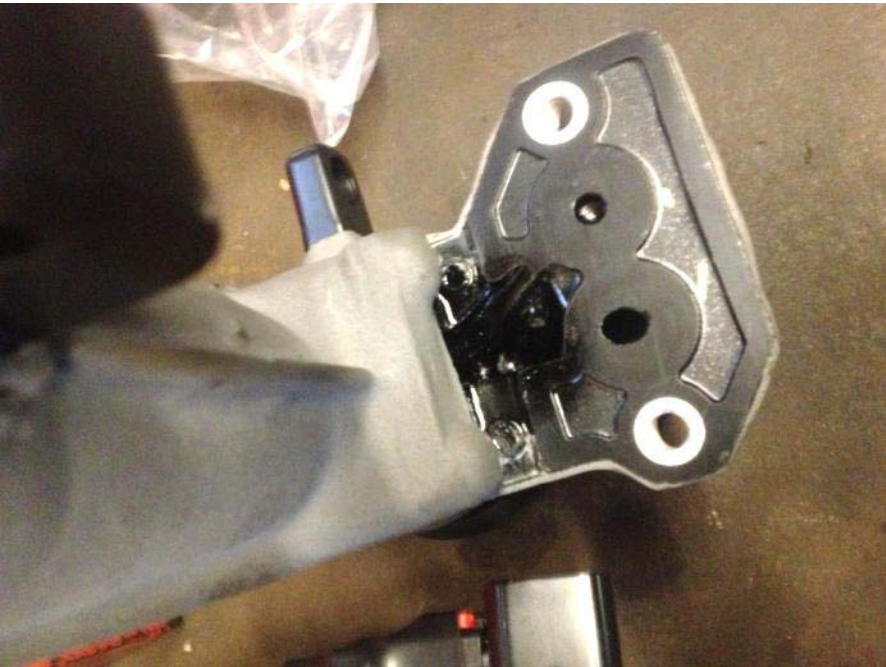
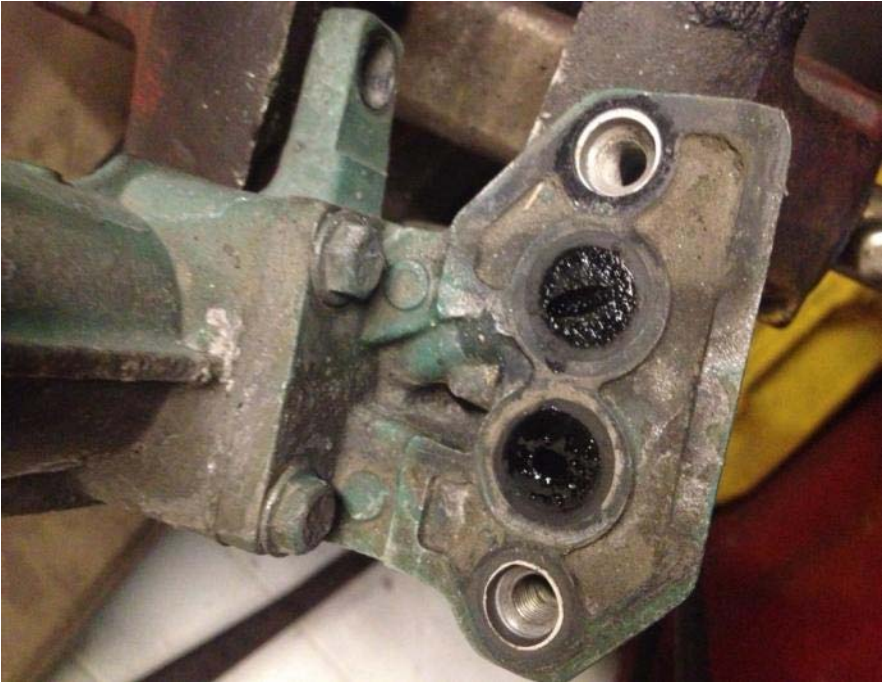
# COMPARISON OF SIZE PORT WHERE SENSOR ATTACHES

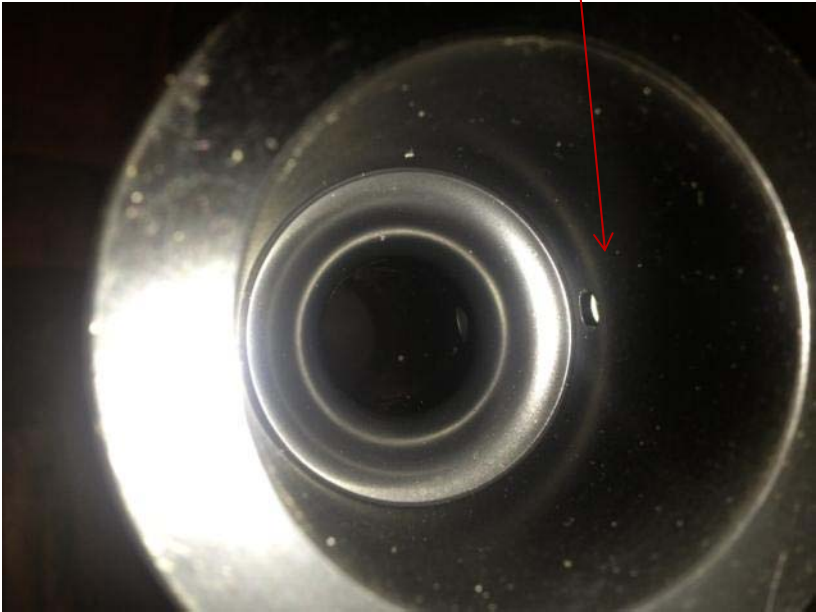
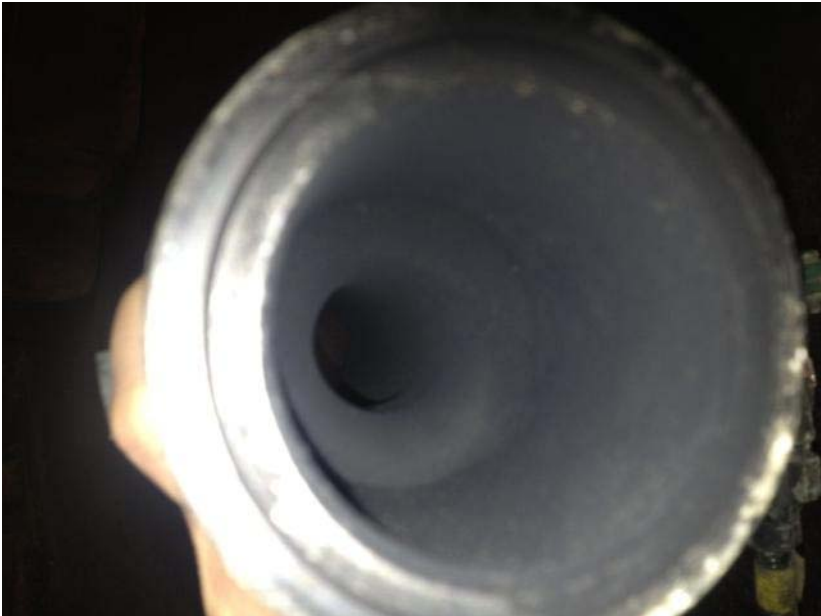
# COMPARISON OF HOLE SIZE ON THE INSIDE OF PIPE

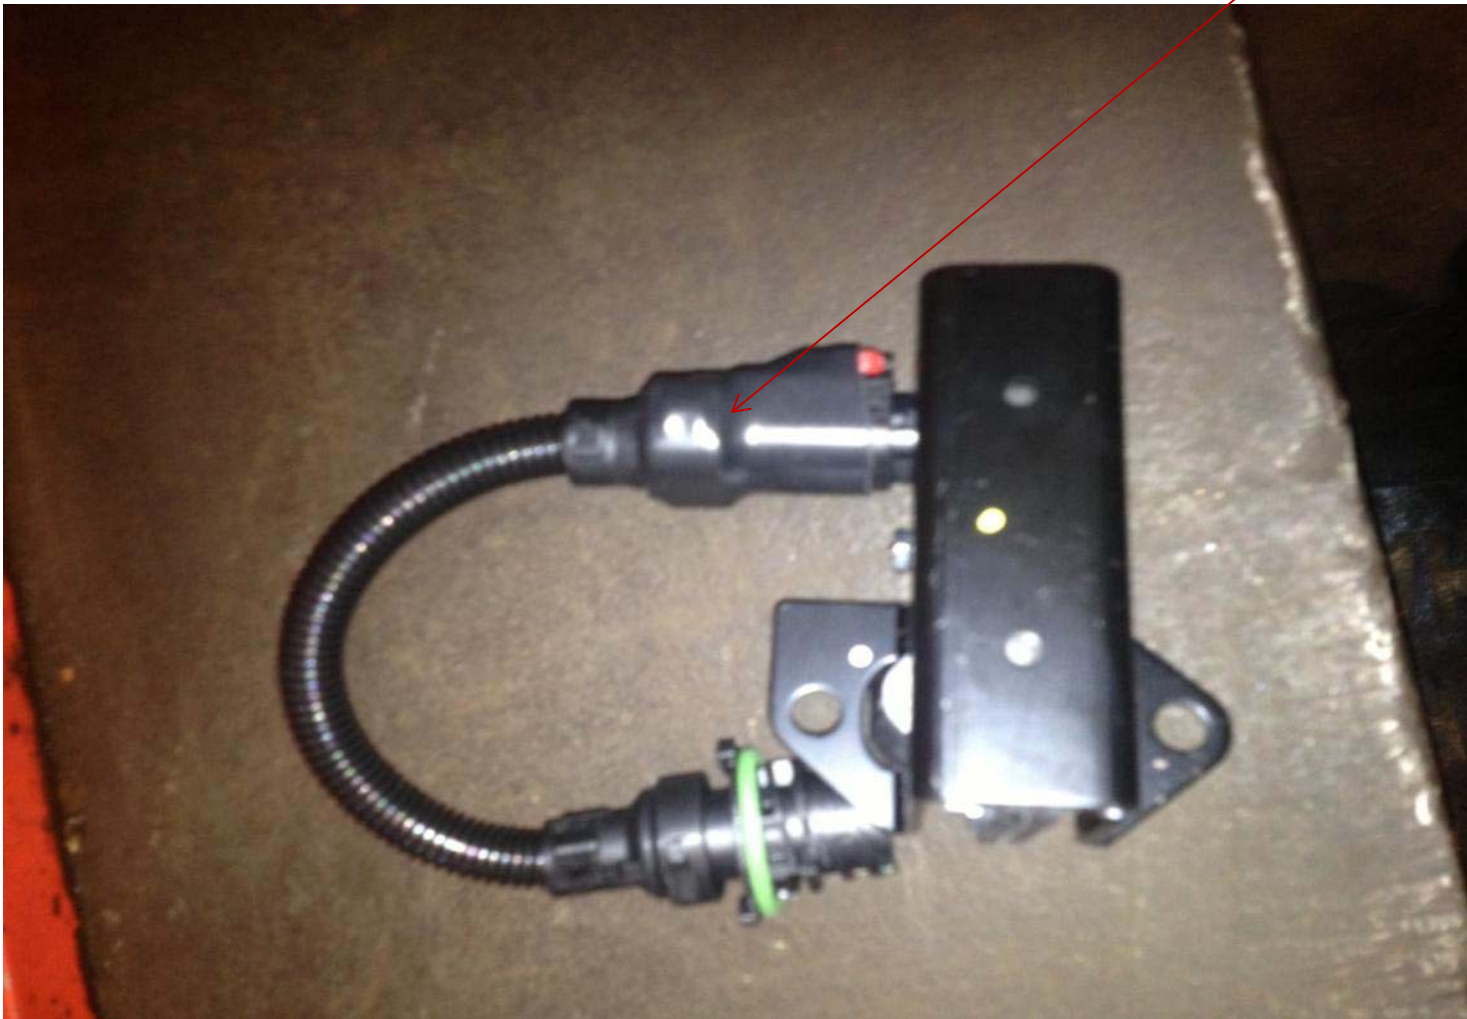
# NEW SENSOR DESIGN HAS A SHRINK AROUND CONECTOR

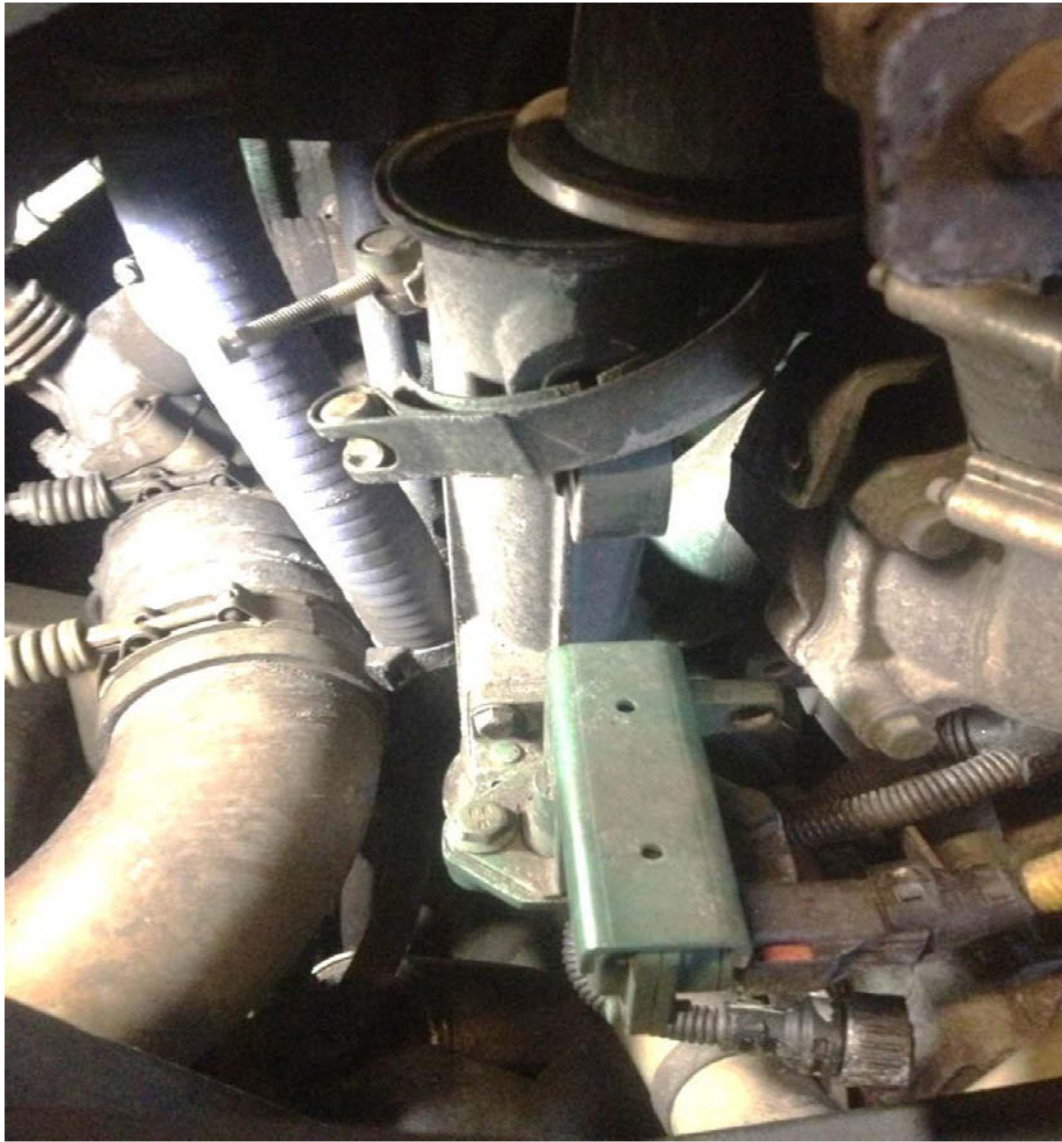
# OLD STYLE INSTALLATION

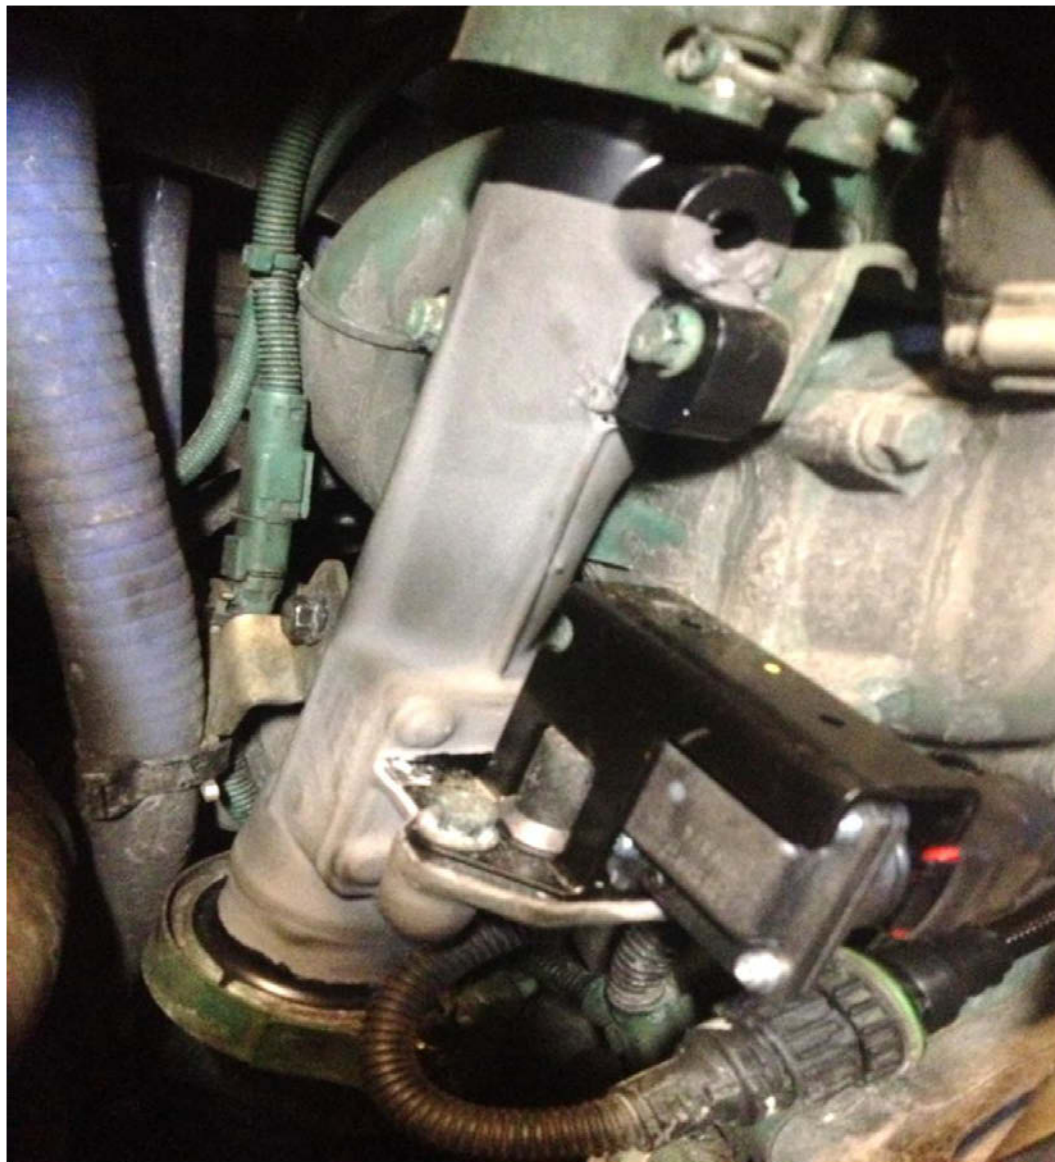
## DIRECT BOLT ON INSTALLATION
