SP13-11: VALVE AHI ERREUR PPID 329 REV A - Feb 2013

Ref: production retrofit 13005 ON STOCK VEHICLES

**REPLACE THE AHI VALVE (AFTER TREATMENT HYDROCARBON INJECTOR)**

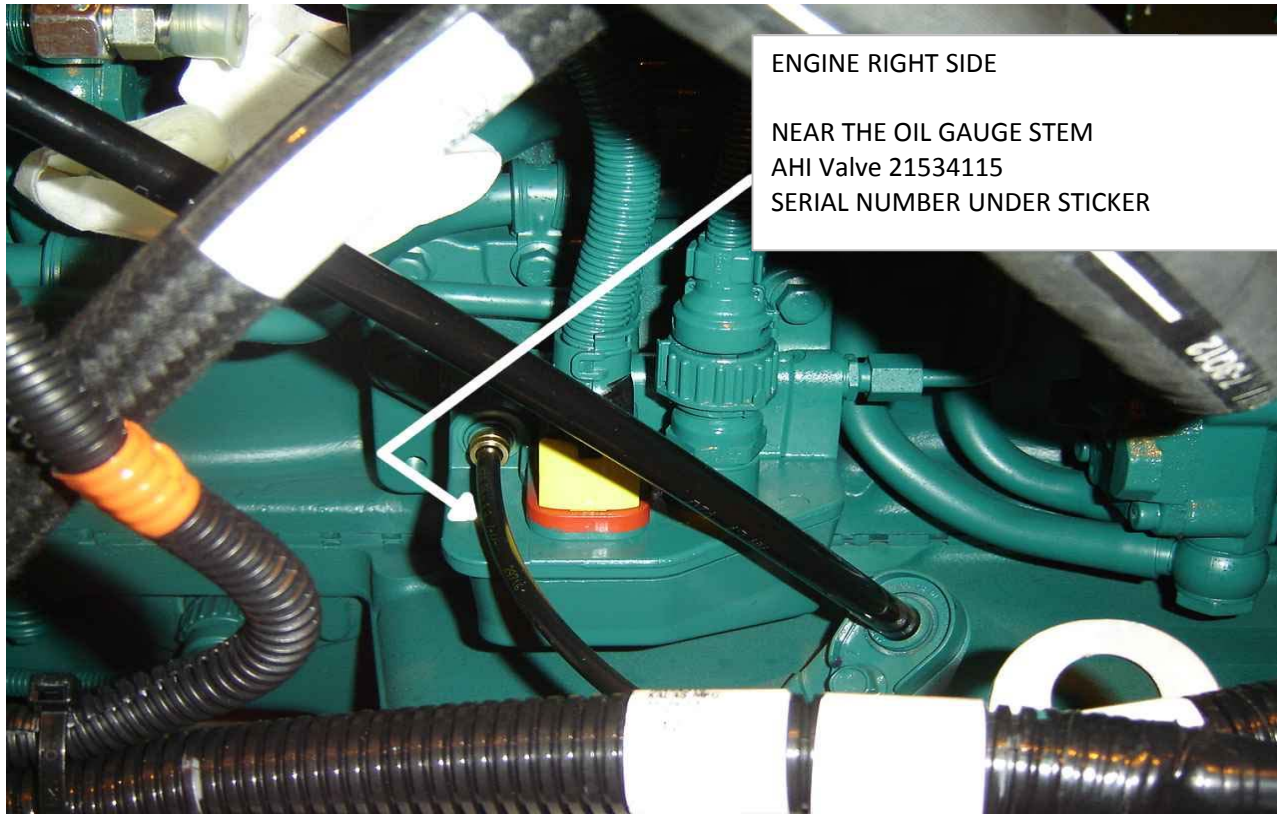
THE CODE IS UNDER REMOVABLE AIR INLET COVER  
SEE PICTURE

ENGINE RIGHT SIDE

NEAR THE OIL GAUGE STEM

AHI Valve 21534115

SERIAL NUMBER UNDER STICKER

To be installed, replacement p/n 21534115 VALVE SHOULD HAVE A MANUFACTURING CODE OVER 12 W 335 0141

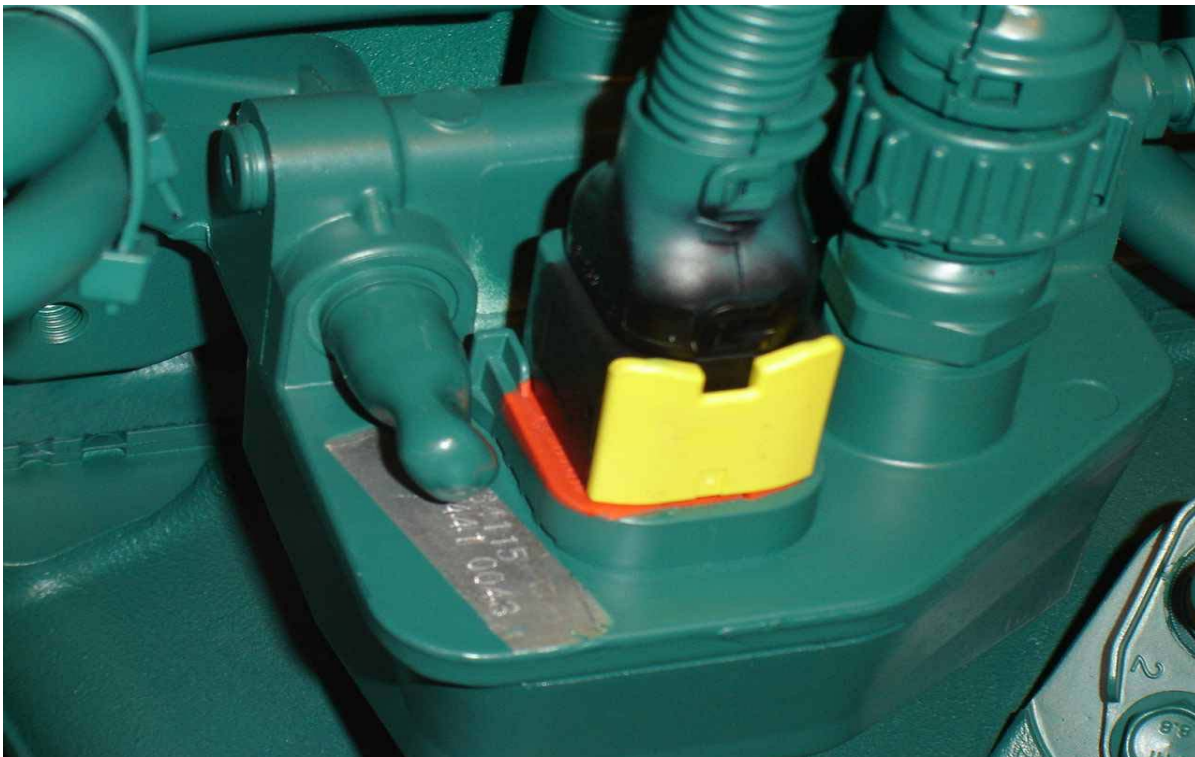
IF THERE IS AN ERROR,  
CHECK THE MANUFACTURING DATE ON THE VALVE. If **LESS THAN 12 W 335 0141 (See below in red)**

**12 YEAR**  
**W33 WEEK**  
**DAY 5**  
**0141 SERIAL NUMBER OF THE DAY**

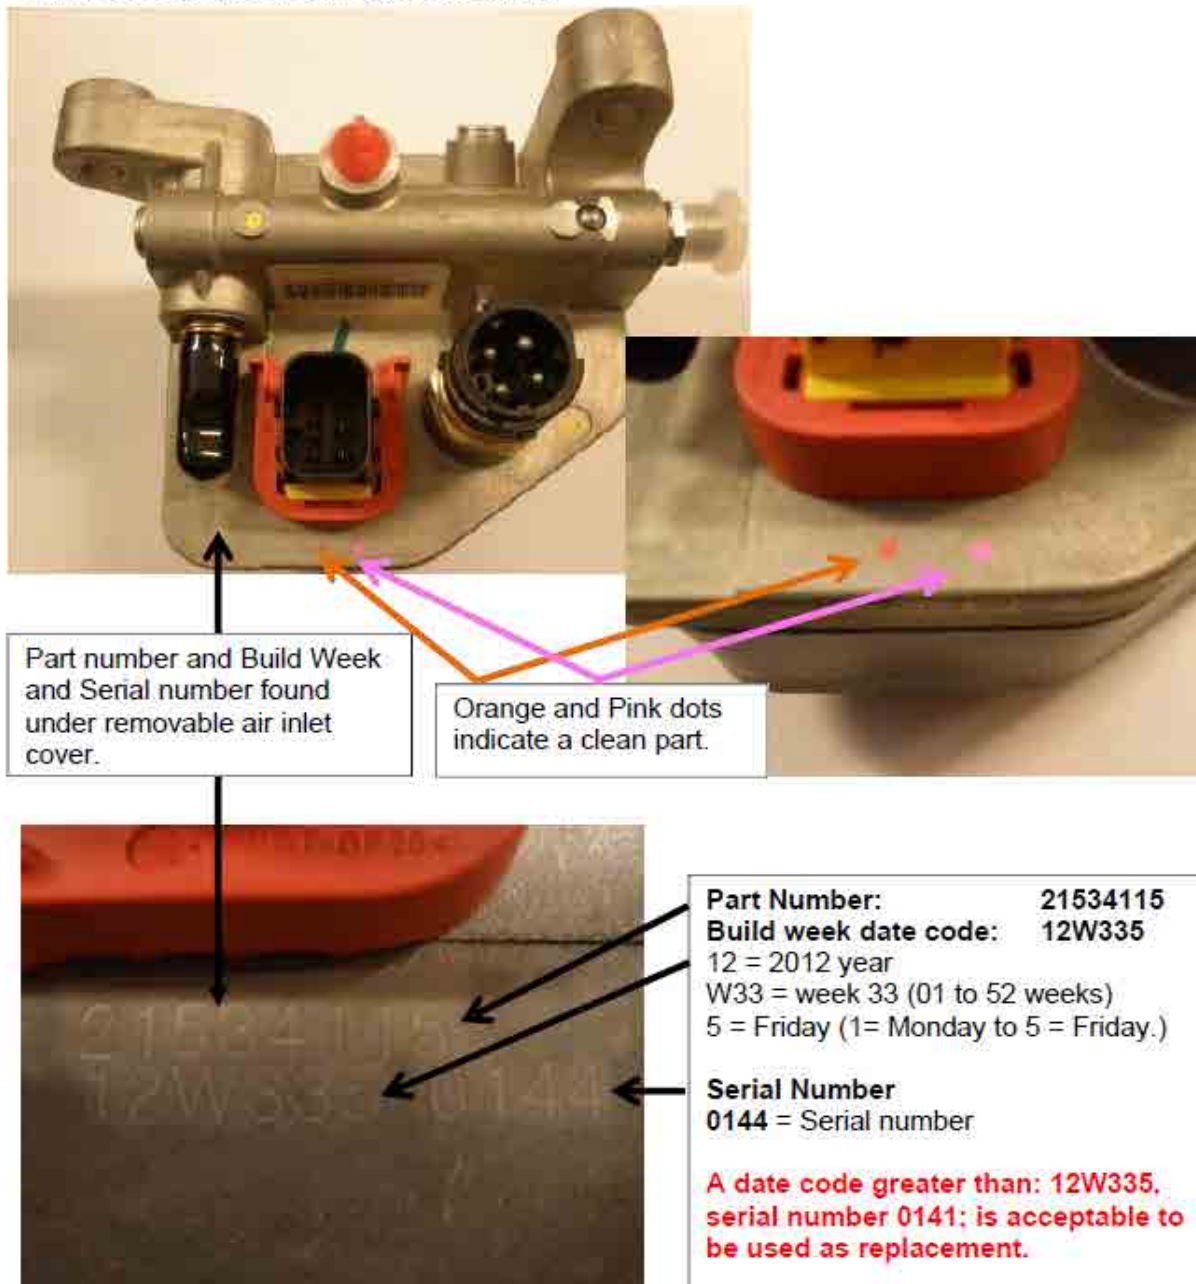
AHI modules with a clean Air Purge Valve (APV) are marked with Orange and Pink dots at the electrical connector.
