SP13-06 COOLANT PIPE CLAMP

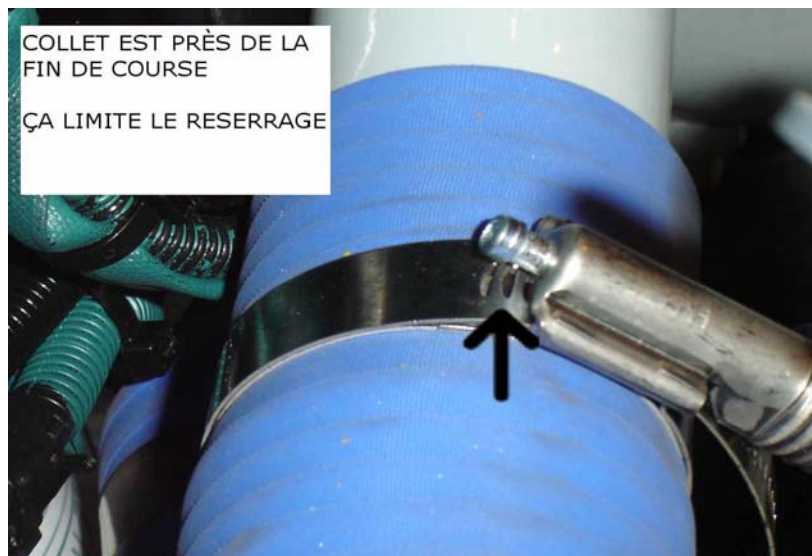
**CLAMP WITH NOT MUCH ADJUSTMENT
LEFT**

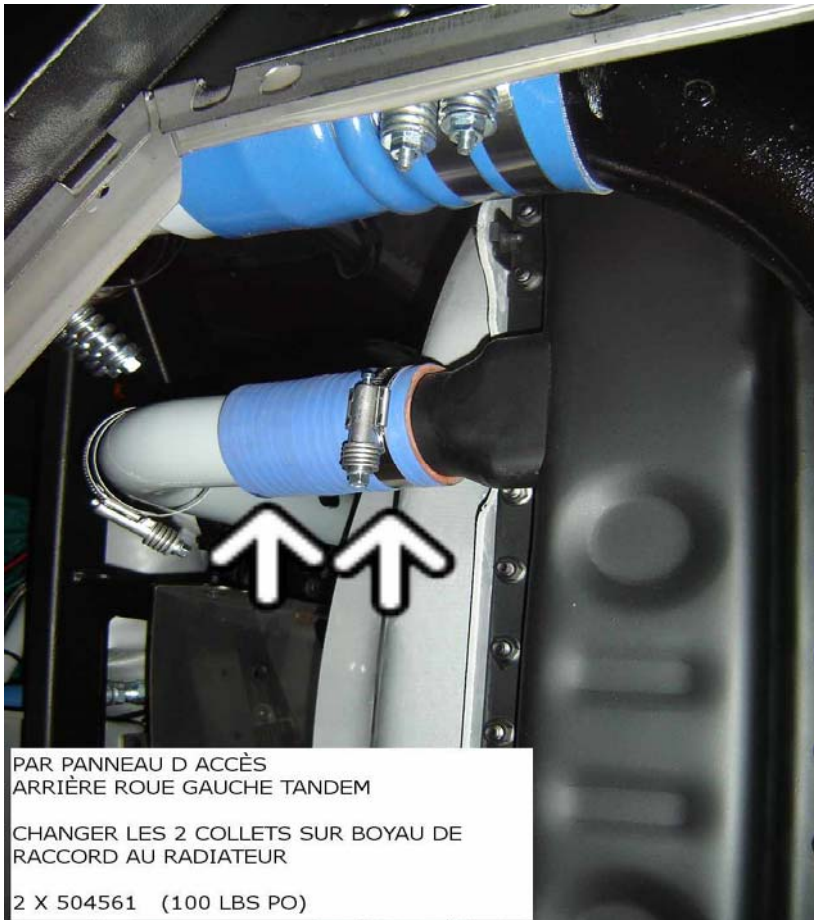
PAR PANNEAU D ACCÈS
ARRIÈRE ROUE GAUCHE TANDEM

**THROUGH THE ACCESS PANEL BEHIND
LEFT TAG AXLE WHEEL**

CHANGER LES 2 COLLETS SUR BOYAU DE
RACCORD AU RADIATEUR

2 X 504561 (100 LBS PO)

**REPLACE TWO (2) CLAMPS USING 2x
504561 (100 lbf-in)**
