## SP13-20 PRESENCE OF RUST ON VERTICAL POST (SQUARE TUBE) BETWEEN BAGGAGE COMPARTMENTS (reference retrofit R13027)

ON X SERIES VEHICLES

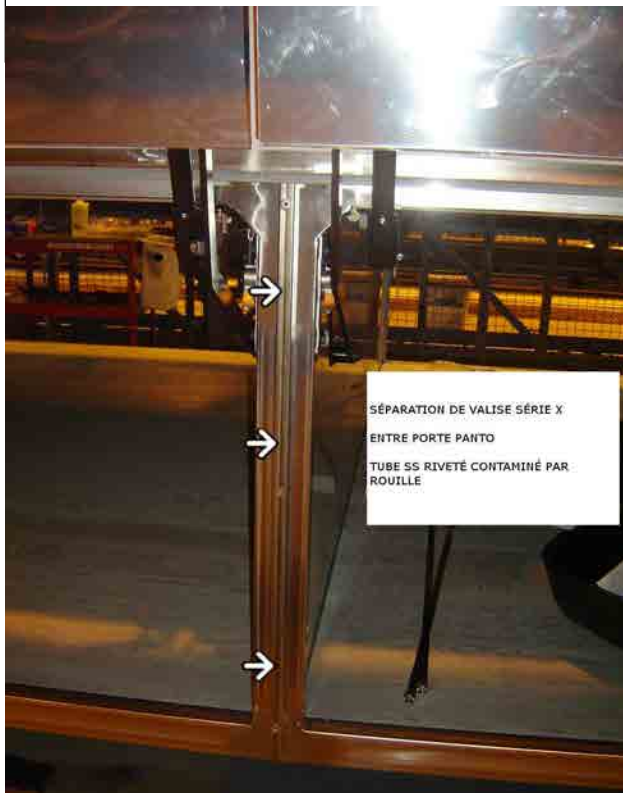
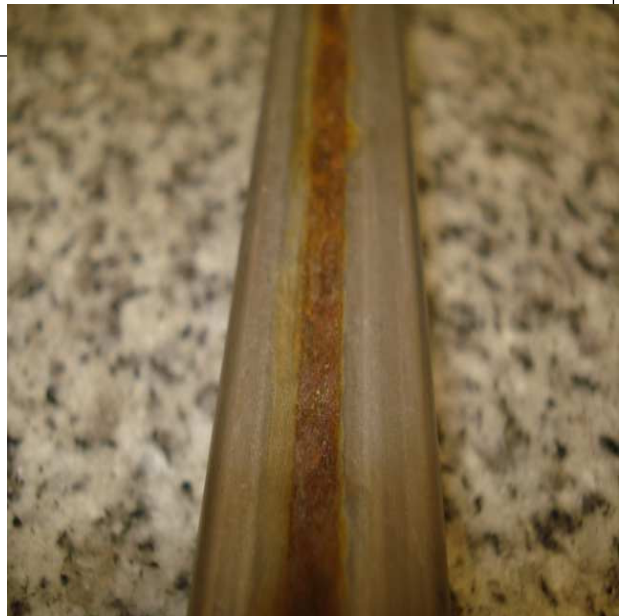
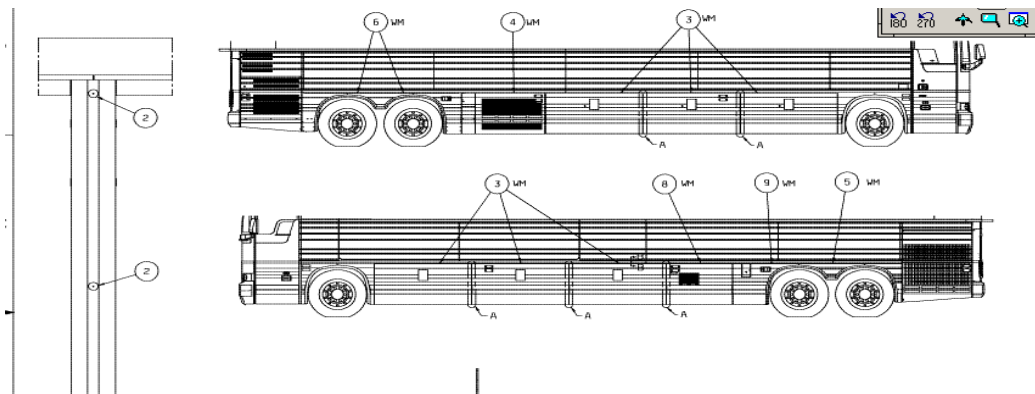
THERE ARE 5 TUBES #221777 ON THE VEHICLE. 3 ON L.H. SIDE, 2 ON R.H. SIDE.

MAKE SURE THAT THE VERTICAL POSTS #221777 BETWEEN BAGGAGE COMPARTMENT ARE NOT CONTAMINATED BY RUSH (TRACES, CORROSION PIN-HOLES).

IF THERE ARE EVIDENCES OF RUST, REPLACE APPLICABLE TUBES. USE 3 RIVETS #507030 PER TUBE.

**RETURN RUSTED TUBES TO PREVOST AS FAULTY TUBES WILL BE RETURNED TO SUPPLIER.**
