# Telescopic Lever Detent Clip Replacement

YEAR(S)	MODEL(S)	ADDITIONAL INFORMATION
2005 – 2012	Avalon

Some 2005 – 2012 model year Avalon vehicles may exhibit a looseness when securing the telescopic adjustment lever on the steering column. A new adjustment lever Detent Clip has been developed to address this condition. Please follow the procedure in this bulletin to replace the telescopic lever Detent Clip.

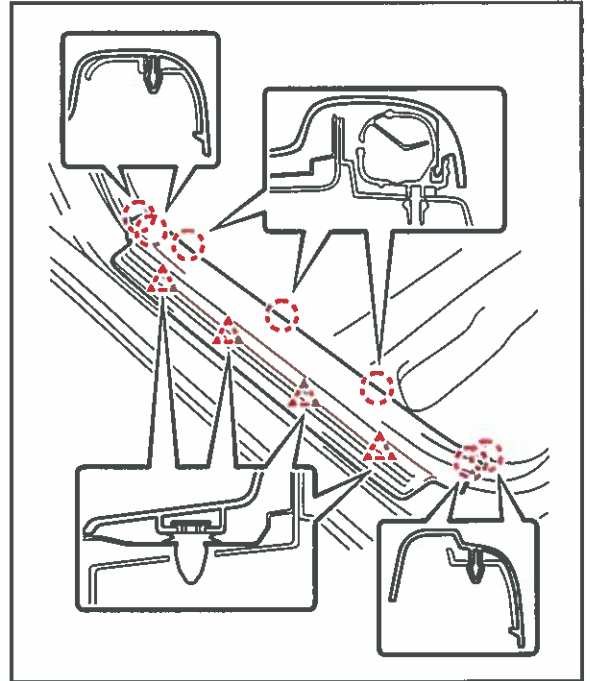
Figure 1.

4. Remove front door scuff plate LH by disengaging the 4 clamps and 7 claws.

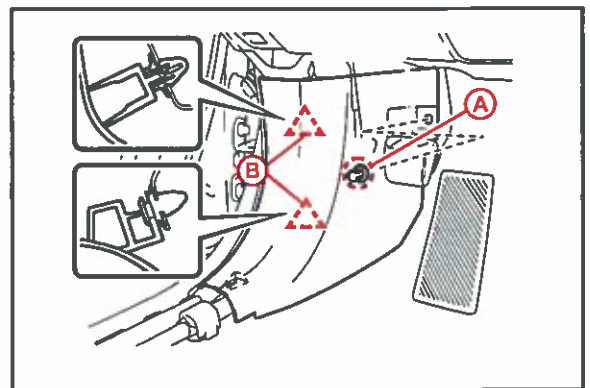
Figure 2.

5. Remove cowl side trim sub-assembly LH.

- A. Remove the clip (A).
- B. Disengage the 2 clips (B) and remove the cowl side trim sub-assembly LH.

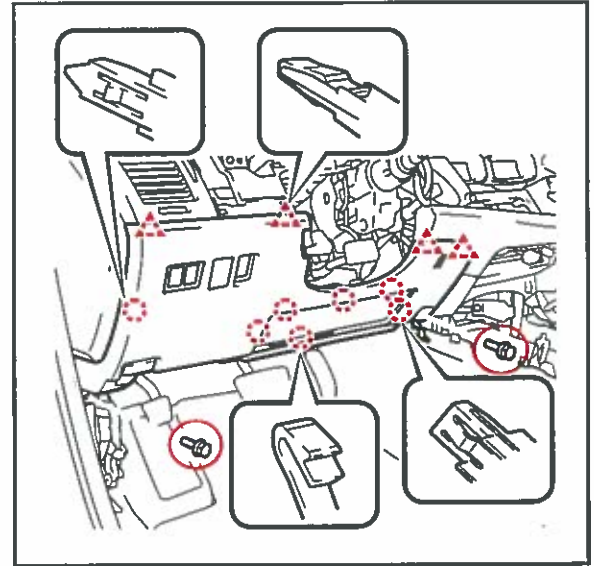
Figure 3.

6. Remove instrument panel finish lower panel LH.
  - A. Disconnect the hood lock control cable.
  - B. Remove the bolt and screw.
  - C. Disengage the 4 claws and 7 clips.
  - D. Disconnect the connectors and remove the instrument panel finish lower panel LH.

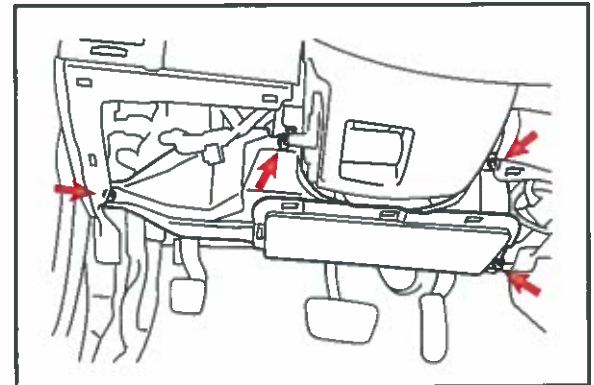
Figure 4.

7. Remove instrument panel airbag assembly lower No. 1.
  - A. Remove the 4 bolts and the driver side knee airbag assembly.
  - B. Disconnect the connector from the driver side knee airbag assembly.

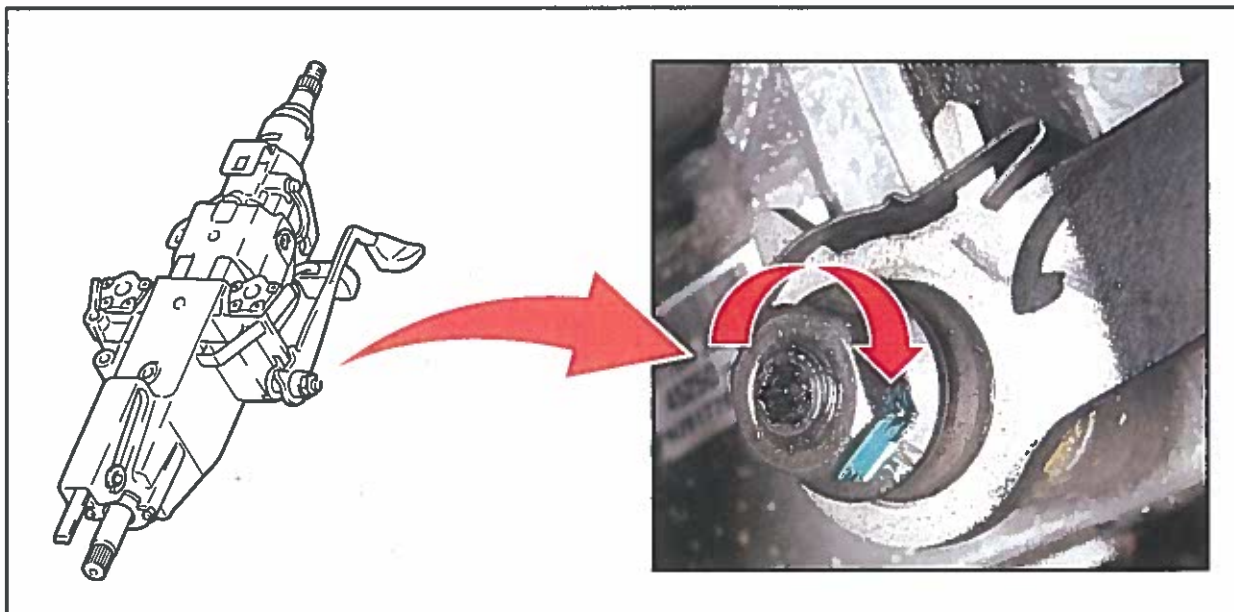
Figure 5.

8. Remove the telescopic lever nut.

- A. Locate the telescopic lever attachment nut.
- B. Remove the nut using a 15 mm wrench.

The telescope lever nut has left-hand threads.

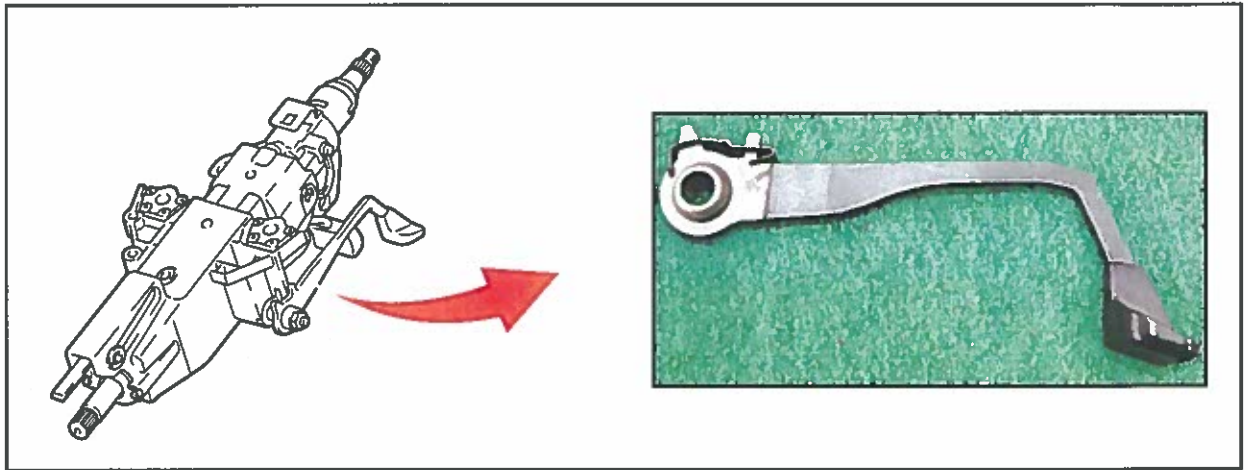
Figure 6.

9. Remove the telescopic lever.

Be careful **NOT** to damage the thread surface.

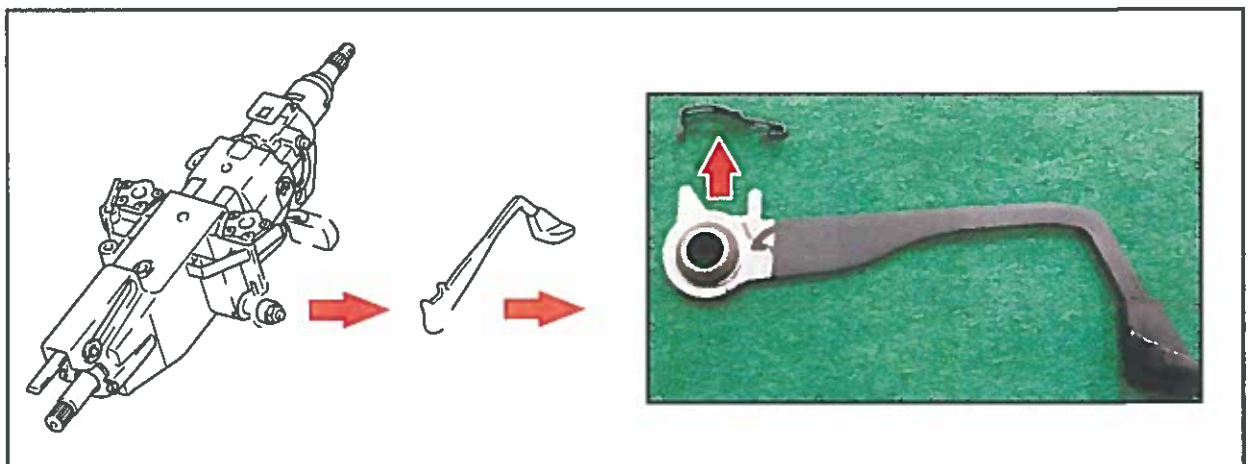
Figure 7.

10. Remove the Detent Clip from the lever.

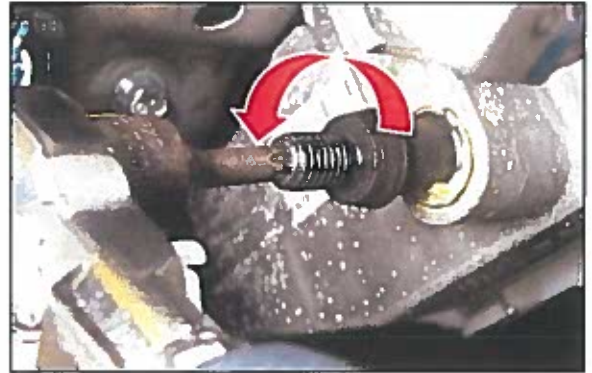
Figure 8.

11. With a T30 socket and torque wrench, tighten the telescopic adjusting bolt.

**Torque: 10 – 12 N\*m (102 – 122 kgf\*cm, 7– 9 ft\*lbf)**

The telescopic locking bolt has left-hand threads.

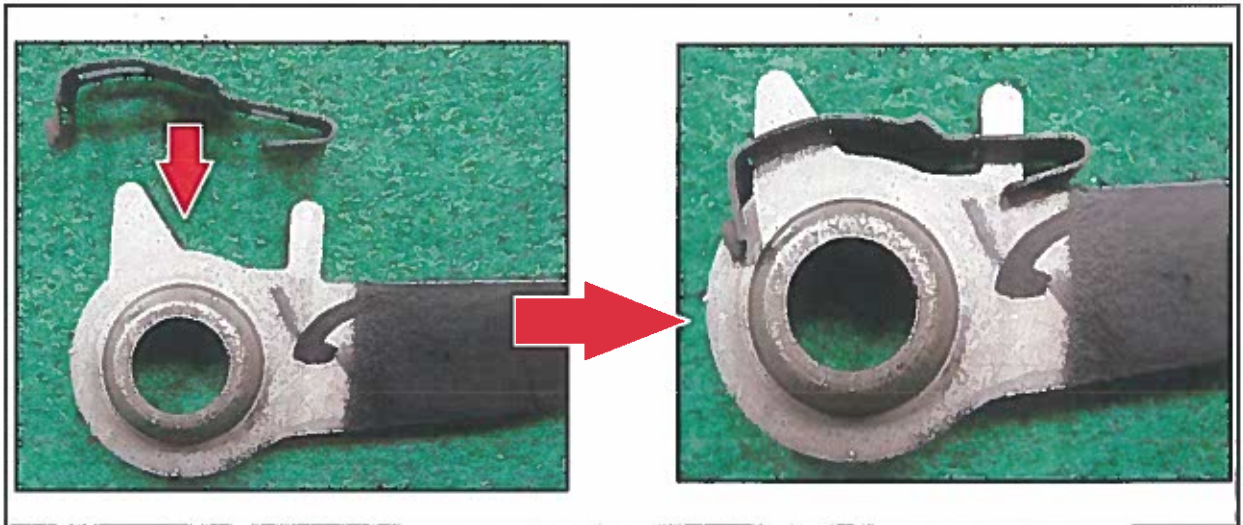
Figure 9.

12. Install the new Detent Clip.

Ensure the clip is installed in the correct orientation.

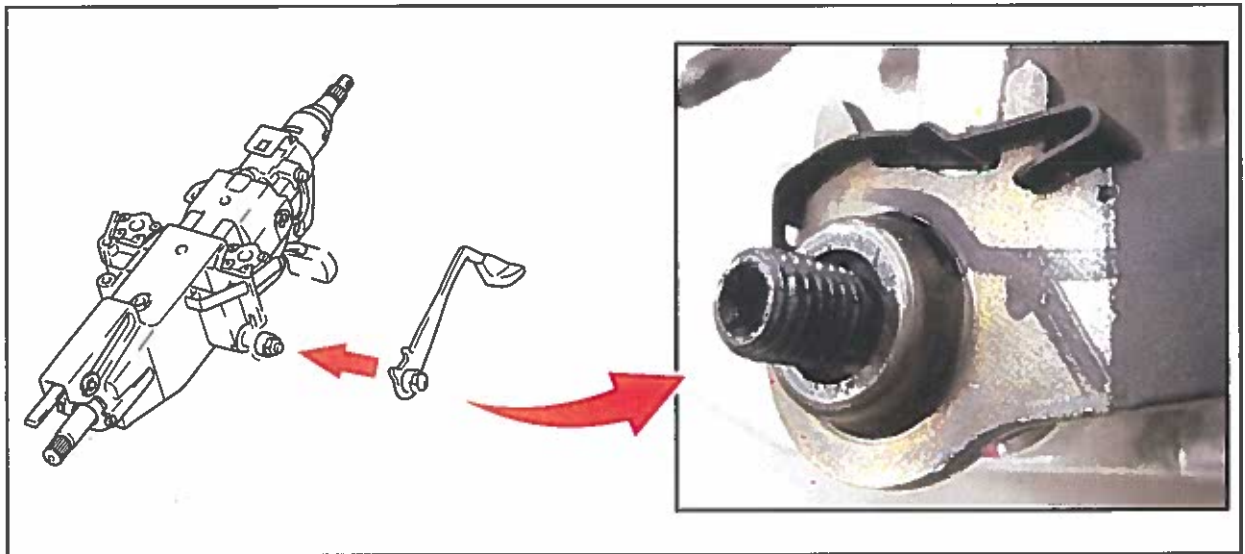
Figure 10.

13. Install the telescopic lever.

Be sure to install the lever in the "UP" locked position.

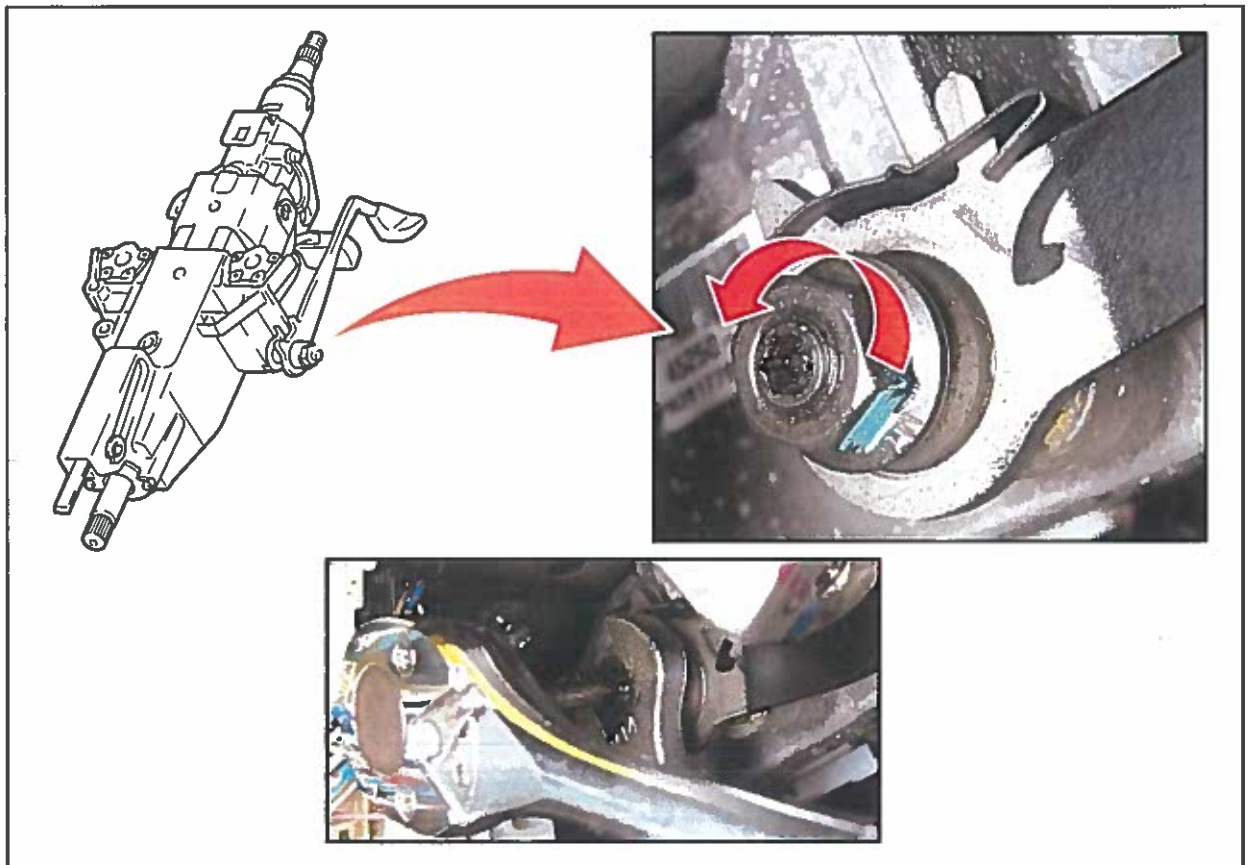
Figure 11.

14. While holding the telescopic adjusting bolt with the T30 socket, tighten the telescopic lever nut using a 15 mm crowsfoot and torque wrench.

Torque: 6 – 8 N\*m (61 – 82 kgf\*cm, 4 – 6 ft\*lbf)

The telescope lever nut has left-hand threads.

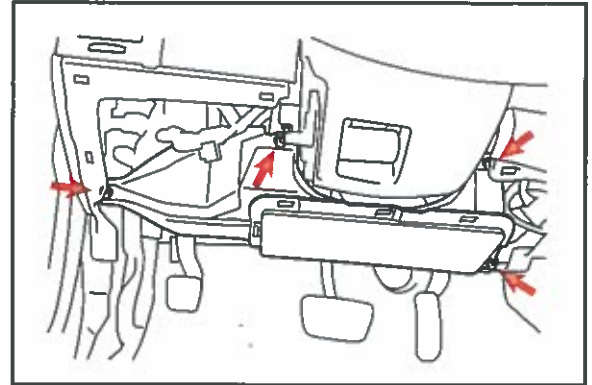
Figure 12.

15. Install the instrument panel airbag assembly lower No. 1.

- A. Connect the connector to the driver side knee airbag assembly.

- B. Install the driver side knee airbag assembly with the 4 bolts.

Torque: 10 N\*m (102 kgf\*cm, 7 ft\*lbf)

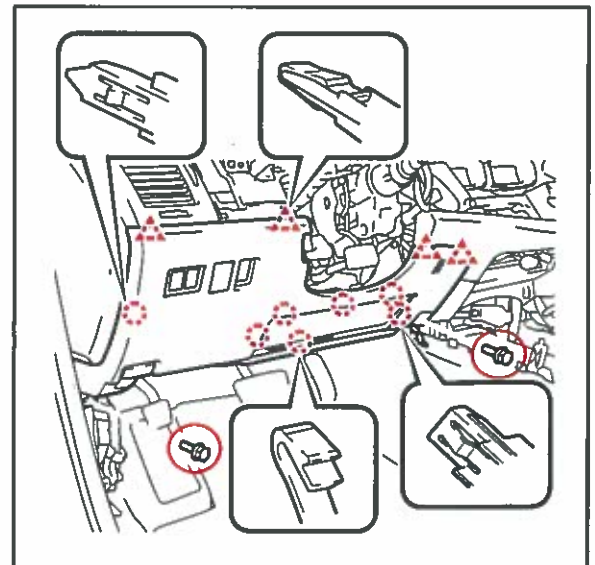
Figure 13.

16. Install the instrument panel finish lower panel LH.

- A. Engage the connectors.
- B. Connect the hood lock control cable.
- C. Engage the 4 claws and 7 clips and install the instrument panel finish lower panel LH.
- D. Install the bolt and screw.

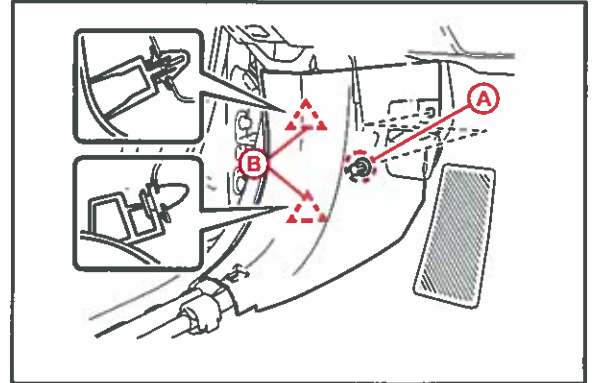
Figure 14.

17. Install the cowl side trim sub-assembly LH.

A. Install the clip (A).

B. Engage the 2 clips (B) and install the cowl side trim sub-assembly LH.

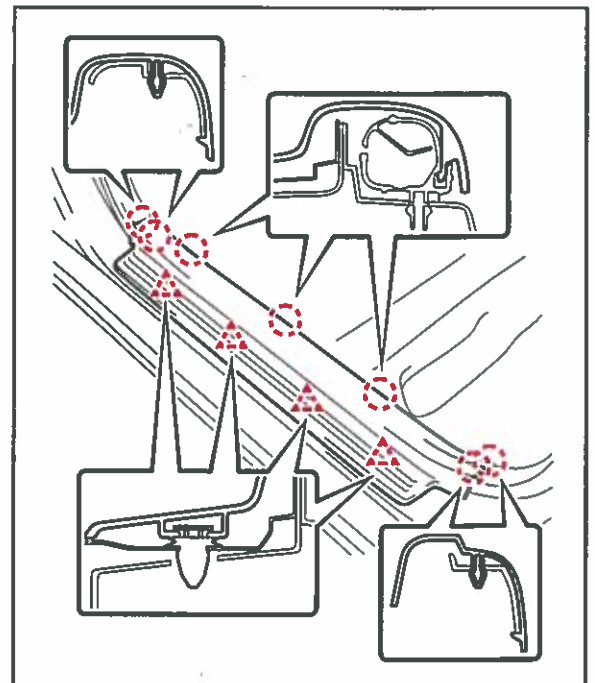
Figure 15.

18. Install front door scuff plate LH. Engage the 4 clamps and 7 claws and install the front door scuff plate LH.
