Front Door Glass Run Is Loose

Service Category Vehicle Exterior

Section Window/Glass

YEAR(S)	MODEL(S)	ADDITIONAL INFORMATION
2011 – 2012	Sienna

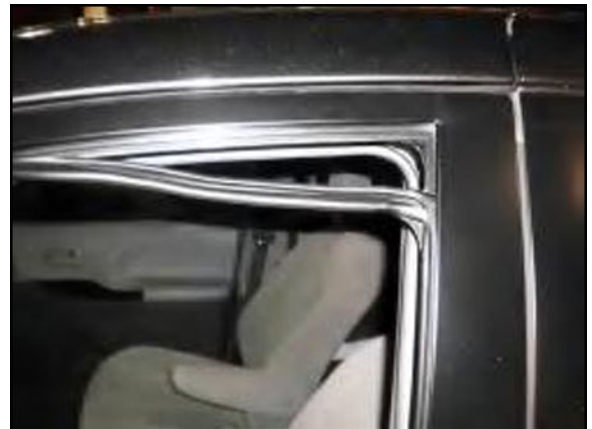
Figure 1.

Some 2011 – 2012 model year Sienna vehicles may exhibit a condition where the front door glass run on either the RH or LH side becomes loose or does not stay in place. Vehicles may also exhibit a condition where the front door glass run is pulled off the track and may come down while the window is operated. Use the following repair procedure to address this condition.

1. Verify condition is present.

2. Replace the front door glass run according to Repair Manual instructions.

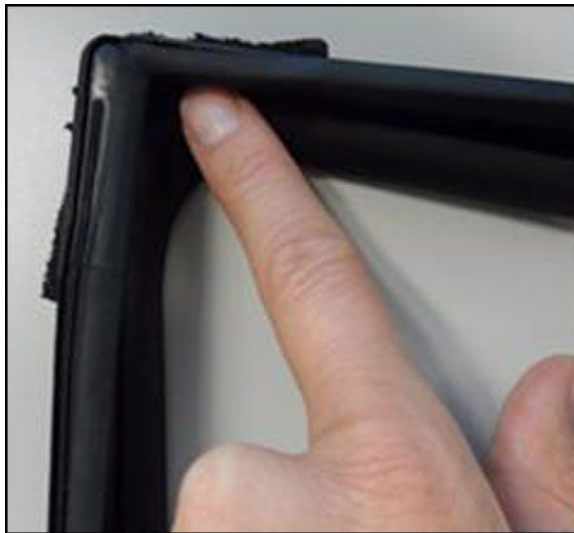
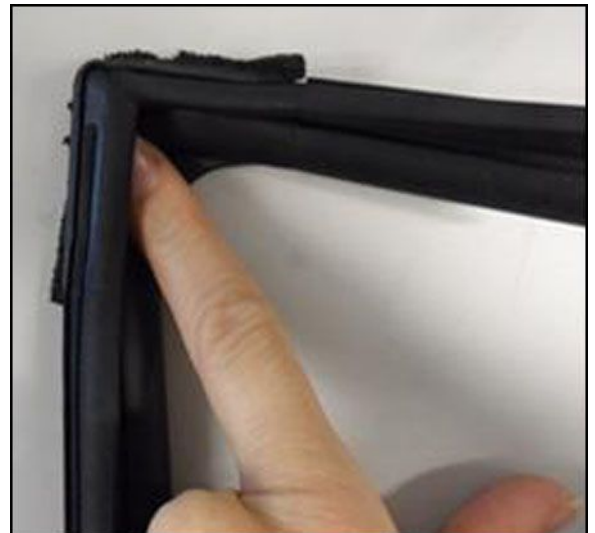
Figure 2.

- [2011](#) / [2012](#) Sienna:
Vehicle Exterior – Door/Hatch – “Door/Hatch: Front Door: Disassembly”
 - [2011](#) / [2012](#) Sienna:
Vehicle Exterior – Door/Hatch – “Door/Hatch: Front Door: Reassembly”
3. Once in place, ensure the front door glass run is properly installed by applying pressure to the vertical and horizontal planes of the upper 90° corner of the window.

4. Confirm the window operates properly and the door glass run stays in place.
