# Service Bulletin

**Subject:** Dark Stains on Tonneau Lid Outlining Convertible Roof

**Models:** 2005-2013 Chevrolet Corvette Convertible Models Only

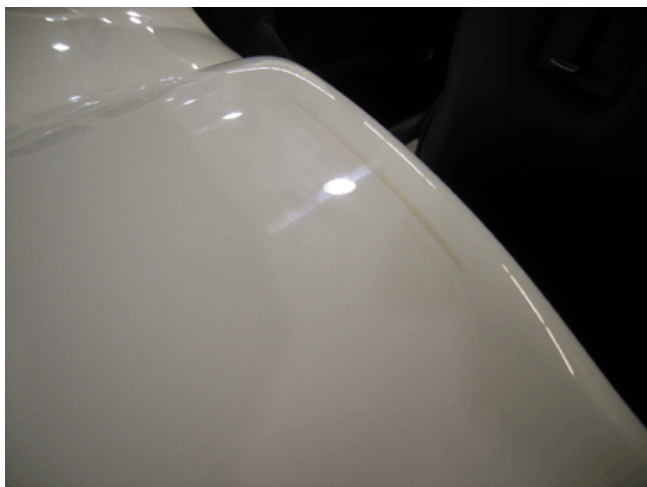
Some customers may comment on a stain on the rear tonneau lid, noticed when the roof is retracted and the tonneau is exposed. The stain is commonly found centered on one or both of the forward hump surfaces of the tonneau lid.

The cause of this condition may be the rear glass sunshade bleeding its dye onto the rear tonneau and the paint absorbing this dye due to the paint curing process at Bowling Green Assembly. This will typically be noticed on lighter colored vehicles, however, it may occur on any color vehicle.

To correct this concern, polish/refinish the rear tonneau and add two pieces of transparent protective film using the procedures below:

1. Following manufacturer specific instructions, use a light rubbing compound to remove the stain.
2. Polish the area.
3. Confirm that the stain is removed. If the stain is removed, apply one piece of transparent protective film, GM P/N 23117964 over the affected areas at each location to prevent the stain from reoccurring.

**If the stain is still present after using the light rubbing compound, do not apply the protective film until continuing with the remaining steps.**

4. Wet sand the affected area.
5. Refinish the panel using the appropriate base and clear coat.
6. Allow to dry fully, then apply one piece of transparent protective film, GMP/N 23117964 over the affected areas at each location to prevent the stain

from reoccurring.
