# Rear Differential Coupling Growl Noise

YEAR(S)	MODEL(S)	ADDITIONAL INFORMATION
2006 – 2012	RAV4	Drive Type(s): 4WD Transmission(s): 5AT, 4AT

Some 2006 – 2012 model year 4WD RAV4 vehicles may exhibit a growl type noise from the rear differential coupling when driving as a result of contamination to the front bearing. Follow the procedure in this bulletin to address this condition.

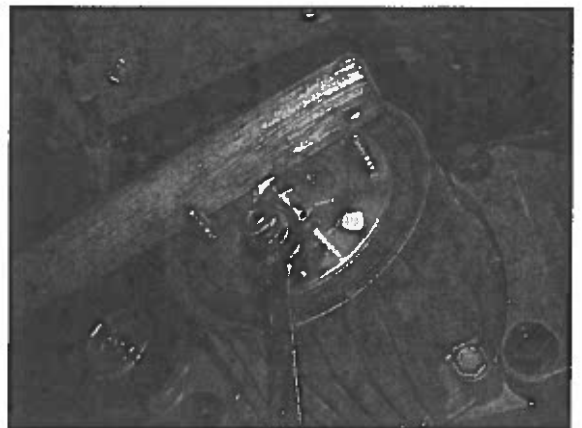
**C. Remove the 4 stud bolts.**

Using a double nut configuration, with new nuts, remove the 4 studs from the rear differential coupling.

Use a wooden or plastic hammer/mallet handle to protect the stud threads and hold the coupling when loosening the stud bolts. Once the stud bolt is removed, loosely thread the stud bolt back into the coupling to allow for removal of the other stud bolts.

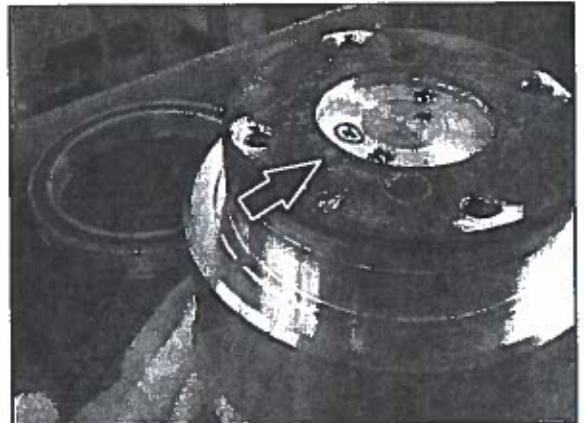
Figure 7. Excessive Rust/Corrosion Buildup on Top of Coupling Body

If the rear differential coupling body assembly shows any of the issues noted below, the rear differential coupling assembly **CANNOT** be rebuilt and must be replaced as an assembly.

- YES** — Continue to step 6. Remove the rear differential coupling cover assembly.
- NO** — Continue to step 5. Replace the rear differential coupling assembly.

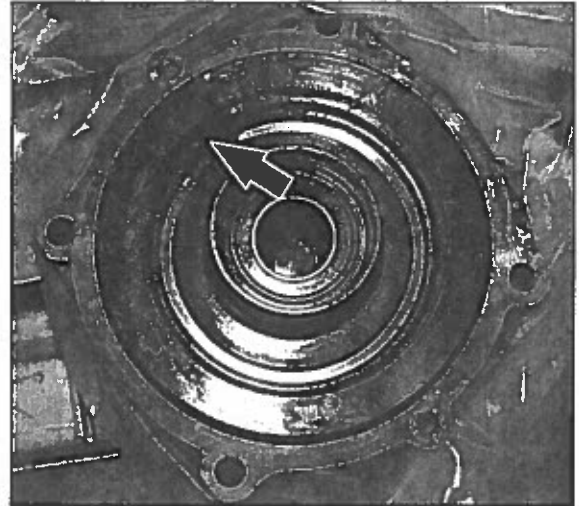
Figure 10. Rear Differential Coupler Body Is Dark in Color

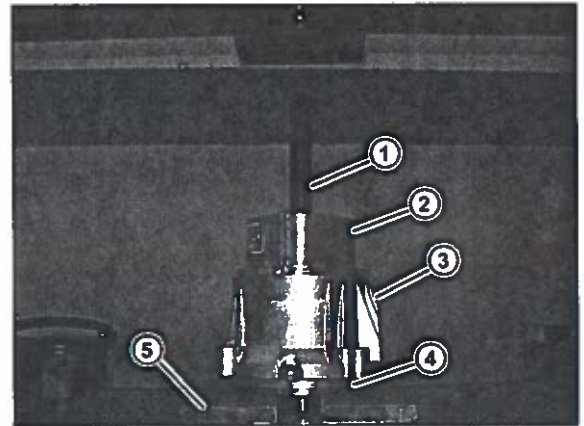
Figure 22.

1	SST 09950-70010
2	SST 09223-15030
3	Coupling Cover Assembly
4	Coupling Body Assembly
5	SST 09527-10011-01

- C. Using a press and the SSTs, slowly press the new coupling cover with the bearing onto the coupling body.

Press the bearing and cover assembly onto the coupling body until the bearing is fully seated against the coupling body.
