Blind Spot Monitor DTC C1AB4/C1AB5

Service Category Audio/Visual/Telematics

Section Park Assist/Monitoring

Some 2013 model year Avalon and Avalon HV vehicles may display a "Check Blind Spot Monitor System" message on the multi-information display with Diagnostic Trouble Code (DTC) C1AB4 and/or C1AB5 stored. The procedure in this bulletin has been developed to address this condition.

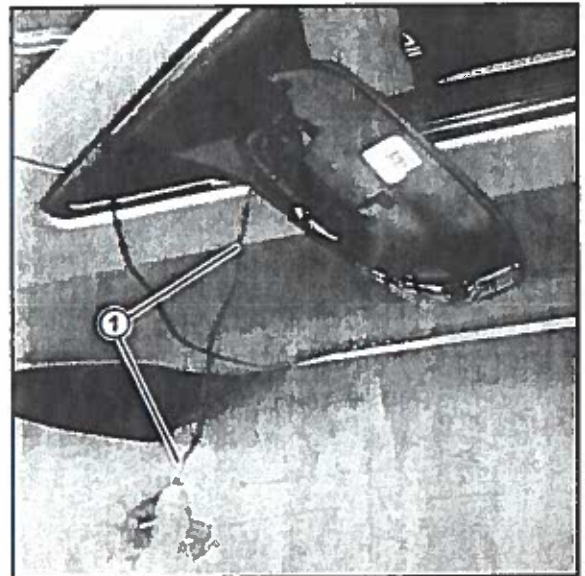
Figure 1.

2. Remove the tape from the two wire Blind Spot Monitor (BSM) indicator wire harness.

1 | Tape Location

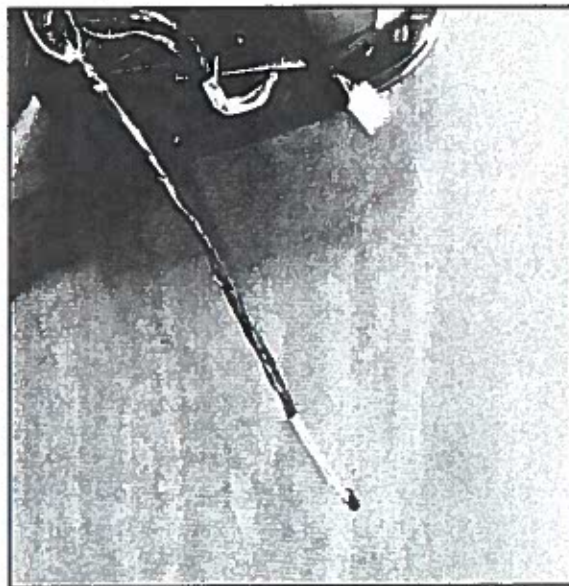
Figure 17.

16. Insulate the BSM indicator wire harness by wrapping with electrical tape.
