Damaged Sliding Roof Sunshade

Service Category Vehicle Interior

Section Interior Panels/Trim

YEAR(S)	MODEL(S)	ADDITIONAL INFORMATION
2012	Camry, Camry HV

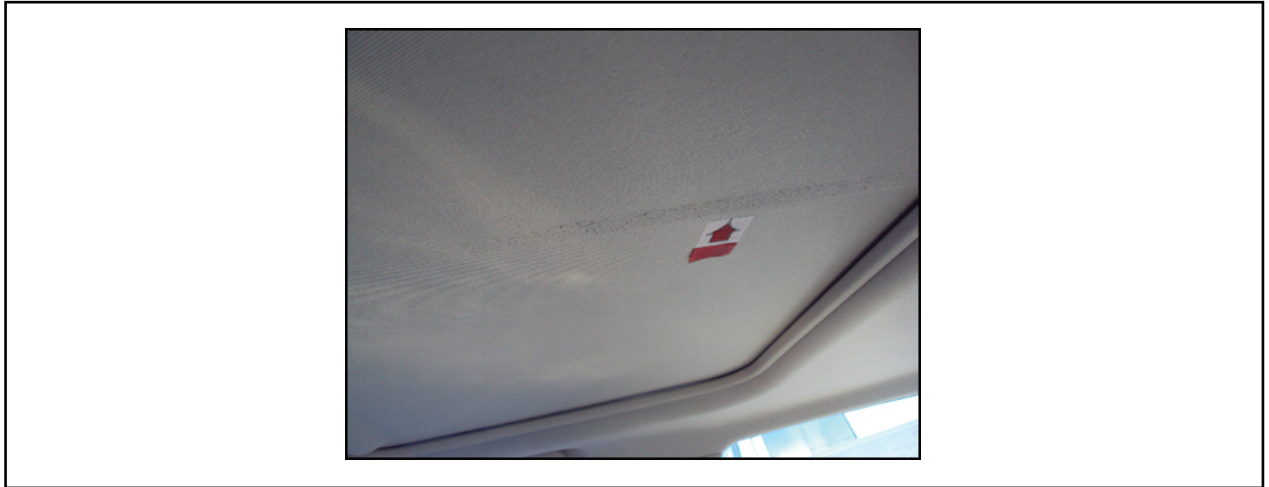
Figure 1.

Some 2012 model year Camry and Camry HV vehicles may exhibit a wear mark down the center of the sliding roof sunshade caused by repeated opening and closing. An updated sunshade is available to address this condition. Follow this bulletin to replace the sunshade.
