S-SB-0001-10 Rev1 January 6, 2010

Back Door Garnish Loose or Broken

Service Category Vehicle Exterior

Section Exterior Panels/Trim

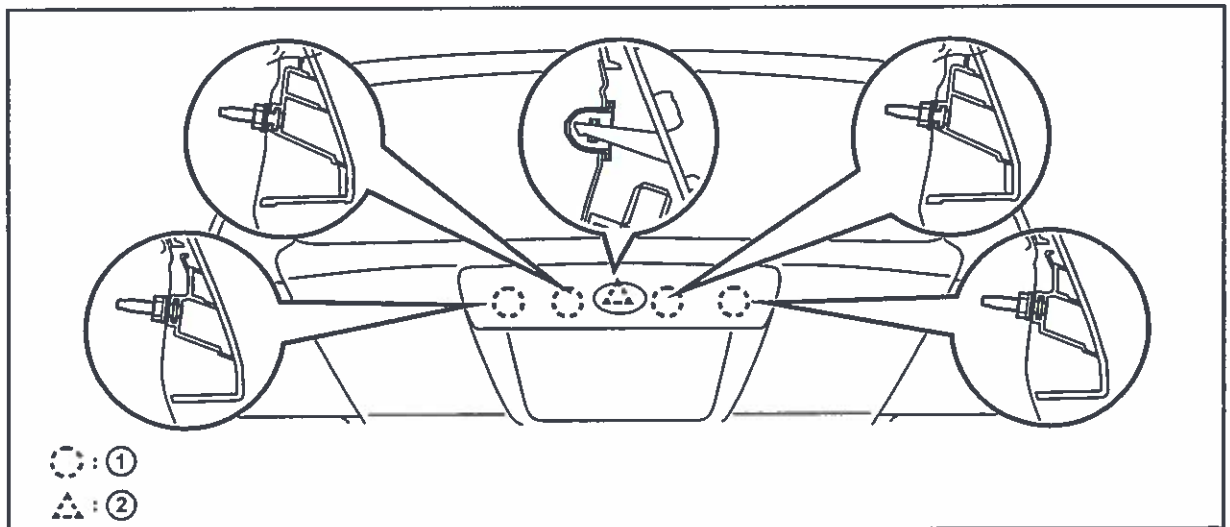
Figure 5.

1	Nuts
2	Clip

4. Remove the Back Door Outside Garnish Sub-assembly.

- A. Remove the 4 nuts.
- B. Detach the clip and disconnect the connector. Then remove the garnish.
