T-SB-0069-12 Rev2 May 1, 2012

SRS Airbag Light "ON" - B0111/B0116 Open Side Squib Circuit

Some 2004 – 2009 model year Sienna vehicles may exhibit an SRS lamp "ON" condition with Diagnostic Trouble Code (DTC) B0111 and/or B0116. An updated repair procedure is available to address this condition. Follow the procedures in this bulletin to repair the floor harness and the side airbag squib circuit.

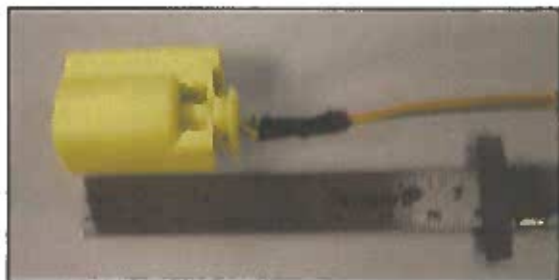
Figure 3.

3. Measure 80 mm (3.15 in.) from the tip of the floor harness connector and cut the wires.

Retain the old floor harness connector for reference.

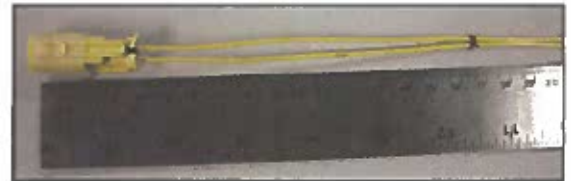
Figure 23.

2. Measure accordingly from the tip of the seat harness connector and mark the wires.
 2004 Sienna: Power Seat, Left: 338 mm (13.3 in.)
 2005 – 2009 Sienna: Power Seat: 165 mm (6.5 in.)

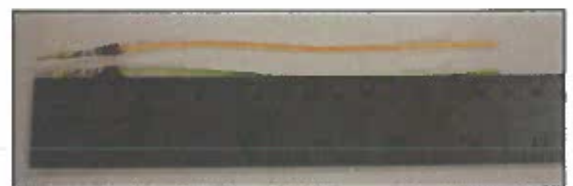
Figure 29.

- A. Measure from the tip of the male terminal and cut each wire.

Power Seat, Left: 348 mm (13.7 in.)

Power Seat: 175 mm (6.89 in.)

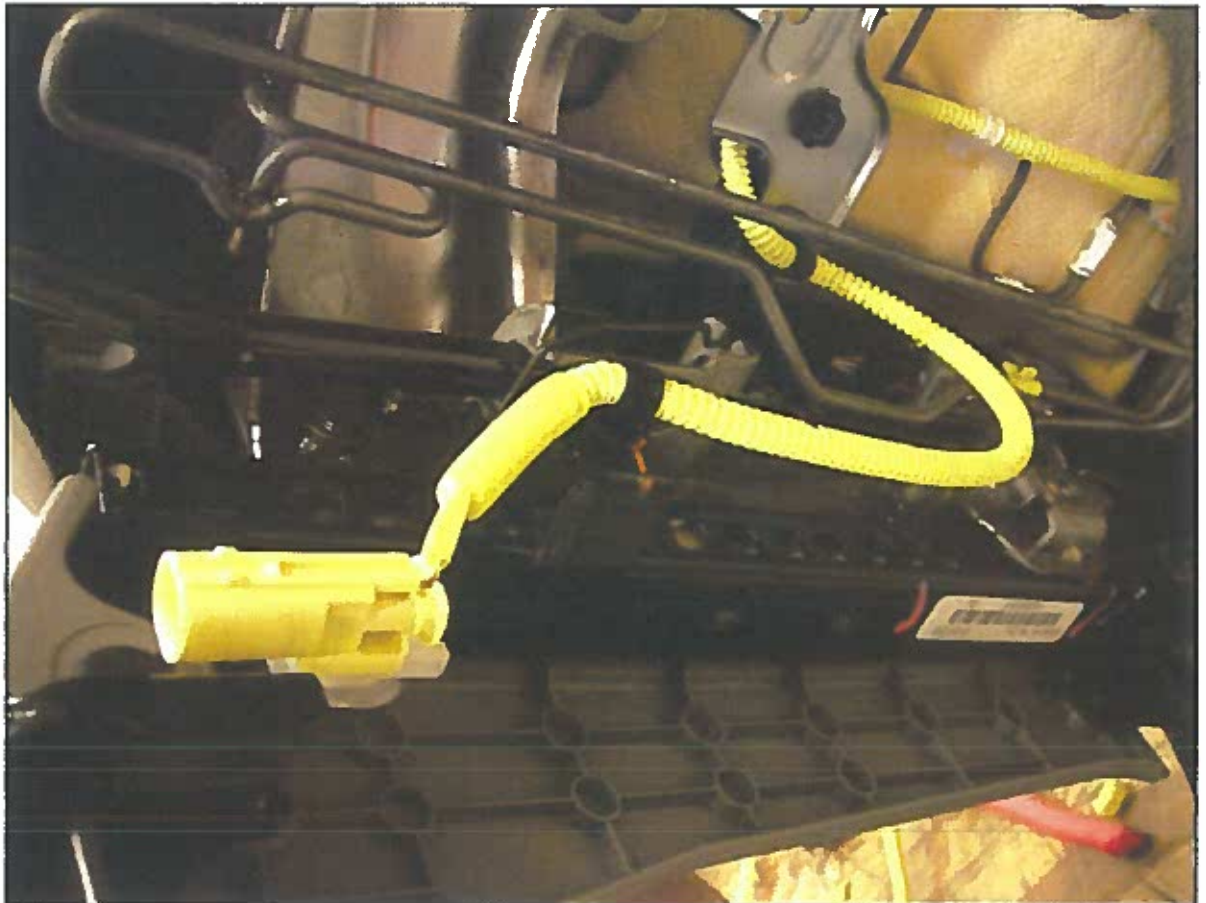
Figure 31.

1. Unclip the SRS seat harness connector. Remove the yellow corrugated tubing and discard.

Some vehicles may have an additional sleeve protecting the wiring that will need to be removed. The additional sleeve can be discarded.

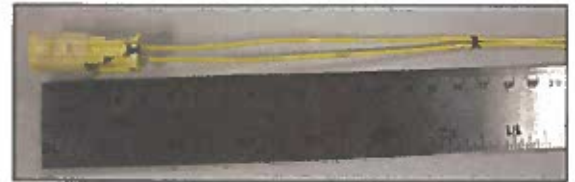
Figure 32.

2. Measure from the tip of the seat harness connector and mark the wires.

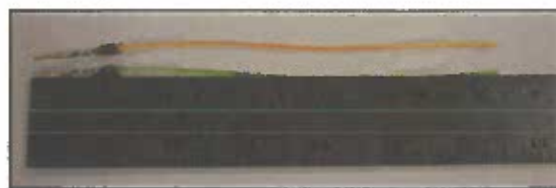
Figure 38.

- A. Measure from the ends of the male terminals and cut the new wires.

Manual Seat, Left: 95 mm (3.74 in.)

Manual Seat, Right: 80 mm (3.15 in.)

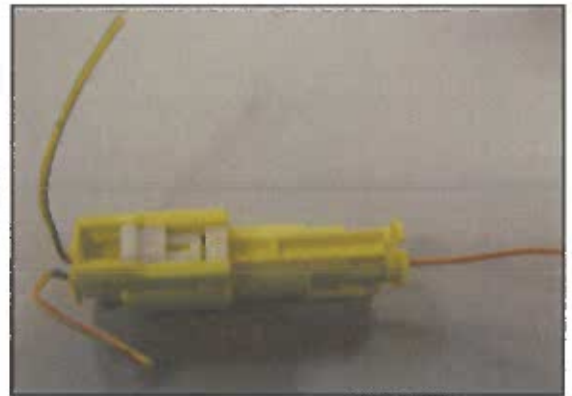
Figure 51.

B. Install the old SRS floor harness approximately 15 mm onto the new SRS seat connector.

C. Insert the yellow wire with the red tracer into the new SRS seat harness connector that lines up with the yellow wire with the red tracer on the old SRS floor harness connector.
