Service Bulletin

Subject: When Installing Accessory Smokers Package (RPO SAO), Cigarette Lighter Does Not Fit/Mate to Accessory Power Outlet (APO) Harness Connector

Models: 2014 Chevrolet Impala

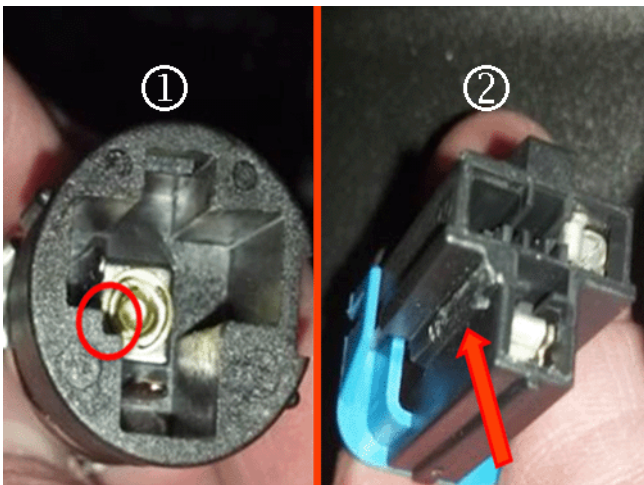
Upon attempting to install the Accessory Smokers Package cigarette lighter, the technician may find that the lighter does not mate with the vehicle APO harness connector, and will not seat properly.

The cause of this condition may be that the engagement slot on the cigarette lighter (1) is on the opposite side as the keyway on the APO harness connector (2). The keyway is obstructing the harness connector from seating properly on the cigarette lighter.

Removing the plastic keyway on the APO harness connector will allow the cigarette lighter to seat and lock into place. Remove the keyway following the steps below:

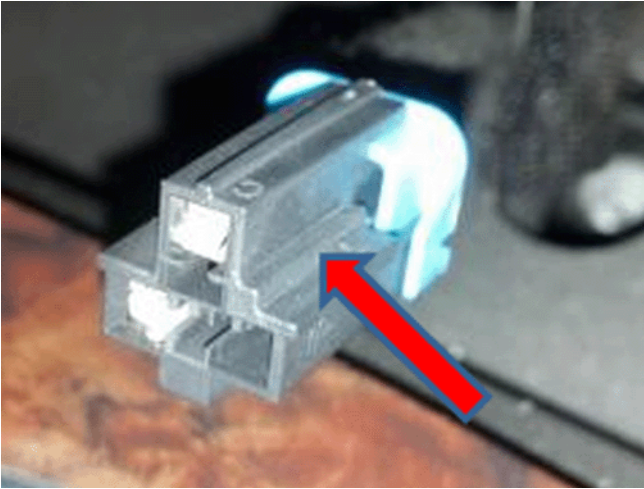
1. Remove the APO plug and inspect the harness connector. Note the location of the plastic key way on the connector, shown by the arrow in the graphic above.
