## Noise sources on instrument panel BR 204

| Topic number | LI68.10-P-055895 |
| Validity | Model series 204 |

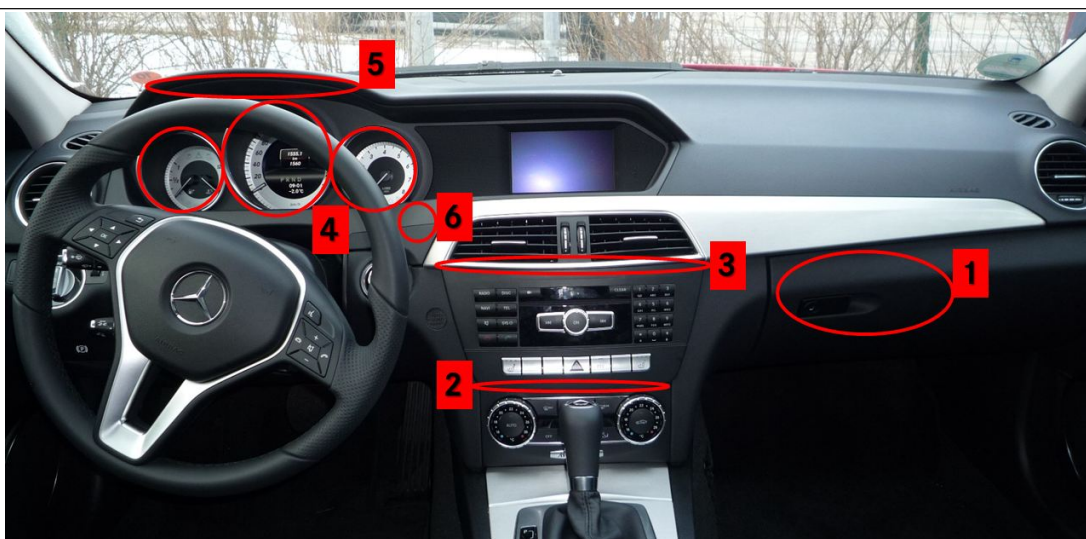
Noise source overview.  
jpg:

1. Glove box squeaks/rattles in top left area.
2. Creaking or friction noise in center console area at transition from lower control panel to HVAC control panel.
3. Chatter/noise in area of center air vent/head unit (as of facelift).
4. Creaking/cracking noise in area of combination cover (as of facelift).
5. Noise from upper area of instrument cluster.
6. Noise in right instrument cluster area.

| Attachments | |
|---|---|
| Noise source overview.jpg | Overview of noise sources on instrument panel, BR 204 |

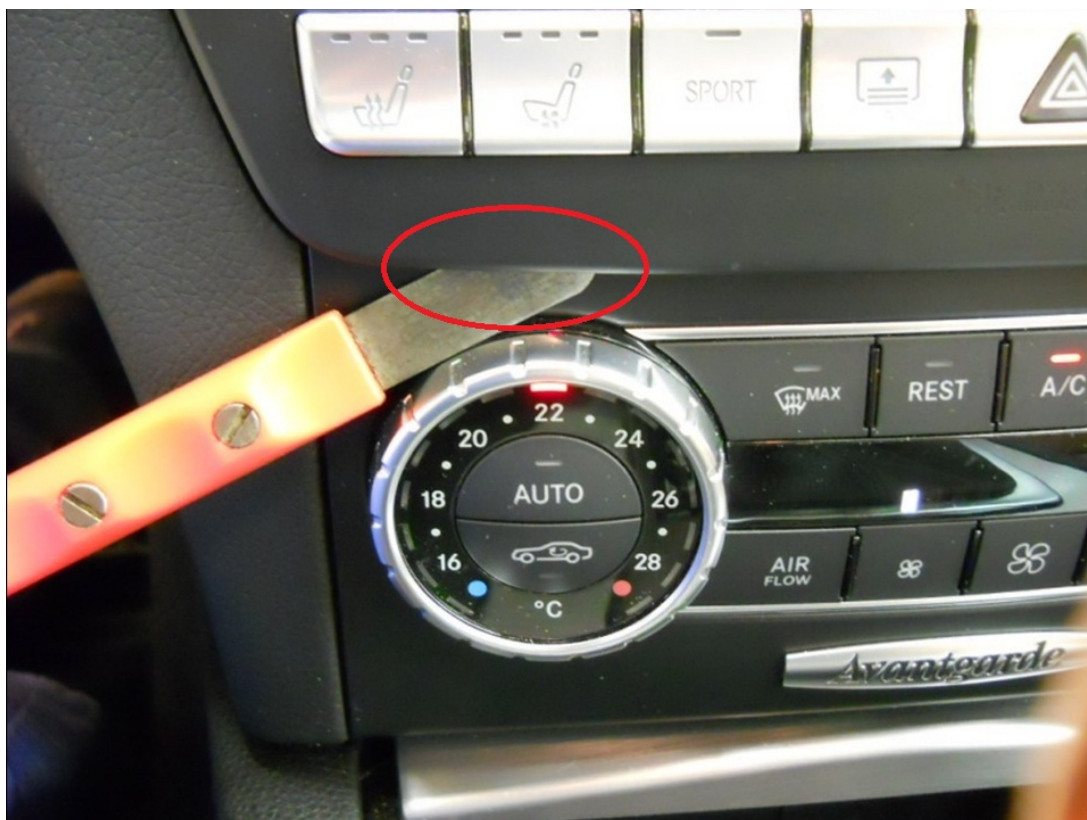
2.jpg:

1. Breakthrough for glove box on crossmember sharp-edged (Attachment 1)
2. Cover of lower control panel makes contact on left side with cover of HVAC control panel (Attachment 2)
3. Lower trim strip of center air vent touches bezel of head unit
4. The material pairing between the chrome rings and the combination cover generates noise at potentially all points of contact (Attachment 4)
5. Relative movement of components to each other (Attachment 5)
6. Improper torque of attachment bolt (Attachment 6)

| Attachments | |
|---|---|
| 2.jpg | Contact area between lower control panel and HVAC control panel |

1. Attach thin layer of felt to suspension at top left of glove box (Attachment 1-2)
2. Apply felt tape to contact points on back side of lower control panel.
3. Attach adhesive pads lined with rubber on lower bar of center air vent (Attachment 3-1 and 3-2)
4. Glue components using hot melt adhesive to each other (Attachment 4-1)

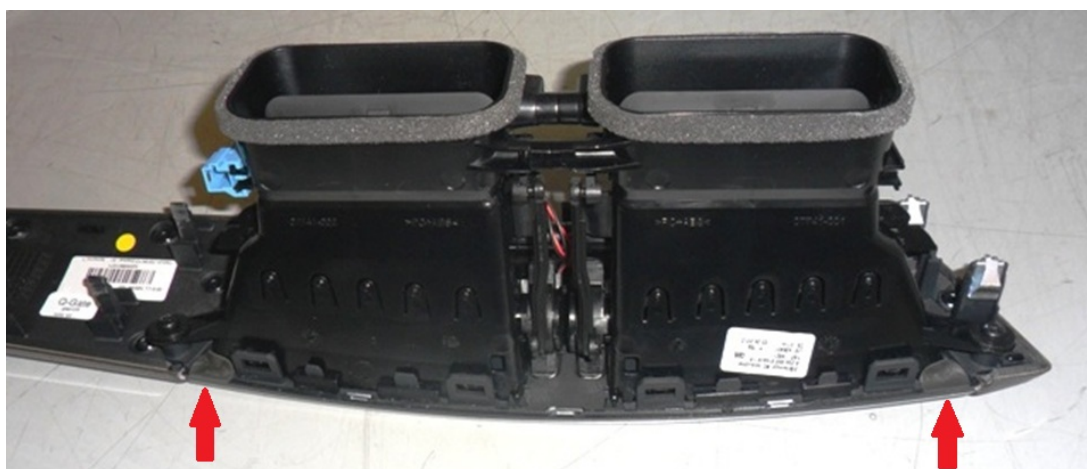
3-1.jpg:

| Attachments | |
|---|---|
| 3-1.jpg | Adhesive pads lined with rubber on lower bar of center air vent |

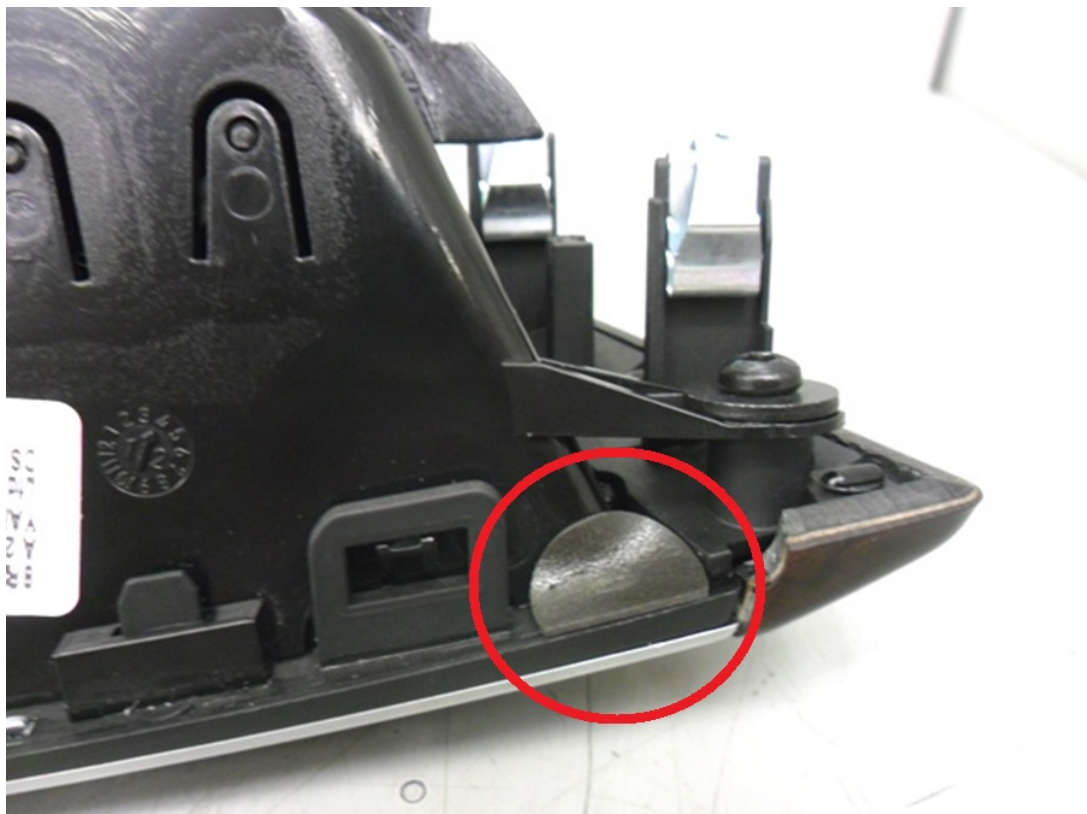
3-2.jpg:

| Attachments | |
|---|---|
| 3-2.jpg | Adhesive pads lined with rubber on lower bar of center air vent |

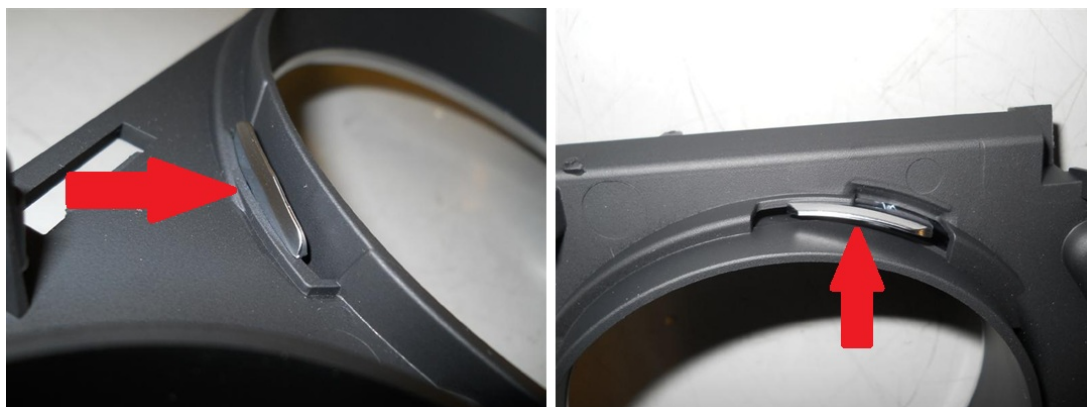
4.jpg:

| Attachments | |
|---|---|
| 4.jpg | Points of contact between chrome ring and instrument cluster cover |

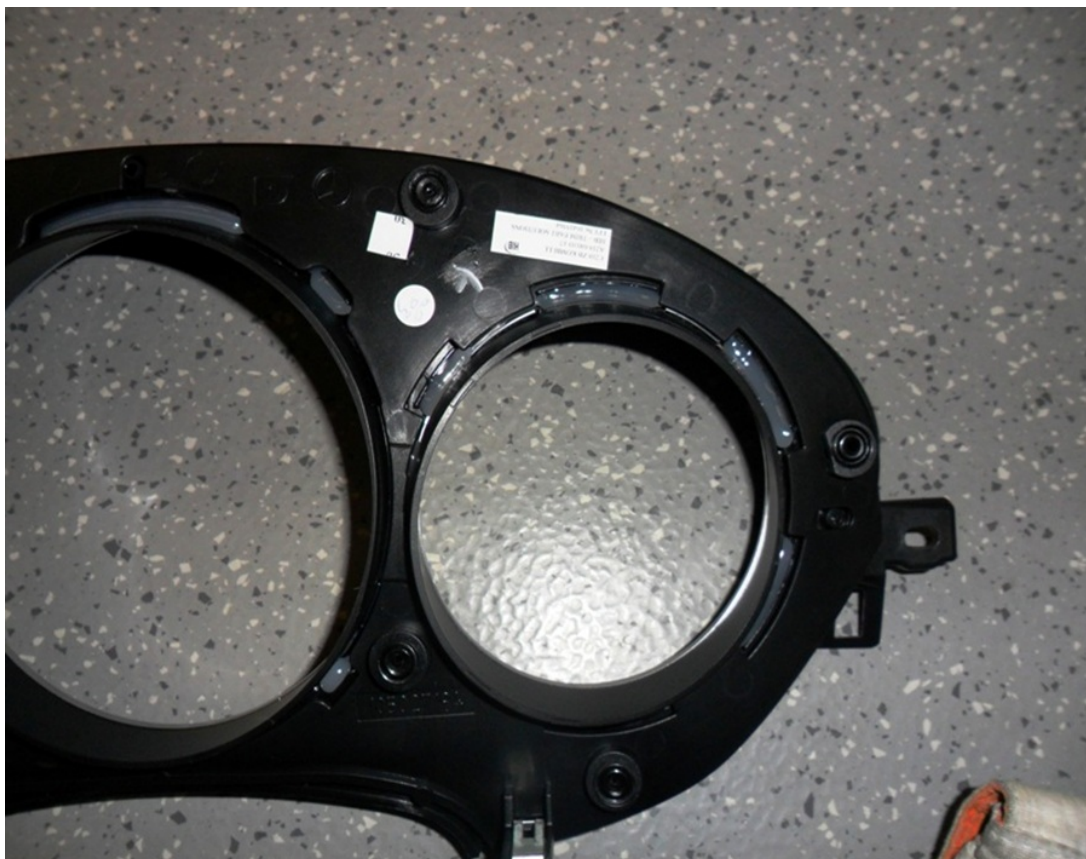
4-1.jpg:

| Attachments | |
|---|---|
| 4-1.jpg | Component bonding. Avoid any thread formation of adhesive. |

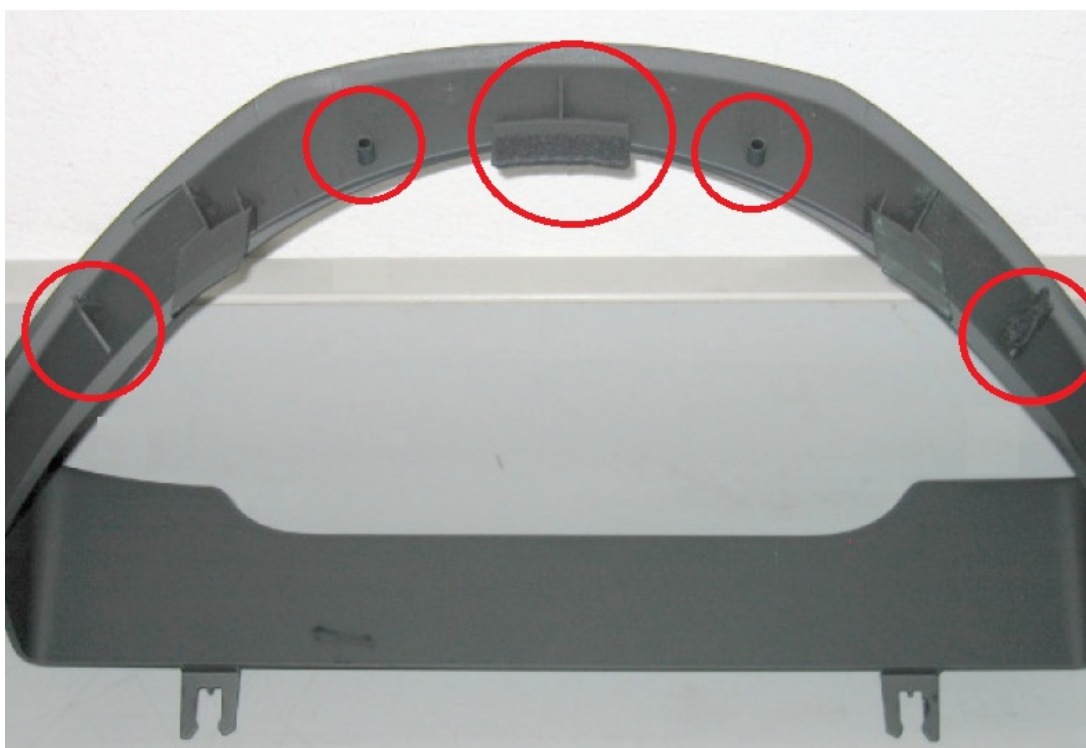
5.jpg:

| Attachments | |
|---|---|
| 5.jpg | Potential noise sources on instrument cluster cover |

5. Attach felt tape to contact points and designated areas.

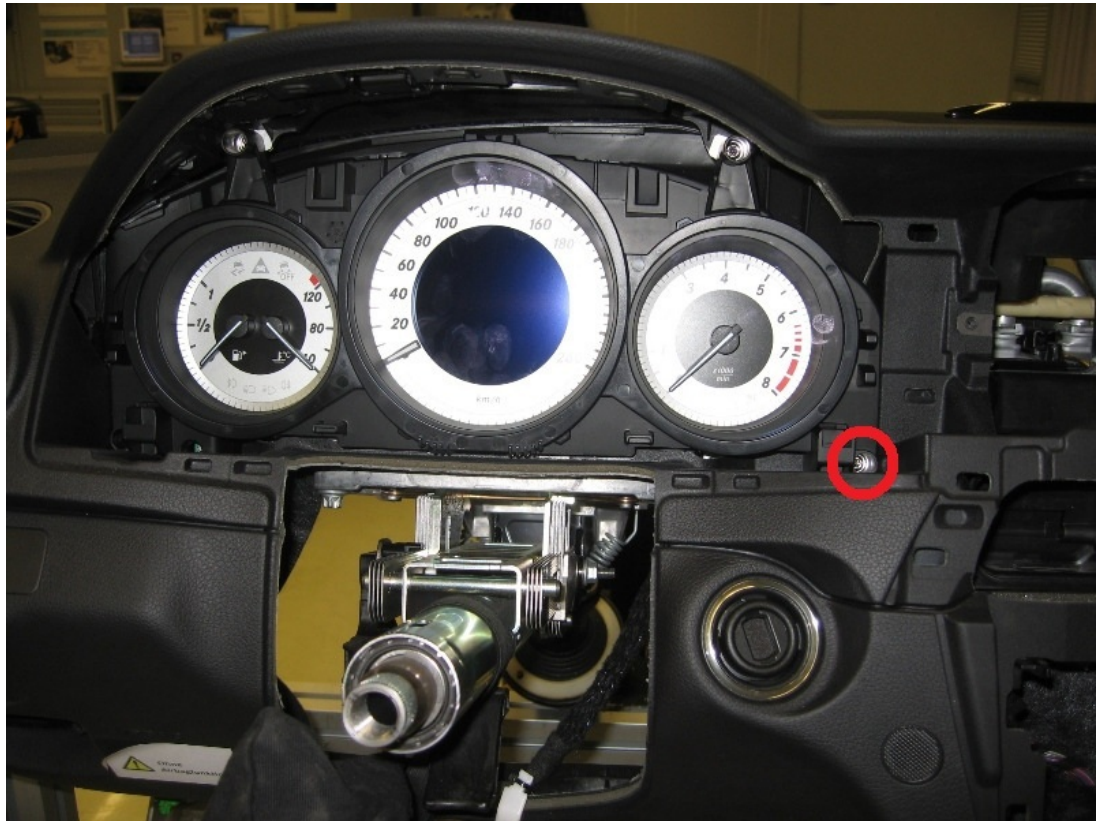
6.jpg:

| Attachments | |
|---|---|
| 6.jpg | Verify torque of bolt and washer assembly |

6. Tighten bolt and washer assembly to 2 Nm (Attachment 6)
