Title: Snow Valve Light Staying ON and Motor Running Constantly

Applies To: 7000, WorkStar

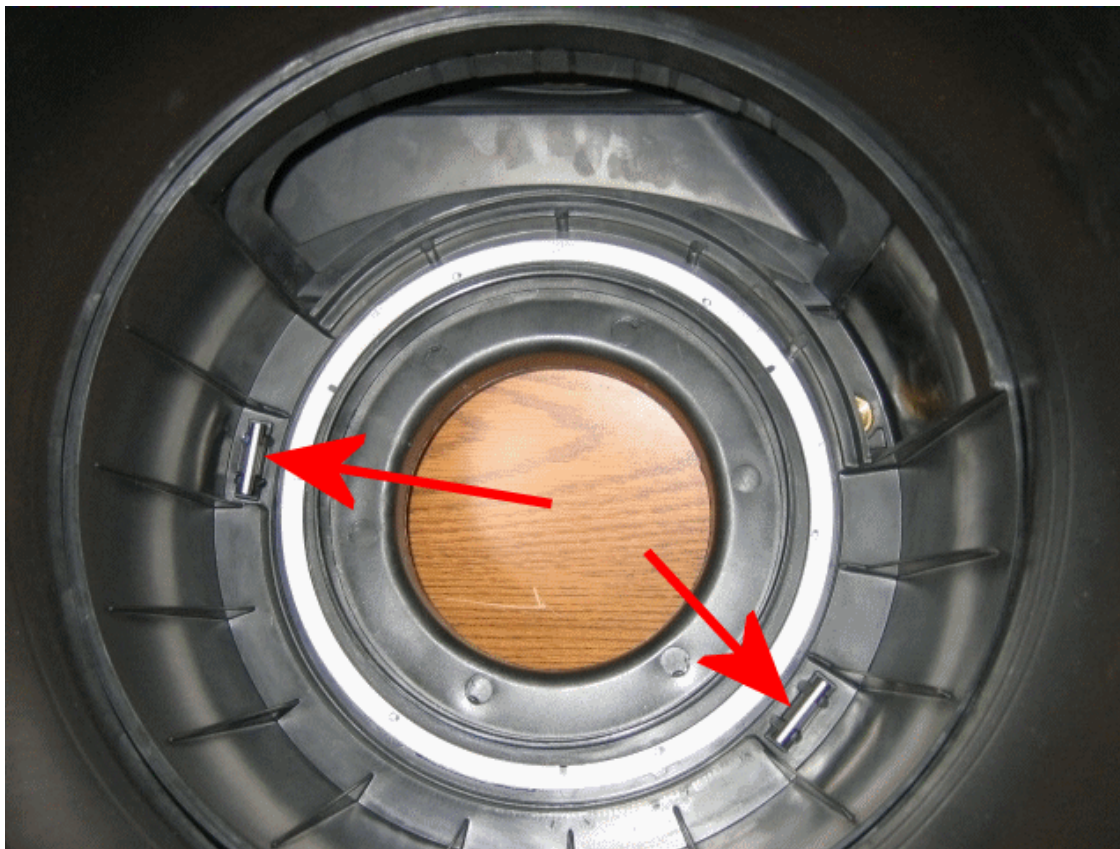
This issue can happen when one or both of the magnets, that look like metal bars, located inside the air cleaner housing, fall out.

These magnets trip the stop switches in the motor assembly.

The switches, in the motor assembly, control when it stops and when the indicators illuminate.

- If the magnets are missing, replace the Housing.

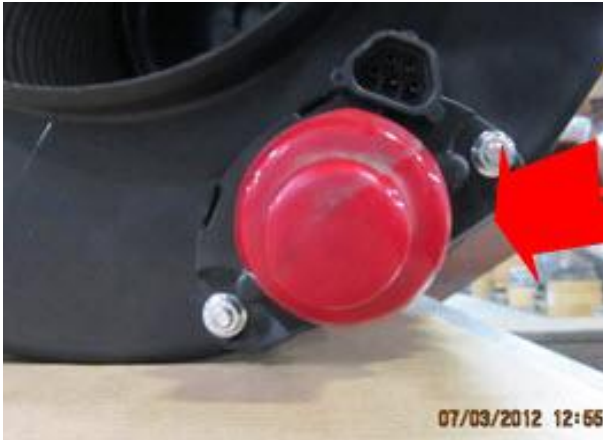
The drive assembly for the MaxxForce 11 and 13 engines is different than the drive for the other engines. It runs in the opposite direction and has a Red cap on it:

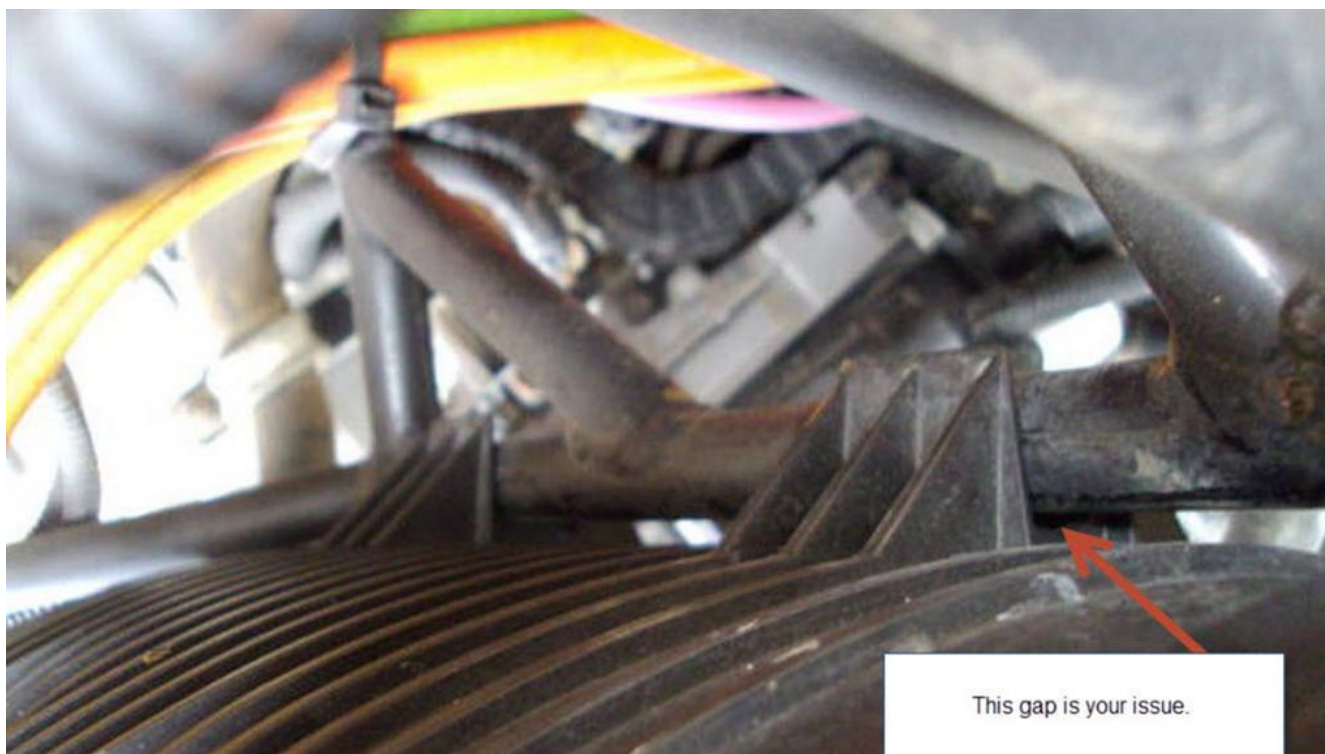
-Be sure that the air cleaner housing is sitting squarely on the bracket. The below picture shows a gap between the bottom mounting point of the air cleaner housing and the bracket. This little bit is enough to cause issue. If this is the case, replace the bracket and the housing, ensuring when it goes back together that the assembly sits flush before operating the snow valve.

- It may be necessary to replace one part or both. Insure there is nothing obstructing the movement of the housing and that the housing is not twisted during installation.
