Title: 2010 MaxxForce 11/13 Aftertreatment Service

Applies To: 2010 MaxxForce 11/13

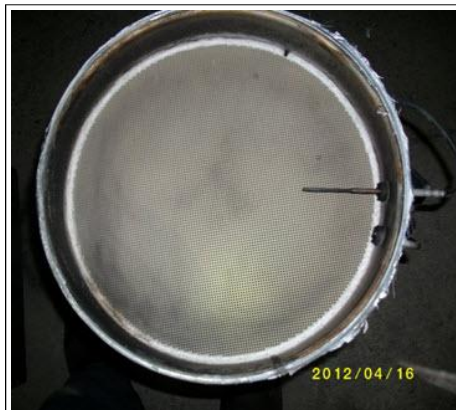
DPF Outlet Normal Operation

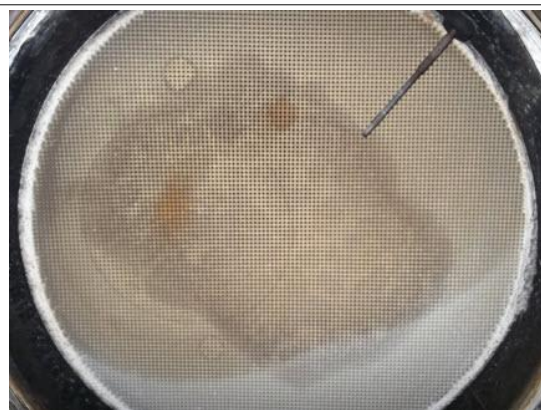
DPF Outlet Coolant Stained - Reusable

- Coolant contaminated DPFs can be cleaned with OBFCT. Reference [Aftertreatment Diagnostic Manual Supplement](#) (performing OBFCT).
- If the DPF has been in service over an extended period of time where coolant has been continually added to the engine, open an iApprove case file.

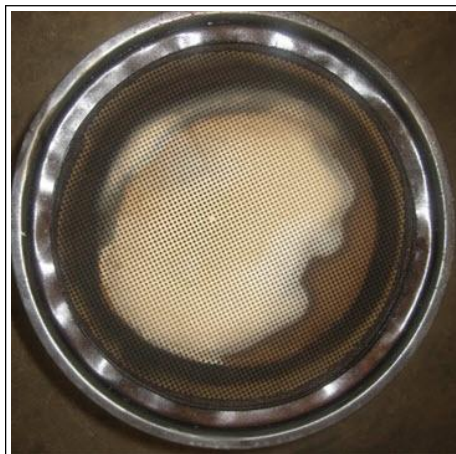
DPF Outlet - Oil Contaminated

1. DPFs that have oil contamination
2. DPF is saturated with oil, see [FSX oil contamination safety letter](#).

**DO NOT ATTEMPT TO RUN THE OBFCT OR CLEAN THE DPF**

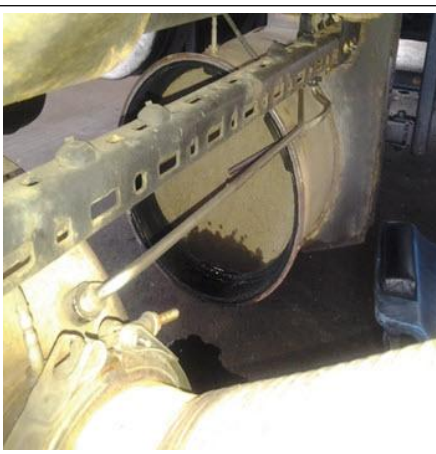
DPF Outlet Coolant - Oil Contaminated

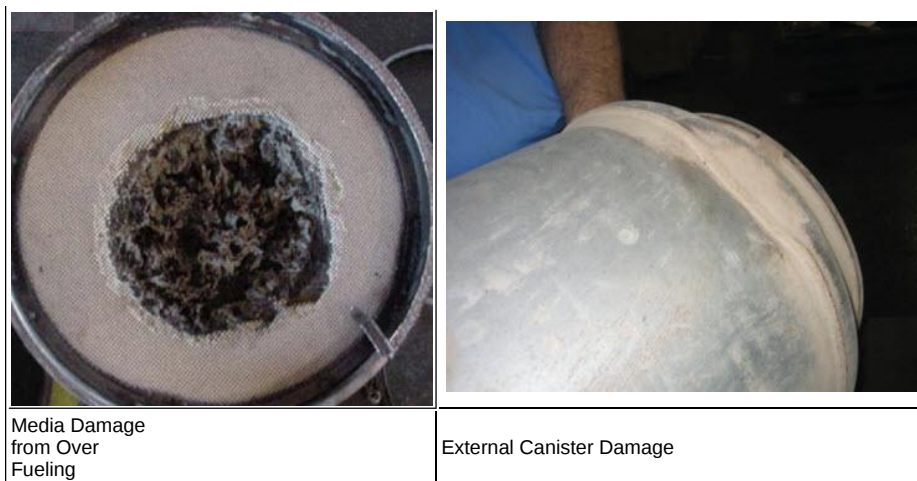
## e. Damaged DPF - Open an iApprove Case File if:

1. External canister damaged (canister or sealing damage).
2. Media damage due to over fueling.
