**Title: ProStar Sleeper Cab Strut Air Leak Detection**

**Applies To: All ProStar Sleeper Models**

Diagnosis of ProStar sleeper cab strut air leaks

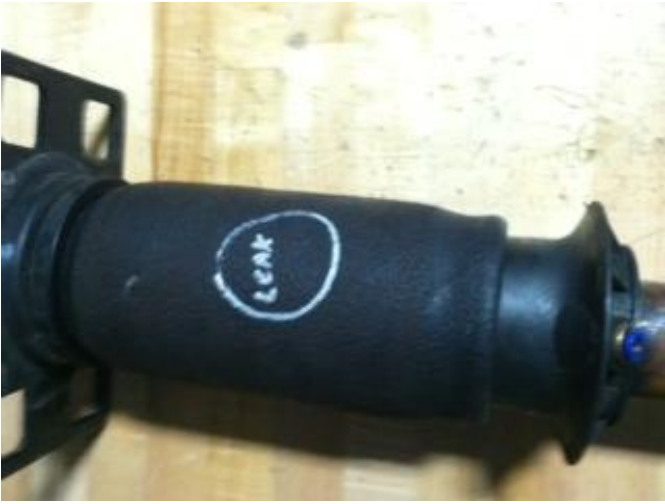
Figure 1 example of marking where air leak was found

To correctly diagnose the cab strut air leaks, the following steps must be taken. Document clearly where the air leak is found and mark the bag distinctly with arrows, circles, and description. **Do NOT replace BOTH cab struts if only one is found defective**
