Service Bulletin

Subject: Rub Type Noise Heard with Steering at Full Turn (Steering Stop) While Driving (Vehicles Equipped with Optional Dealer Installed 19" Wheels Only)

Models: 2013 Cadillac ATS with Dealer Installed 19" Wheel/Tire Package

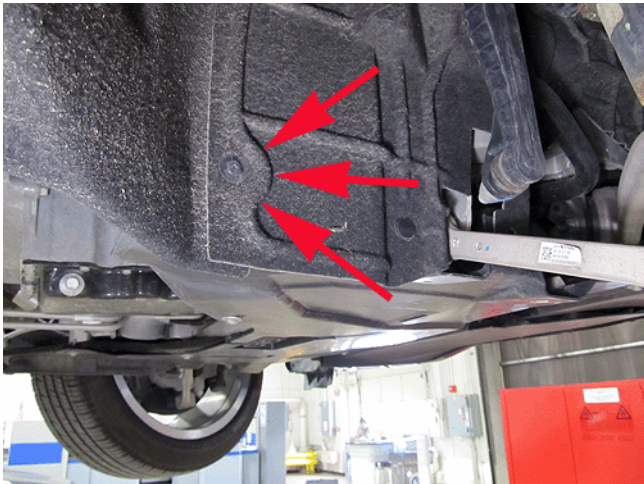
Some customers may comment that after the installation of the 19" accessory wheel and tire package, there is a rubbing noise heard at full turn (steering stop) while driving.

This condition may be caused by the tire contacting a raised section of the front wheelhouse splash shield.

Use the following steps to determine if the updated splash shield is installed on the vehicle and to heat and reshape the splash shield to allow for clearance.

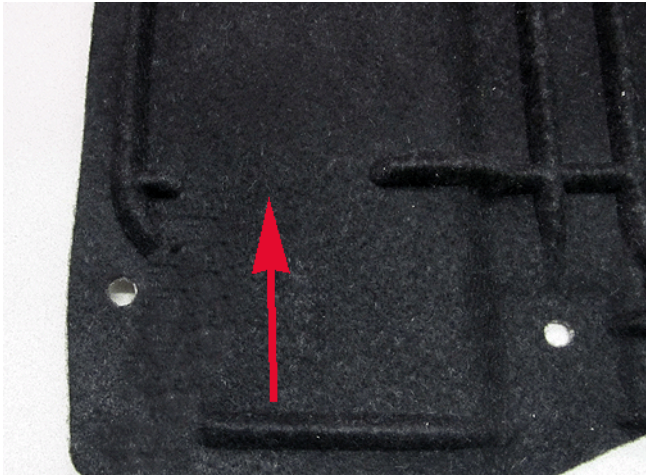
- **Updated design (Rib Removed)**

1. Determine if the vehicle is equipped with the updated design wheelhouse shield.
